# Power-Share Setpoint Sweep under Trapezoidal Load: Bench Results, a Minority-Channel Dropout Limit Cycle, and Validation of Its Firmware Mitigation

Ricky Tan  
rstan@ucdavis.edu

2026-08-11 (revised with the firmware v3 validation sweep)

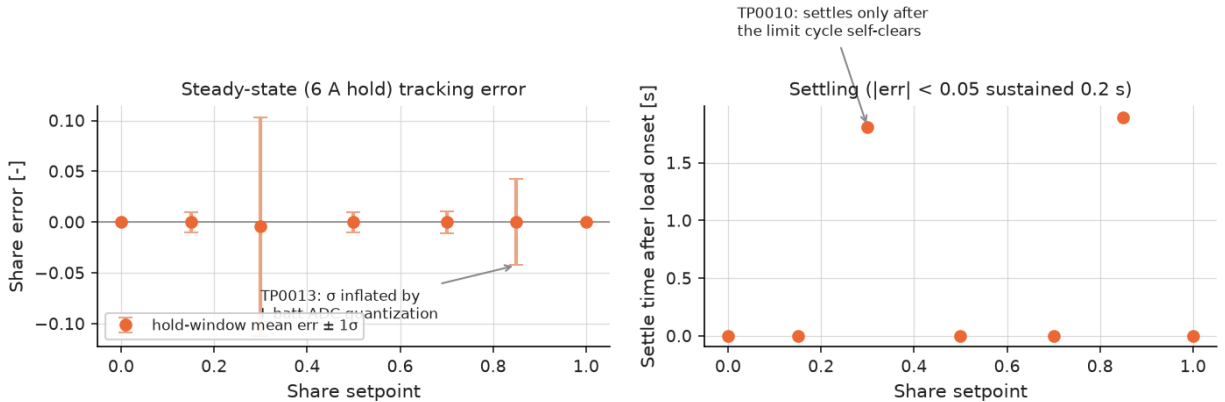
**Figure 1:** Sweep summary. Left: hold-window tracking error is unbiased at every setpoint; the two inflated  $\sigma$  bars belong to the limit-cycle runs (TP0010) and the quantization-corrupted high-share run (TP0013). Right: settling time; interior and endpoint runs are within band at load onset, while the two anomalous runs take  $\approx 1.8$ – $1.9$  s.

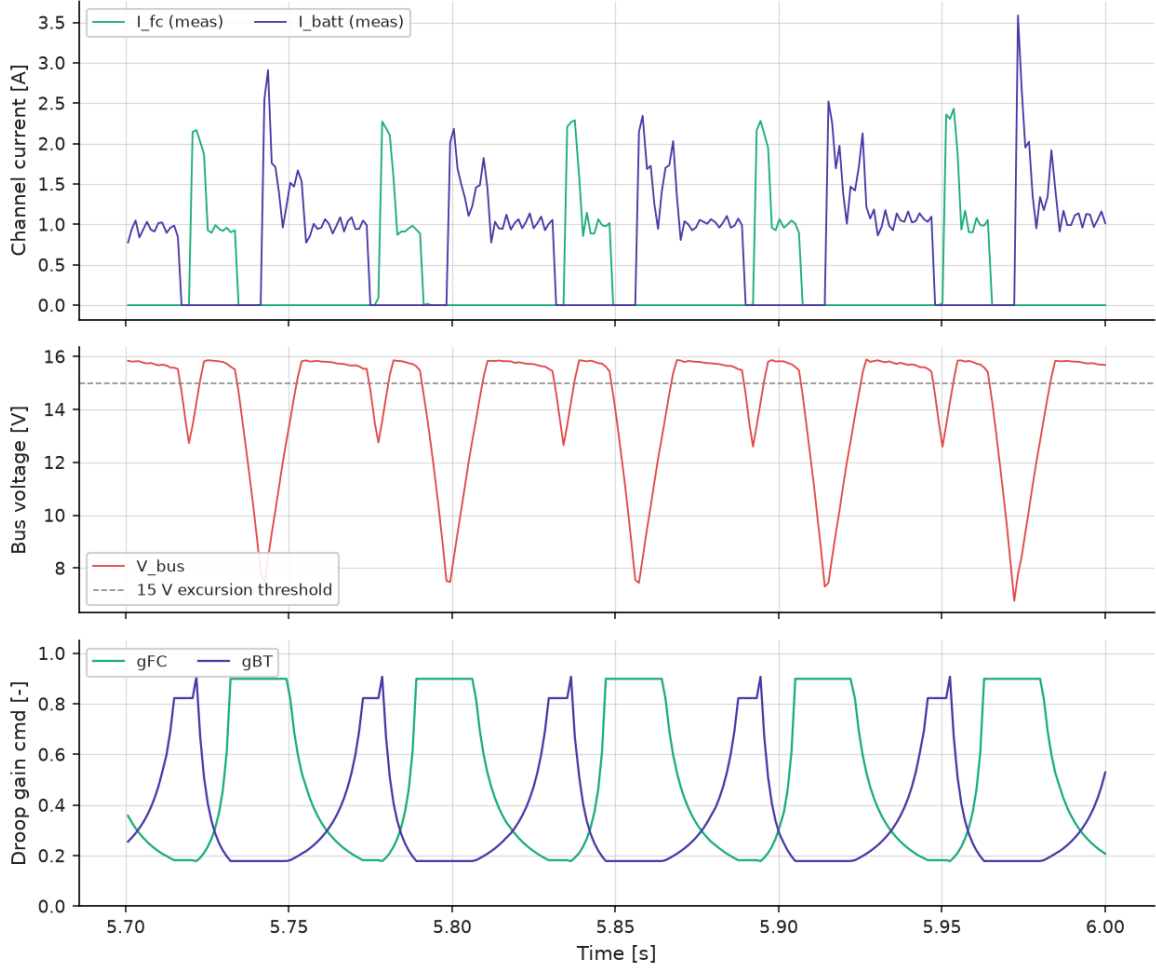
**Figure 4:** Five consecutive cycles of the TP0010 limit cycle. The two channels conduct *mutually exclusively* (both conducting in only 0.1 % of samples); each handoff includes a 10–18 ms window in which *both* channels read zero current and the bus — carrying only its  $\approx 40\ \mu\text{F}$  of ceramics — falls as low as 6.5 V before the incoming channel reconnects with a 2–3.6 A spike.

The data support a *starved-minority-channel dropout loop*: at low total current, the droop command needed to hold the minority channel at a small fraction pushes that channel out of conduction entirely (its RT1987 ideal diode blocks once the droop-raised source characteristic falls below the

bus); the measured share then slams to 0 or 1, the controller drives both MDACs toward their rails, the starved channel reconnects with a large spike, and the cycle repeats. This explains the frequency similarity between the two runs, the mutual exclusivity, the confinement to low total current, and the self-clearing once the minority channel's commanded current rises above its conduction floor.

What that loop alone does *not* explain is TP0010's 10–18 ms *both-channels-off* windows. Two candidates remain open, and the mechanism is explicitly **unconfirmed** pending a scope capture:

1. both boosts are simultaneously droop-commanded out of conduction during the crossover (a pure control-loop artifact of the antiphase rail-to-rail MDAC slew);
2. the RT1987 bus switches' short-circuit-protection cut/retry participates: the 58–59 ms period is suspiciously close to the 64 ms `tSCP_RST` retry fingerprint documented in the board's bring-up record (captures 9–10), and both bus switches have carried 100 nF soft-start capacitors since 2026-08-07, lengthening every reconnect.

Practically, the discrimination no longer gates the fix: both surviving candidates are downstream of the droop loop railing both MDACs antiphase, so the mitigation set of Section 6 (feasibility-gated integrator hold, MDAC slew limiting) is the correct next step under either mechanism.

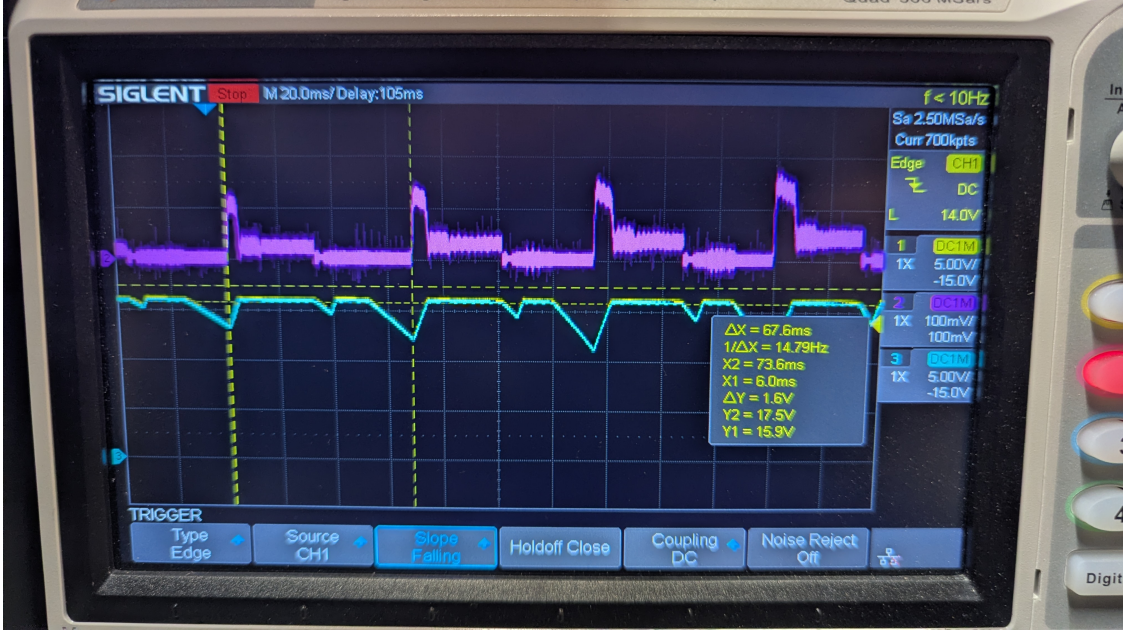
A scope capture aimed at this question was taken on 2026-08-11 (capture 12 in the bring-up record; Figure 6): a repeat of the TP0010 condition with VBUS, V-MOT, and the battery-channel INA monitored, single-shot trigger on VBUS falling through 14 V. It *narrows* the question without closing it:

- **Confirmed: the events are total source-feed dropout windows.** VBUS and V-MOT sag *together* — slow linear ramps of  $\approx 3\text{--}4$  V over tens of milliseconds at a 67.6 ms cursor period (14.8 Hz), each ended by a sharp recovery synchronized with a  $\approx 1$  A reconnect burst on the battery INA. Because the motor switch conducts throughout, the bus rides the combined  $\approx 1\text{--}1.5$  mF motor+VESC capacitance during each window — which is why the decay is slow, and which independently corroborates the SD log's 10–18 ms both-channels-off reading.

- **Ruled out: the VBUS→V-MOT switch as a cutting element** (the two nodes track through every dip).
- **Still open: candidates (1) vs (2).** Both predict exactly this bus signature, and the 67.6 ms period is consistent with either (the RT1987 retry timer is 64 ms; the SD-log median was 58–59 ms). The sharper discriminator, if needed: probe a *boost output* alongside VBUS during a dropout — reconnect at the voltage crossing indicates droop-commanded blocking, reconnect on a fixed 64 ms cadence indicates SCP.

**Figure 6:** Capture 12 (2026-08-11): TP0010-condition repeat, 20 ms/div. CH1 VBUS (yellow, 5 V/div) and CH3 V-MOT (blue, 5 V/div) overlap and sag together in  $\approx 3\text{--}4$  V sawtooth ramps at a 67.6 ms period (cursors); CH2 battery INA (purple, 1 A/div) shows the dropout–reconnect–spike–conduction pattern synchronized with the voltage recoveries. The flat yellow line near 15.9 V is the Y1 measurement cursor, not the VBUS trace.
