# Power-Share Setpoint Sweep under Trapezoidal Load: Bench Results, a Minority-Channel Dropout Limit Cycle, and Validation of Its Firmware Mitigation

Ricky Tan  
rstan@ucdavis.edu

2026-08-11 (revised 2026-08-12 with the firmware v3, v4, and v5 validation sweeps)

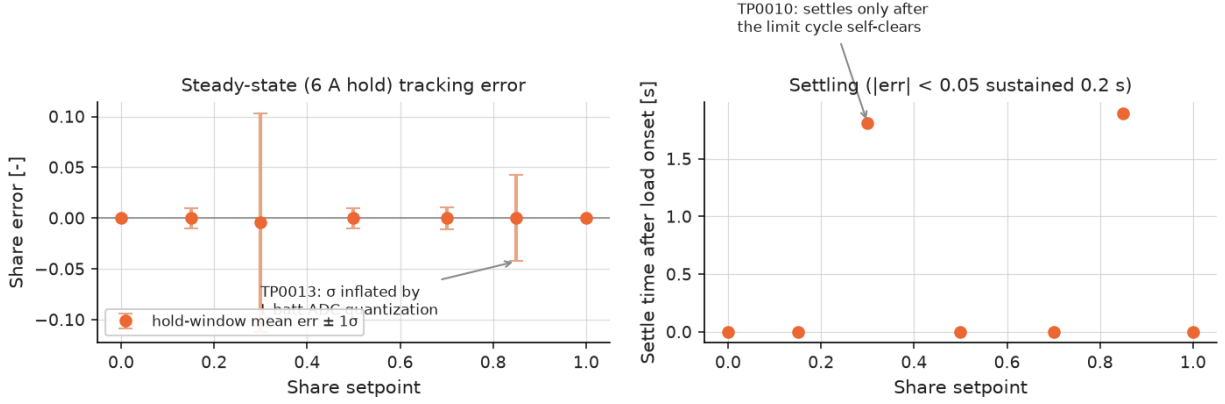
**Figure 1:** Sweep summary. Left: hold-window tracking error is unbiased at every setpoint; the two inflated  $\sigma$  bars belong to the limit-cycle runs (TP0010) and the quantization-corrupted high-share run (TP0013). Right: settling time; interior and endpoint runs are within band at load onset, while the two anomalous runs take  $\approx 1.8$ – $1.9$  s.

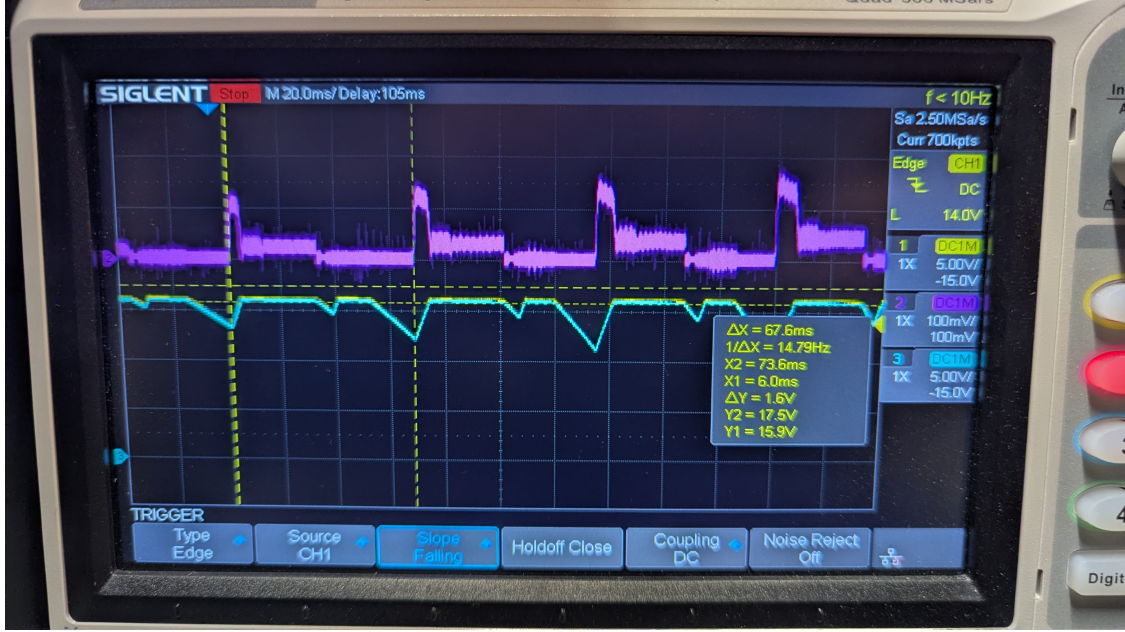
A scope capture aimed at this question was taken on 2026-08-11 (capture 12 in the bring-up record; Figure 6): a repeat of the TP0010 condition with VBUS, V-MOT, and the battery-channel INA monitored, single-shot trigger on VBUS falling through 14 V. It *narrows* the question without closing it:

- **Confirmed: the events are total source-feed dropout windows.** VBUS and V-MOT sag *together* — slow linear ramps of  $\approx 3\text{--}4\text{ V}$  over tens of milliseconds at a 67.6 ms cursor period (14.8 Hz), each ended by a sharp recovery synchronized with a  $\approx 1\text{ A}$  reconnect burst on the battery INA. Because the motor switch conducts throughout, the bus rides the combined  $\approx 1\text{--}1.5\text{ mF}$  motor+VESC capacitance during each window — which is why the decay is slow, and which independently corroborates the SD log's 10–18 ms both-channels-off reading.

- **Ruled out: the VBUS→V-MOT switch as a cutting element** (the two nodes track through every dip).
- **Still open: candidates (1) vs (2).** Both predict exactly this bus signature, and the 67.6 ms period is consistent with either (the RT1987 retry timer is 64 ms; the SD-log median was 58–59 ms). The sharper discriminator, if needed: probe a *boost output* alongside VBUS during a dropout — reconnect at the voltage crossing indicates droop-commanded blocking, reconnect on a fixed 64 ms cadence indicates SCP.

**Figure 6:** Capture 12 (2026-08-11): TP0010-condition repeat, 20 ms/div. CH1 VBUS (yellow, 5 V/div) and CH3 V-MOT (blue, 5 V/div) overlap and sag together in  $\approx 3\text{--}4\text{ V}$  sawtooth ramps at a 67.6 ms period (cursors); CH2 battery INA (purple, 1 A/div) shows the dropout–reconnect–spike–conduction pattern synchronized with the voltage recoveries. The flat yellow line near 15.9 V is the Y1 measurement cursor, not the VBUS trace.

Practically, the discrimination no longer gates the fix: both surviving candidates are downstream of the droop loop railing both MDACs antiphase, so the mitigation set of Section 8 (feasibility-gated integrator hold, MDAC slew limiting) is the correct next step under either mechanism.

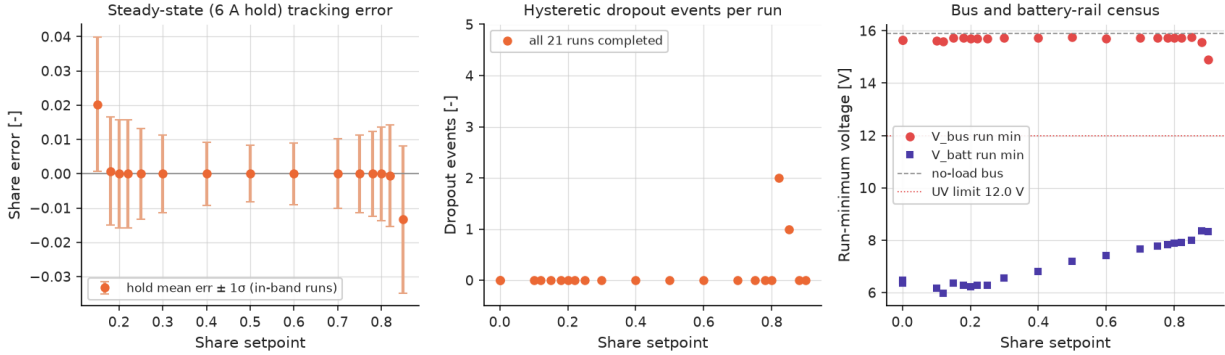
Tracking bias in the 6 A hold window is below  $10^{-3}$  at every in-band setpoint from 0.18 to 0.82. The two band-edge runs show the governor clip, not a tracking failure: at  $r^* = 0.15$  the floor raises the effective setpoint to 0.169 and the measured share lands  $+1.5 \times 10^{-3}$  from it ( $+0.020$  from the raw value); at  $r^* = 0.85$  the clip is active in the other direction ( $-0.013$  from the raw value). The five out-of-band runs ( $r^* \in \{0, 0.10, 0.12, 0.88, 0.90\}$ ) latch a hard single-channel cut: the starved channel’s measured current is exactly zero for the whole run, the controller stays frozen, and the isolated dropout-counter events in Figure 17 are threshold-crossing artifacts at the ramp edges, not cycling. The spectral check is negative everywhere: over every hold window the 14–24 Hz band

**Figure 17:** Firmware v5 trapezoid ladder (TP0074–TP0094). Left: hold-window tracking error versus the raw setpoint; the two outliers at 0.15 and 0.85 are the governor clip acting as designed. Center: dropout events; the two nonzero counts (1 at 0.85, 2 at 0.82) are ramp-edge threshold crossings, with zero events inside any hold window. Right: run-minimum bus and battery-rail voltages; the battery rail dips lowest where the battery is the sole source (setpoints  $\leq 0.12$ ), reaching 5.98 V at  $r^* = 0.12$ .
