# Power-Share Setpoint Sweep under Trapezoidal Load: Bench Results, a Minority-Channel Dropout Limit Cycle, and Validation of Its Firmware Mitigation

Ricky Tan  
rstan@ucdavis.edu

2026-08-11 (revised 2026-08-13 with the firmware v3, v4, v5, and v6 validation sweeps)

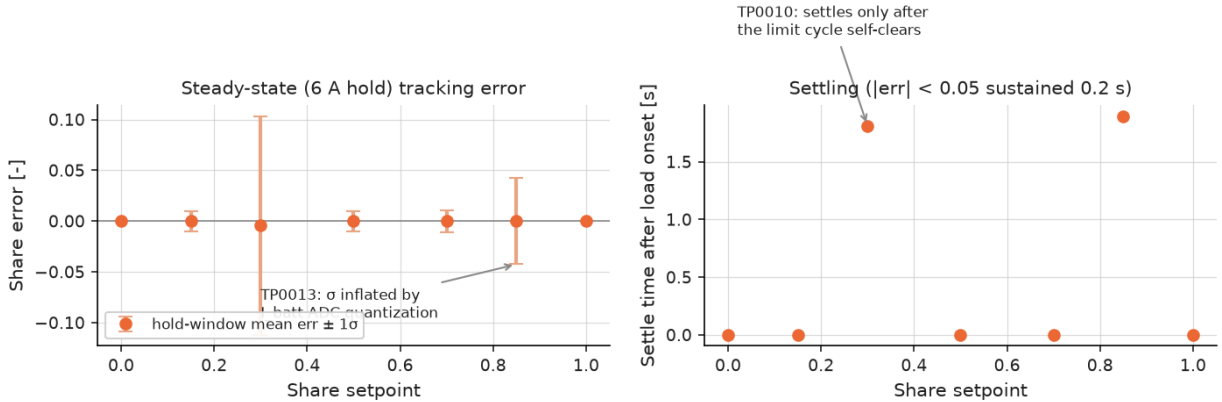
Figure 1 summarizes the sweep. Hold-window mean error is below  $10^{-3}$  at every setpoint from 0 to 1 — the integral action carries no bias anywhere in the span, matching the design intent of the Youla controller’s exact  $T(0) = 1$  constraint. Interior setpoints (0.3–0.7) show  $\sigma \approx 0.01$  with the droop-gain commands comfortably mid-band, and Figure 2 shows the representative clean run at  $r^* = 0.5$ . The endpoints are degenerate by construction: at  $r^* = 1$  the BT channel simply stops conducting and both MDAC commands sit pinned at the band edges (an open loop with zero error); at  $r^* = 0$  the loop freezes mid-range with the FC channel dark. Neither endpoint misbehaves.

**Figure 1:** Sweep summary. Left: hold-window tracking error is unbiased at every setpoint; the two inflated  $\sigma$  bars belong to the limit-cycle runs (TP0010) and the quantization-corrupted high-share run (TP0013). Right: settling time; interior and endpoint runs are within band at load onset, while the two anomalous runs take  $\approx 1.8$ – $1.9$  s.

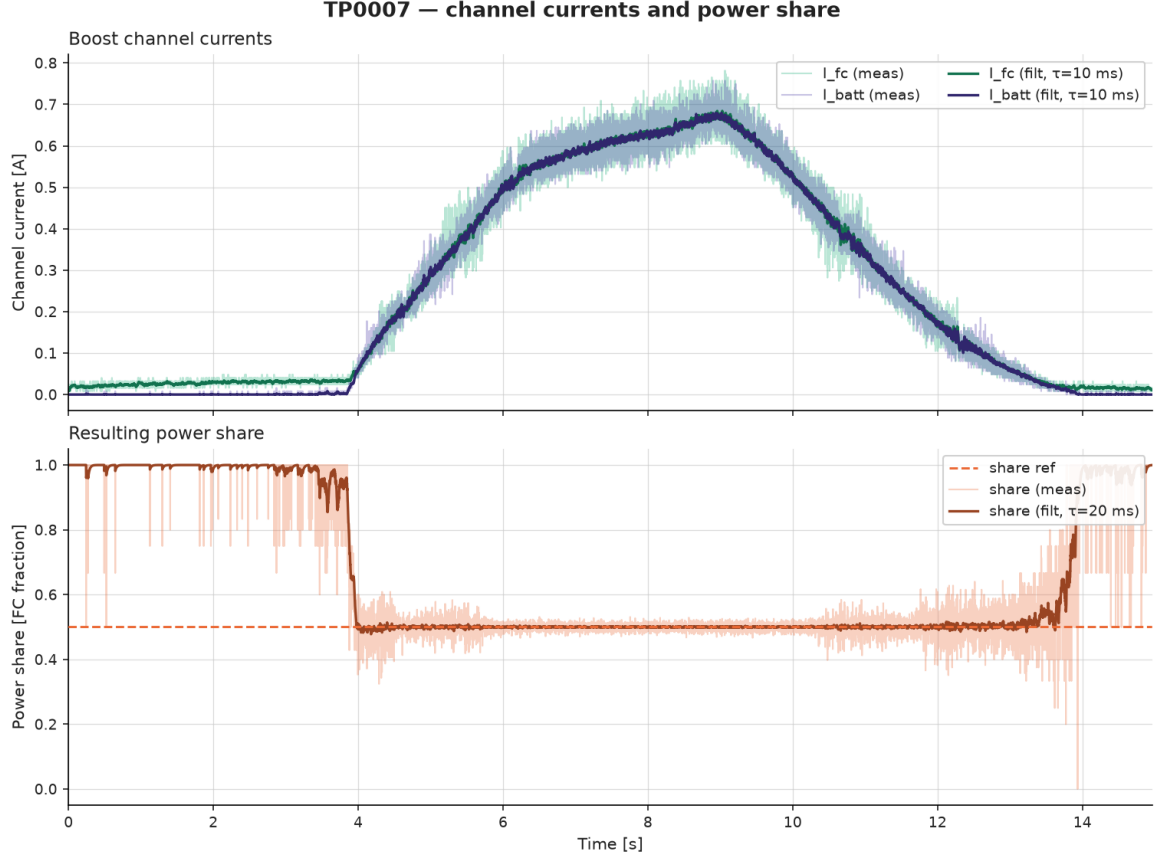
**Figure 2:** Representative clean run (TP0007,  $r^* = 0.5$ ): symmetric channel currents through the full trapezoid, share locked to the setpoint whenever total current is above the measurement floor. The share excursions before load onset and after load release are the known low-current region where the share ratio is numerically undefined, not a control failure.

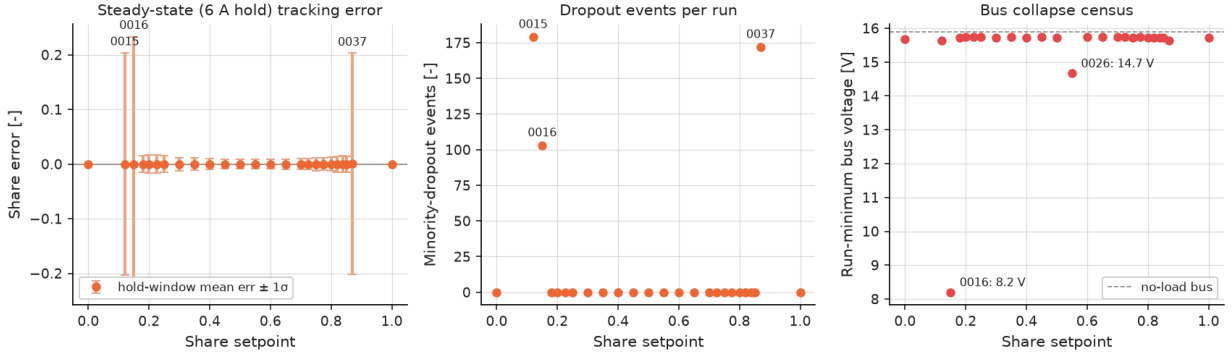
Figure 8 summarizes the ladder. Every setpoint from 0.18 to 0.85 — including 0.30 and 0.85, the two original failure points — runs with zero dropout events, a flat bus (run minimum 15.72 V against a 15.9 V rail), and hold-window bias below  $10^{-4}$  with  $\sigma = 0.009$ –0.017. At the original severe point 0.30 (TP0021), the comparison against TP0010 is: 64 collapse events to zero; bus minimum 6.55 V to 15.73 V; peak reconnect current 3.6 A to 0.74 A.

**Figure 8:** Validation-sweep summary, TP0014–TP0038 (firmware v3). Left: hold-window tracking error remains unbiased at every setpoint; the three inflated  $\sigma$  bars are the residual failure runs. Center: hysteretic dropout-event count — only 0.12, 0.15, and 0.87 cycle; the deep out-of-band endpoints 0 and 1 are clean latched cutoffs. Right: run-minimum bus voltage; only TP0016 (0.15) collapses the bus.

The governor’s mechanism is directly observable in the logs. In every clean asymmetric run the minority-channel current is pinned at 0.204–0.214 A — the 0.20 A floor held to within 5% — across a threefold span of total current, then released at the predicted crossover  $I_{\text{tot}} = I_{\text{min}}/r^*$  plus the load-filter lag. The collapse-to-0.5 plateau below 0.40 A filtered total appears as a distinct shelf in every ramp. The slew limiter is respected exactly in all 27 runs (maximum per-record ratio step 0.0200) and saturates for substantial stretches, confirming it is load-bearing.

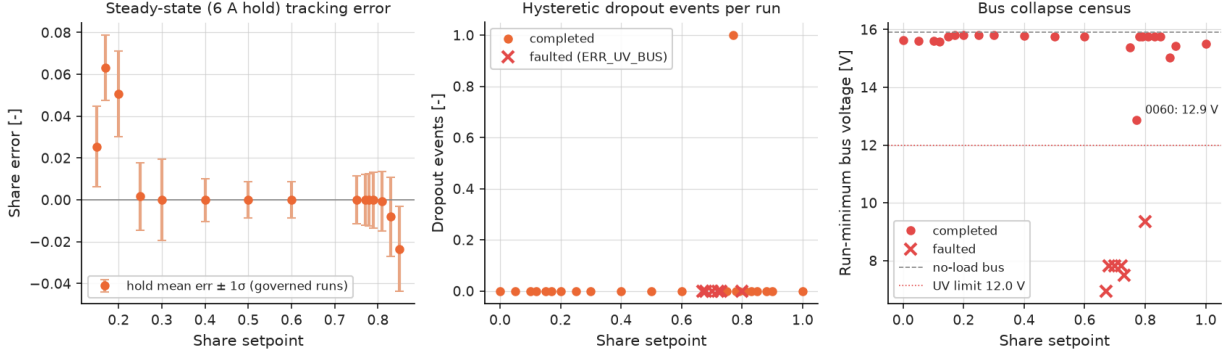
Figure 13 summarizes the ladder. All three residual failure classes of Section 5 are eliminated:

- **The band edge.** TP0045 ( $r^* = 0.15$ ), the firmware v3 bus collapse, is clean: zero dropout events, bus minimum 15.75 V, and the commanded minority current bottoms at exactly 0.3000 A — the raised floor holding on its design boundary. Measured share tracks the reconstructed governed setpoint with residual  $0.0001 \pm 0.019$ , against an apparent raw-setpoint “error” of +0.137 that is entirely governor action.

- **The governed band.** Every completed in-band run tracks with hold bias below  $10^{-3}$  where the governor is inactive, and matches the reconstructed clip elsewhere; the W profiles reproduce the governor law with residuals  $\leq 0.0019$  at every non-cycling region and respect the slew ceiling exactly (maximum per-record step 0.020000). The TP0026-class ramp-down burst did not recur at any setpoint.

**Figure 13:** Firmware v4 ladder summary, TP0041–TP0068. Left: hold-window tracking error of the governed (in-band, completed) runs; the non-zero means at 0.15–0.20 and 0.83–0.85 are the raised governor floor clipping at hold, not loop error. Center: hysteretic dropout events — zero everywhere, including the six faulted runs, whose relay cycle never co-conducts and is therefore invisible to a minority-dropout counter. Right: run-minimum bus voltage; crosses mark the six `ERR_UV_BUS` latches, and TP0060 is the surviving near-miss at 12.9 V.

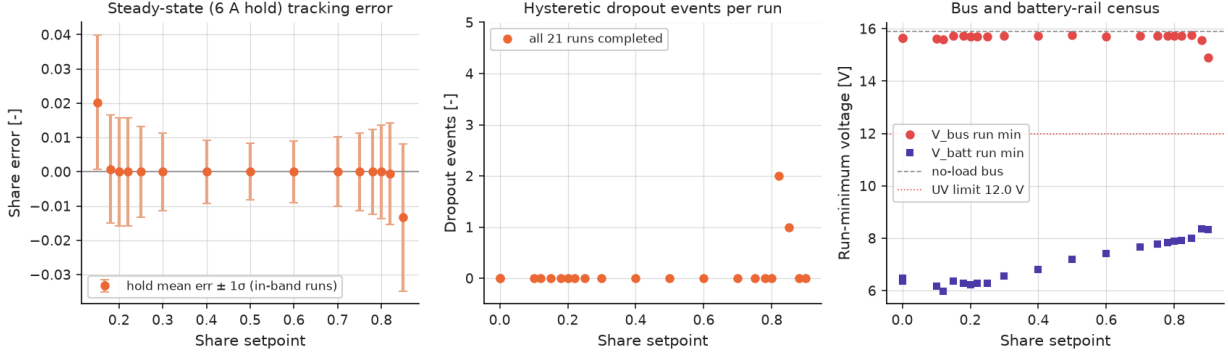
Figure 17 summarizes the ladder: 21 of 21 runs complete, zero fault flags in every sample, and no bus sample below 14.89 V anywhere in the campaign. The firmware v4 relay region is closed. Table 3 compares the four relay-cycle setpoints directly.

Tracking bias in the 6 A hold window is below  $10^{-3}$  at every in-band setpoint from 0.18 to 0.82. The two band-edge runs show the governor clip, not a tracking failure: at  $r^* = 0.15$  the floor raises the effective setpoint to 0.169 and the measured share lands  $+1.5 \times 10^{-3}$  from it ( $+0.020$  from the raw value); at  $r^* = 0.85$  the clip is active in the other direction ( $-0.013$  from the raw value). The five out-of-band runs ( $r^* \in \{0, 0.10, 0.12, 0.88, 0.90\}$ ) latch a hard single-channel cut: the starved channel’s measured current is exactly zero for the whole run, the controller stays frozen, and the isolated dropout-counter events in Figure 17 are threshold-crossing artifacts at the ramp edges, not cycling. The spectral check is negative everywhere: over every hold window the 14–24 Hz band

carries 4–6 % of the residual energy with no peak.

**Figure 17:** Firmware v5 trapezoid ladder (TP0074–TP0094). Left: hold-window tracking error versus the raw setpoint; the two outliers at 0.15 and 0.85 are the governor clip acting as designed. Center: dropout events; the two nonzero counts (1 at 0.85, 2 at 0.82) are ramp-edge threshold crossings, with zero events inside any hold window. Right: run-minimum bus and battery-rail voltages; the battery rail dips lowest where the battery is the sole source (setpoints  $\leq 0.12$ ), reaching 5.98 V at  $r^* = 0.12$ .

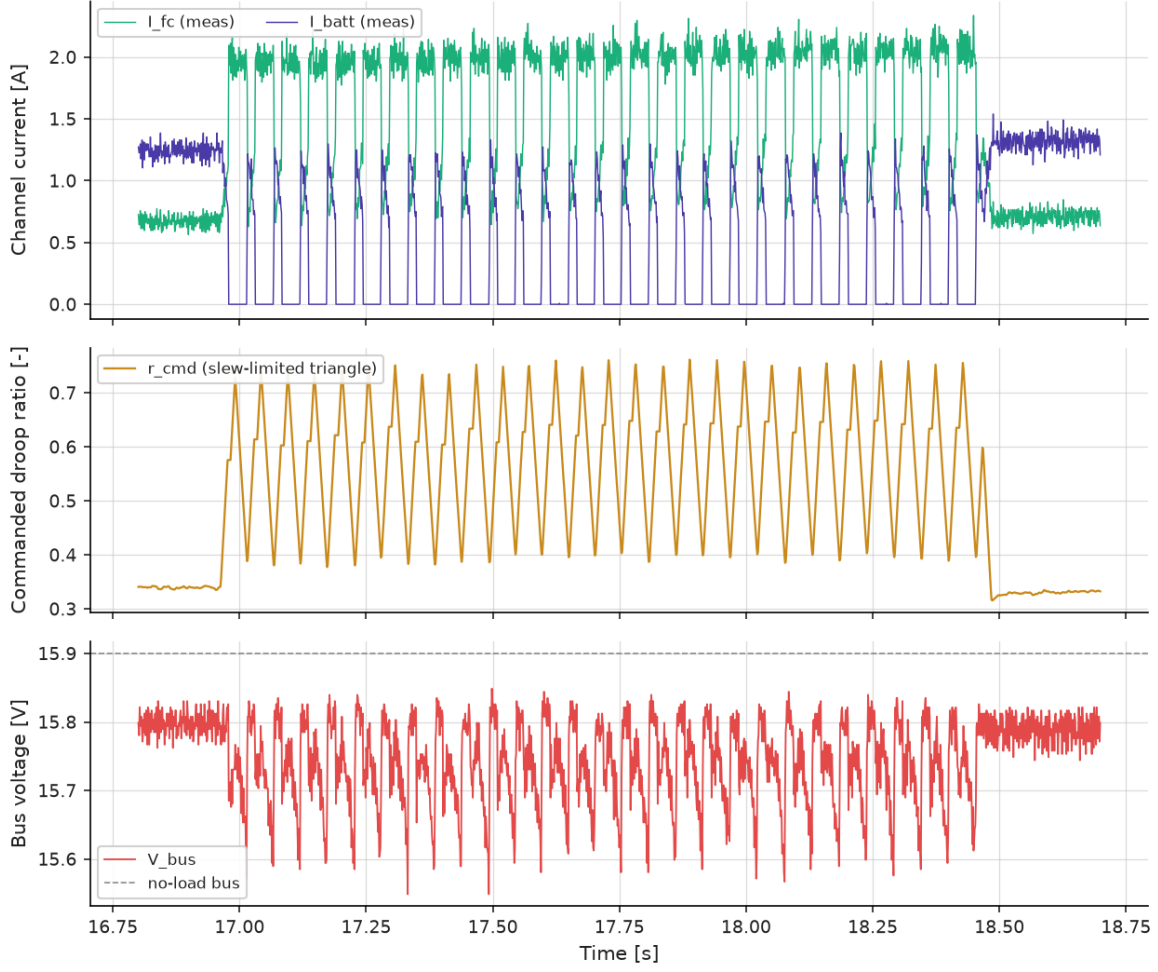
**Targets 0.80–0.85: the firmware v4 dropout cycle, in band.** The setpoint is inside  $[0.15, 0.85]$ , so no latch fires and the closed loop stays live. The equilibrium it is asked for is infeasible, and the loop limit-cycles: the battery channel stops conducting, the controller walks the ratio back down at the slew ceiling, the channel reconnects, and the cycle repeats at 18.8 Hz — the period set by the 0.02-per-tick limit walking the ratio triangle (Figure 18). This is the firmware v4 pre-brownout mode, not the relay cycle: the fuel-cell channel conducts continuously and there are no both-off gaps. The governor is structurally inert here — at 2 A total the floor clips only outside  $[0.15, 0.85]$ , so targets 0.80 and 0.85 pass through unmodified — and the channel drops out at a *commanded* minority current of 0.55–1.04 A, two to three times the 0.30 A floor.

**Figure 18:** WP0100 ( $b = 0.15$ ), region R6. Top: the battery channel drops out and reconnects 28 times at 18.8Hz while the fuel-cell channel carries the full  $\approx 2$  A. Middle: the commanded droop ratio is the slew-limited triangle between  $\approx 0.39$  and  $\approx 0.75$ . Bottom: the bus notches by  $\approx 0.25$  V per episode but never approaches the 12 V limit. The cycle self-terminates the instant R7 steps the setpoint back to 0.35.

13. **The W-profile R6 excursion is a test-design hazard and a finding in one.** It is the only region combining peak load with an extreme share command, and it generated all five failures. Do not run W/Y profiles with  $b < 0.30$  until the region drops its motor axis; record  $b$  and  $I_{\text{max}}$  in the log header. Separately, the  $b = 0$  case shows the setpoint-latched cutoff acting as an under-load channel cut that collapses the surviving source in 40 ms — the latch needs a load-aware guard (defer the cut, or ramp it, when the surviving channel cannot carry the measured total).

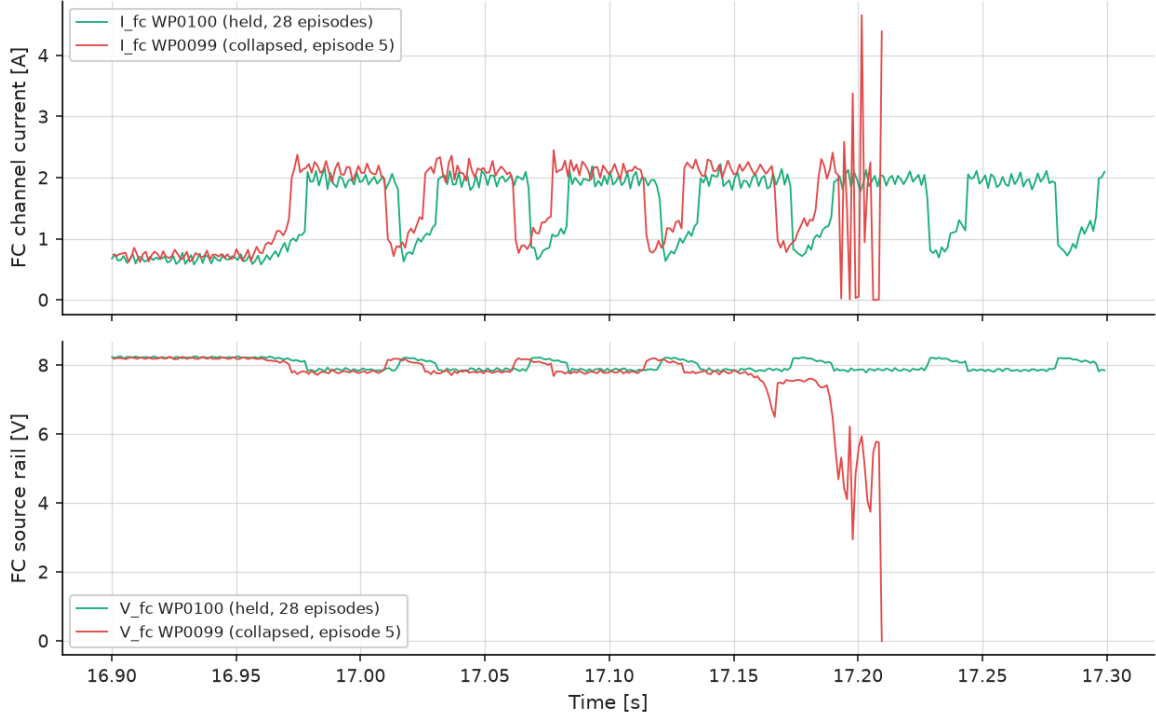
Whether a run at target 0.80–0.85 survives is decided not by the cycle itself but by the fuel-cell source. During each battery-off half-cycle the fuel-cell input carries the whole load, and the source exhibits a hard knee at  $\approx 2.1$  A: WP0100 ran 28 consecutive solo episodes at 1.96–2.08 A with the rail flat at 7.8 V, while WP0096, WP0098, and WP0099 drew 2.11–2.19 A and the rail collapsed within two to five episodes (Figure 19). Roughly 0.1 A of motor load separates the clean run from the three deaths. Once the rail falls, the boost demands more input current to hold the bus — logged fuel-cell current spikes reach 6.1 A as the rail passes below 5 V — a positive-feedback source-collapse runaway. Whether the knee is bench-supply current foldback or source droop is not distinguishable from the logs.

**Figure 19:** The fuel-cell source knee. WP0100 (green) and WP0099 (red) run the same  $b = 0.15$  profile; their solo-episode fuel-cell currents differ by  $\approx 0.1$  A. WP0100 holds 7.8 V through 28 episodes; WP0099’s rail collapses on its fifth episode and the input current runs away.

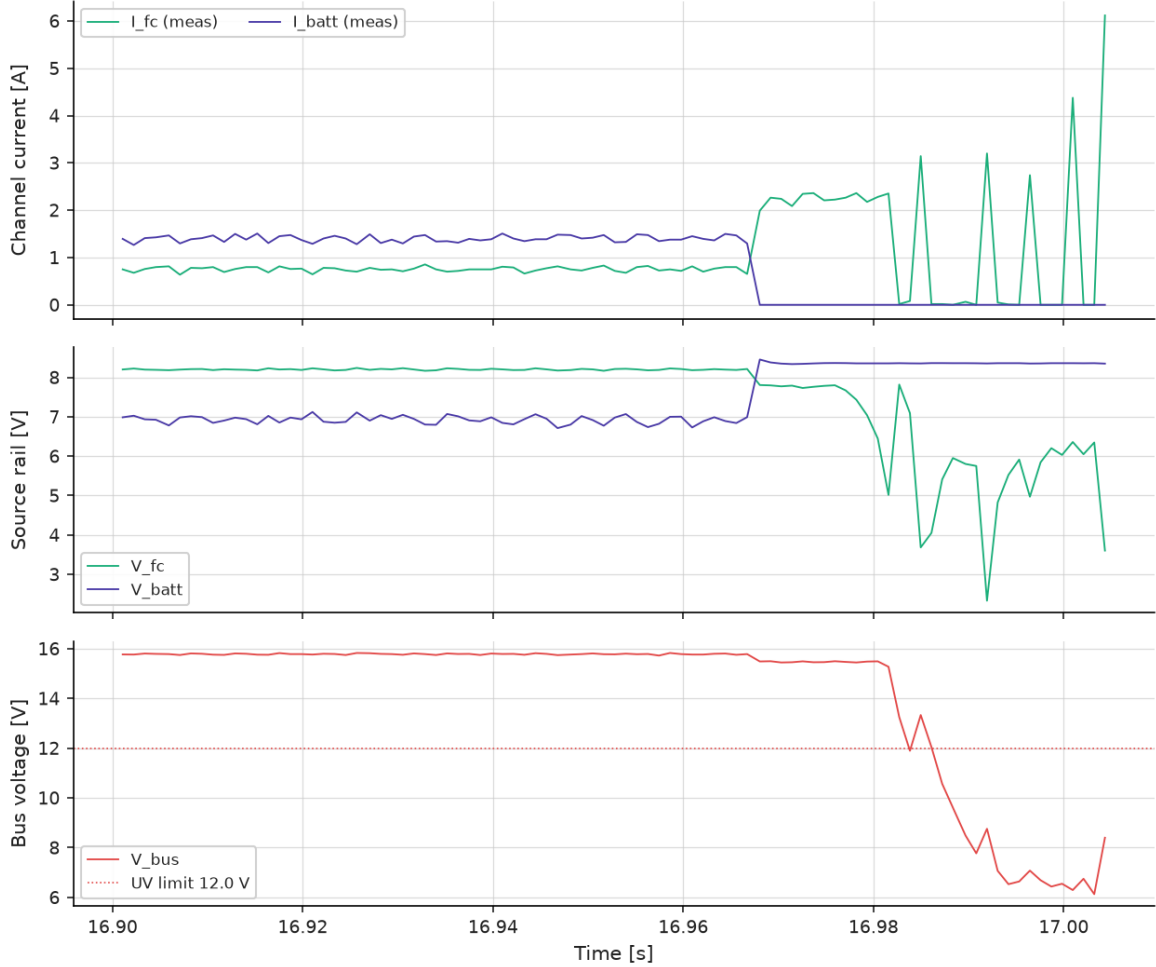
**Target 1.00: the setpoint latch becomes the killer.** With  $b = 0$  the R6 command exceeds `DROOP_R_MAX`, and the setpoint-latched cutoff — introduced in firmware v4 to *prevent* switch cycling — opens the battery bus switch in one tick under 2 A of load (Figure 20). The battery current steps to zero in one sample and its rail rebounds to the unloaded 8.4 V; the fuel-cell source, alone above its knee, collapses from 7.8 V through 3.4 V within 23 ms; the bus falls out of regulation and the undervoltage fault latches. Both  $b = 0$  runs die this way in under 45 ms — the fastest failure in the campaign, and a direct demonstration that an under-load channel cut is itself a hazardous actuation when the surviving source cannot carry the total.

**Figure 20:** WP0101 ( $b = 0$ ), R6 entry. Top: the setpoint latch cuts the battery channel in one sample; the fuel-cell channel steps to the full load and then runs away as its source collapses. Middle: the battery rail rebounds to its unloaded 8.4 V — the battery is healthy and disconnected — while the fuel-cell rail falls to 2.3 V. Bottom: the bus leaves regulation  $\approx 15$  ms after the cut and the dwell-filtered undervoltage fault latches  $\approx 20$  ms later.

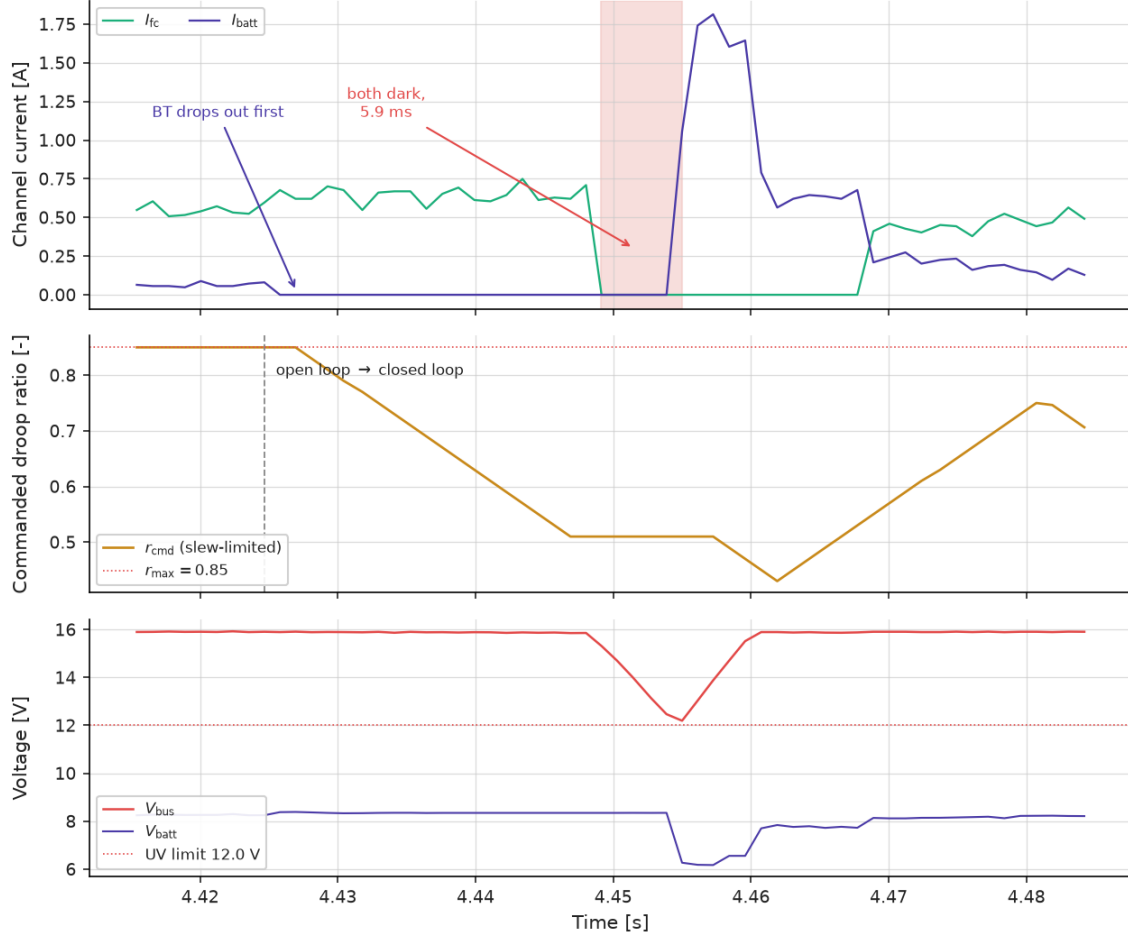
Figure 22 resolves the event. It is not a limit cycle and not a measurement artifact: five consecutive samples carry both channels at hard zero while the bus decays monotonically at  $0.31 \text{ V ms}^{-1}$ , after which the battery channel reconnects at 1.81 A and pulls its own rail from 8.35 V to 6.17 V. The sequence is ordered. The battery channel stops conducting one sample after the closed-loop mode edge; the controller, seeing a measured share of unity against its reference, drives the ratio down at the full slew limit; 24 ms later the fuel-cell channel also drops out, leaving the bus unfed.

**Figure 22:** TP0115,  $r^* = 0.85$ : a 5.9 ms total source dropout at the open-loop-to-closed-loop handover. Top: both channels dark, the battery channel first. Centre: the commanded ratio slewing at its 0.02-per-tick limit. Bottom: the bus decaying to 12.19 V and the battery rail collapsing on reconnection. Window 70 ms of a 15 s run.

The mechanism generalises, and the ladder contains its mirror image. Both dropouts observed anywhere in the campaign — TP0115 at  $r_{\max}$  and a smaller fuel-cell-only event in TP0105 at  $r_{\min} = 0.15$ , which the bus rode out at 15.89 V — occur at the open-loop-to-closed-loop handover, and both at an exact band edge. Every run crosses into closed loop at the same 0.6 A total, where the 0.30 A floor demands half the total current from a channel the open-loop feedforward has been running at 61 mA. The discriminator is monotonic in setpoint: measured minority current in the 50 ms before the crossing is 0.061 A at  $r^* = 0.85$ , 0.072 A at 0.83, and 0.179 A at 0.65.

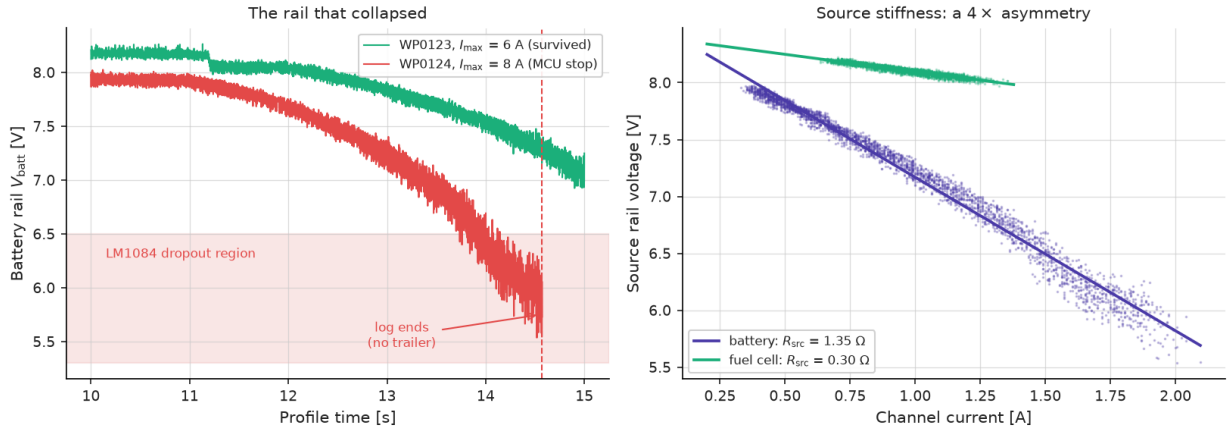
against  $V_{\text{fc}} = 8.40 - 0.30 I_{\text{fc}}$  on the fuel-cell side. Figure 23 shows both. **The bench battery source is approximately four times softer than the fuel-cell source**, at  $1.01\text{--}1.35\ \Omega$  against  $0.26\text{--}0.30\ \Omega$ . Because the Teensy is board-powered through an LM1084 linear regulator fed from the battery rail, drawing 1.9 A from a  $1.35\ \Omega$  source walks the microcontroller’s own supply into regulator dropout.

**Figure 23:** WP0124 against its surviving twin. Left: the battery rail through region R4; WP0123 runs the same profile and the same  $b$  at  $I_{\max} = 6$  A and bottoms at 6.93 V, while WP0124 at 8 A enters the LM1084 dropout region and the log ends. Right: source stiffness measured over the same window.

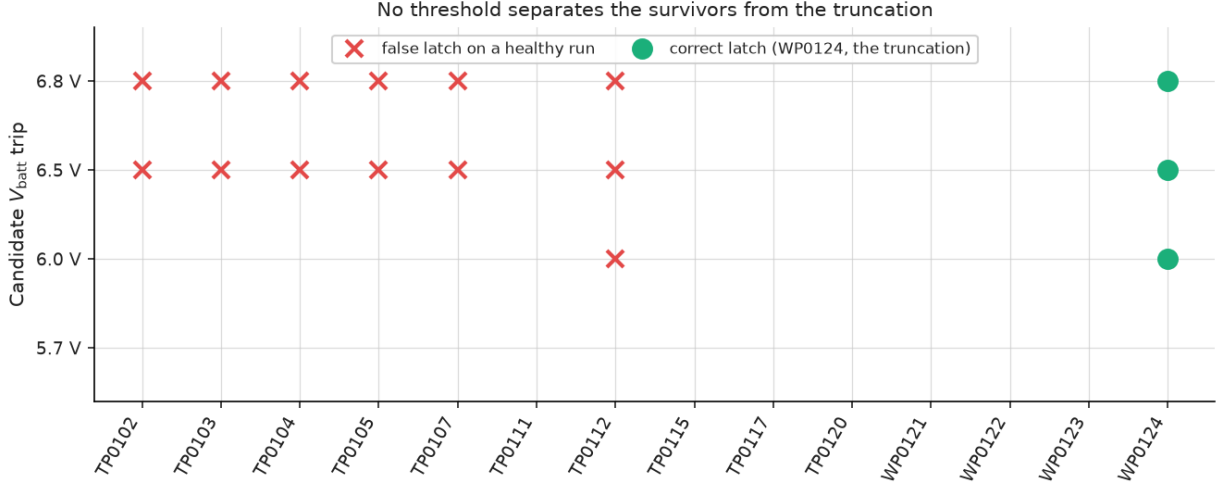
Replaying the firmware-v6 leaky-dwell filter against the logged battery rail of every run in the campaign gives Figure 24. Healthy trapezoid runs in which the battery is the sole source sag as low as 5.75 V and complete without incident, while WP0124 died at 5.54 V. A trip at 6.8 V or 6.5 V latches six healthy runs; a trip at 6.0 V still latches TP0112; a trip at 5.7 V catches nothing at all, including the truncation.

**Figure 24:** The firmware-v6 leaky-dwell filter replayed against the logged battery rail at four candidate trip voltages. No row separates the truncation from the healthy runs.

A separation of roughly 0.2 V across a hard survive-or-die boundary is the signature of a *cliff* — the regulator dropout knee — rather than of a gradual margin. It follows that the logged direct-current level under-determines the outcome, and that the real discriminator is the sub-millisecond ripple depth riding on it, which is precisely what capture 14 resolves and what an 870 Hz log cannot see. A threshold fitted to this data would therefore encode bench conditions rather than the failure mechanism. The blocking measurement is unchanged from Section 7: the LM1084 input and output, probed together through a truncation.
