Failure Analysis Report of Knife Blade Failure

FRACTURE MECHANICS AND FAILURE ANALYSIS
ENME803

ASSIGNMENT 2

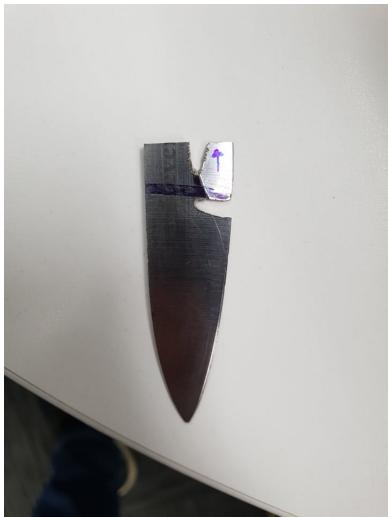
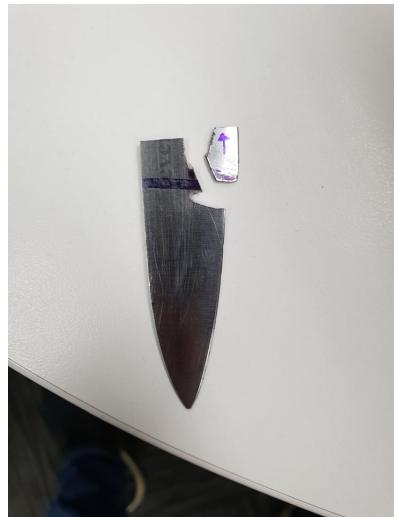
Figure 1 represents a fractured part of a kitchen knife blade, which has failed prematurely when trying to open a can. Failure analysis was conducted to investigate the cause of this premature failure.

Figure 1: Fractured knife blade

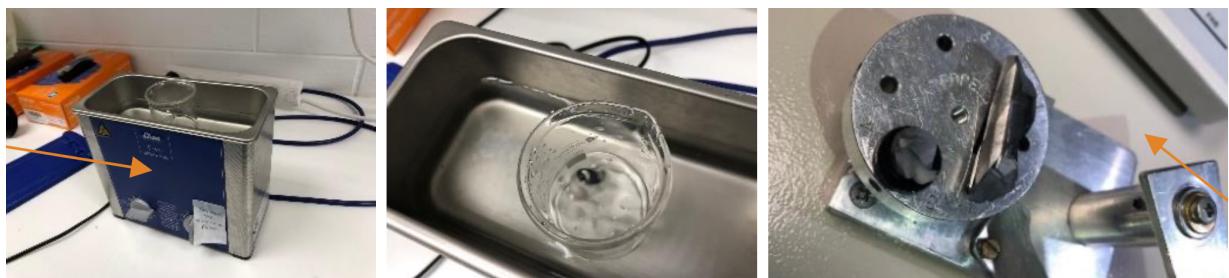
Figure 2: Cleaning and loading of specimen

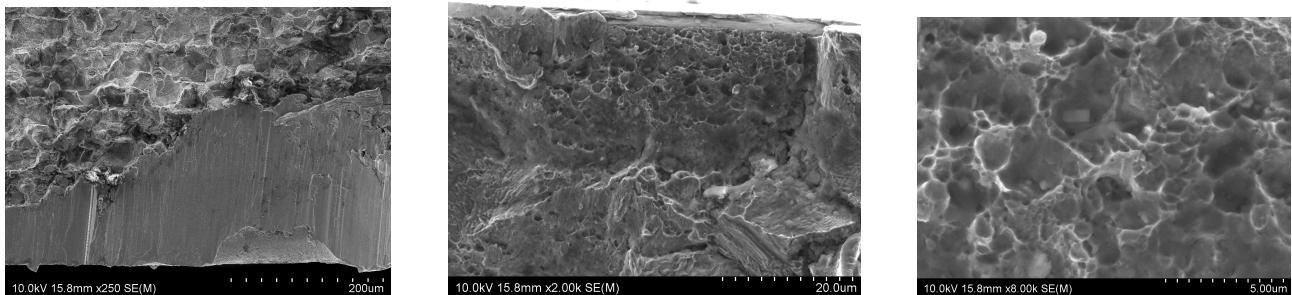
Multiple images of the fracture surface were taken at differing magnification factors aiding to the investigation of the type of fracture present along the surface grain boundaries. As seen in figure 3, the captured images show no signs of fatigue, dimples however, very faint lines show internal cracking due to manufacturing defect. This would be the cause for premature failure. With ductile fracture on the top of the blade propagating along with internal cracks from manufacturing defects, it aided the sudden brittle fracture indicated in these images below. Because this knife was a cheap, mass produced knife, it was manufactured using the conventional method as talked about in subsection 3.1 - forging where internal cracks can easily form due to different cooling rates at different points.

Figure 3: SEM Magnification

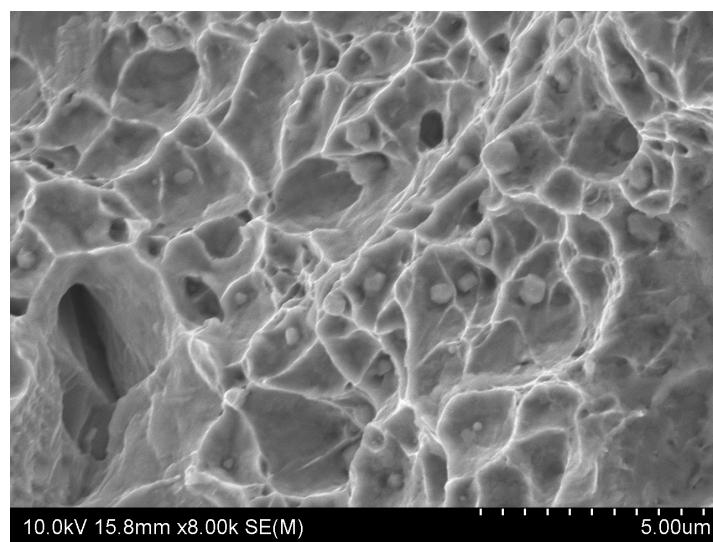
Looking at the SEM image of high magnification, ($5\mu\text{m}$), the carbide structure around the iron grain boundaries appears to have been pulled/sheared, suggesting the knife was under more pressure than it was designed to handle leading to fracture. The fracture is probably a intercrystalline fracture due to grain boundary embrittlement setting up micro stress fractures during the tempering / heat treatment in production as seen in figure 9.

The blade was quenched too fast and not properly tempered as part of the heat treatment as evident with porous surfaces.

Figure 4: SEM of grain structure

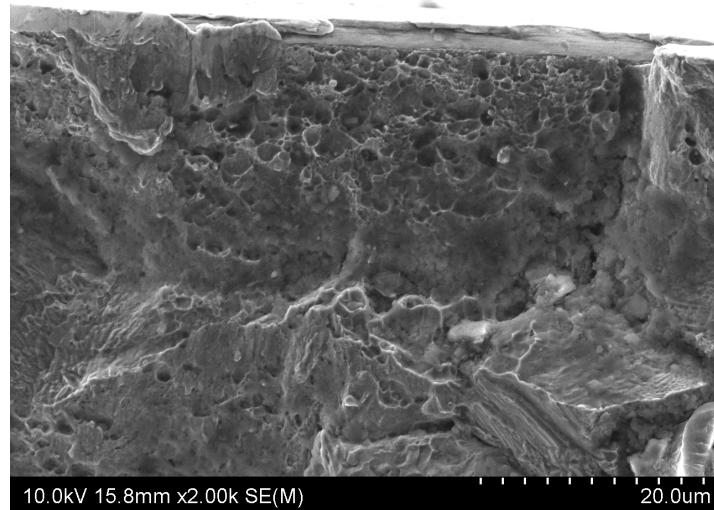
Figure 5: SEM of grain structure
