COLUMBIA

ACCIDENT INVESTIGATION BOARD

REPORT VOLUME I
AUGUST 2003

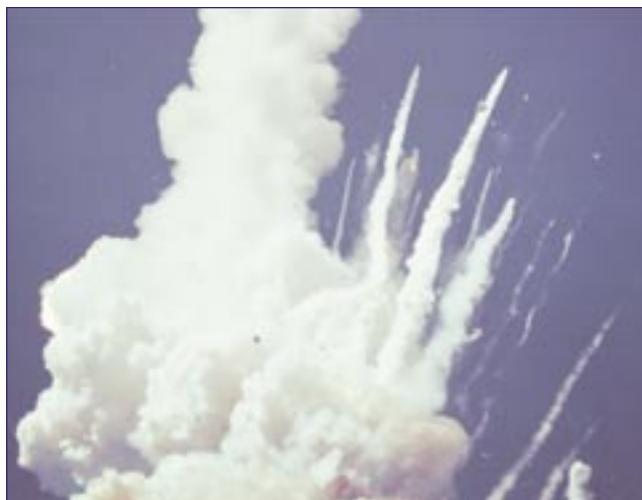
To investigate, President Reagan appointed the 13-member Presidential Commission on the Space Shuttle Challenger Accident, which soon became known as the Rogers Commission, after its chairman, former Secretary of State William P. Rogers.¹⁸ Early in its investigation, the Commission identified the mechanical cause of the accident to be the failure of the joint of one of the Solid Rocket Boosters. The Commission found that the design was not well understood by the engineers that operated it and that it had not been adequately tested.

Figure 1.5-1. The Space Shuttle Challenger was lost during ascent on January 28, 1986, when an O-ring and seal in the left Solid Rocket Booster failed.

The Rogers Commission report, issued on June 6, 1986, recommended a redesign and recertification of the Solid Rocket Motor joint and seal and urged that an independent body oversee its qualification and testing. The report concluded that the drive to declare the Shuttle operational had put enormous pressures on the system and stretched its resources to the limit. Faulting NASA safety practices, the Commission also called for the creation of an independent NASA Office of Safety, Reliability, and Quality Assurance, reporting directly to the NASA Administrator, as well as structural changes in program management.²⁰ (The Rogers Commission findings and recommendations are discussed in more detail in Chapter 5.) It would take NASA 32 months before the next Space Shuttle mission was launched. During this time, NASA initiated a series of longer-term vehicle upgrades, began the construction of the Orbiter *Endeavour* to replace *Challenger*, made significant organizational changes, and revised the Shuttle manifest to reflect a more realistic flight rate.

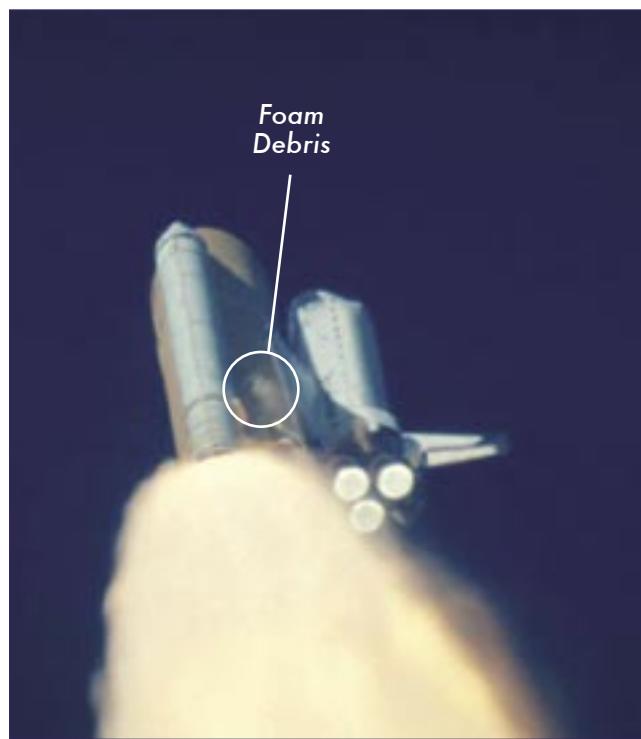
Figure 2.3-2. A shower of foam debris after the impact on *Columbia's* left wing. The event was not observed in real time.

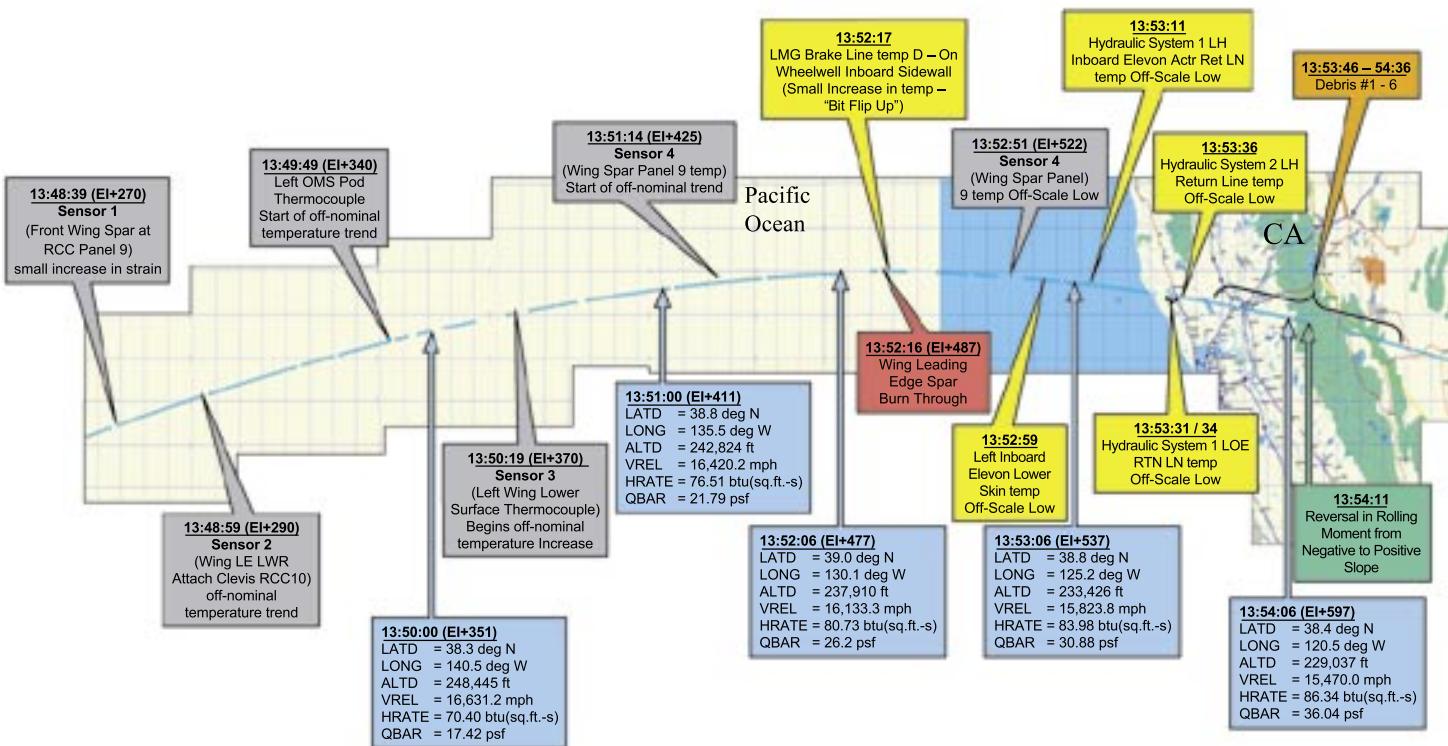
At 8:48:39 a.m. (EI+270), a sensor on the left wing leading edge spar showed strains higher than those seen on previous *Columbia* re-entries. This was recorded only on the Modular Auxiliary Data System, and was not telemetered to ground controllers or displayed to the crew (see Figure 2.6-1).

Figure 2.6-1. This simplified timeline shows the re-entry path of Columbia on February 1, 2003. The information presented here is a composite of sensor data telemetered to the ground combined with data from the Modular Auxiliary Data System recorder recovered after the accident. Note that the first off-nominal reading was a small increase in a strain gauge at the front wing spar behind RCC panel 9-left. The chart is color-coded: blue boxes contain position, attitude, and velocity information; orange boxes indicate when debris was shed from the Orbiter; green boxes are significant aerodynamic control events; gray boxes contain sensor information from the Modular Auxiliary Data System; and yellow boxes contain telemetered sensor information. The red boxes indicate other significant events.

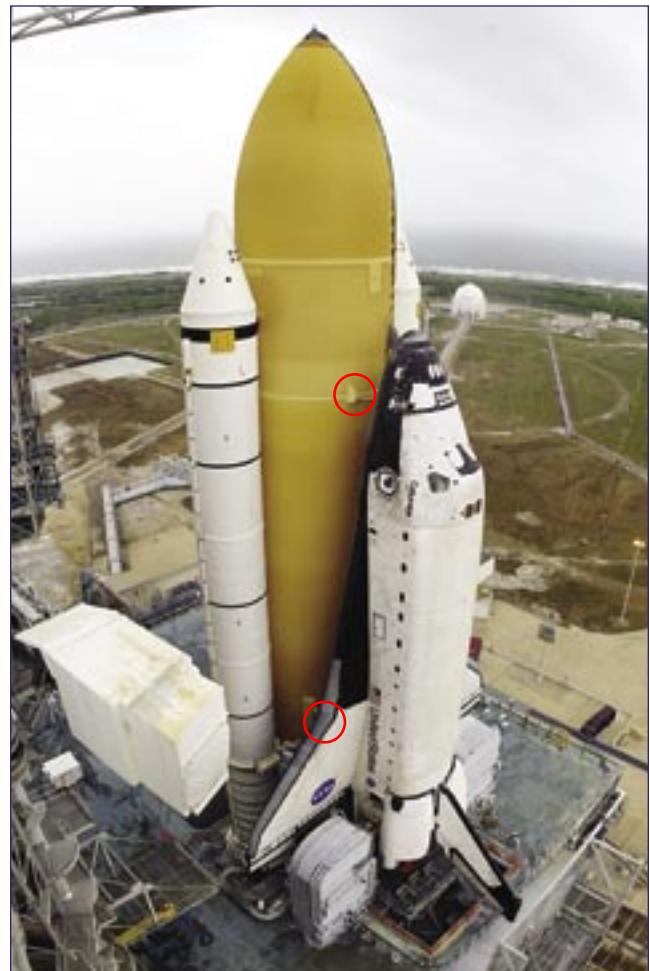
Figure 3.1-1. Columbia sitting at Launch Complex 39-A. The upper circle shows the left bipod (-Y) ramp on the forward attach point, while the lower circle is around RCC panel 8-left.

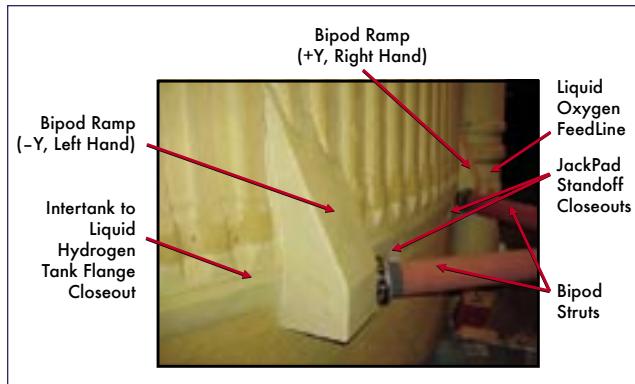
Figure 3.2-2. The exterior of the left bipod attachment area showing the foam ramp that came off during the ascent of STS-107.

A combination of factors, rather than a single factor, led to the loss of the left bipod foam ramp during the ascent of STS-107. NASA personnel believe that testing conducted during the investigation, including the dissection of as-built hardware and testing of simulated defects, showed conclusively that pre-existing defects in the foam were a major factor, and in briefings to the Board, these were cited as a necessary condition for foam loss. However, analysis indicated that pre-existing defects alone were not responsible for foam loss.

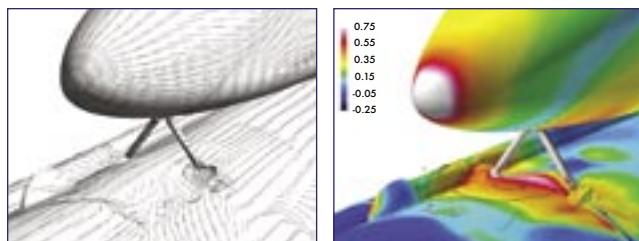
Significant analytical advancements have been made since the External Tank was first conceived, particularly in computational fluid dynamics (see Figure 3.2-5). Computational fluid dynamics comprises a computer-generated model that represents a system or device and uses fluid-flow physics and software to create predictions of flow behavior, and stress or deformation of solid structures. However, analysis must always be verified by test and/or flight data. The External Tank and the bipod ramp were not tested in the complex flight environment, nor were fully instrumented External Tanks ever launched to gather data for verifying analytical tools. The accuracy of the analytical tools used to simulate the External Tank and bipod ramp were verified only by using flight and test data from other Space Shuttle regions.

Figure 3.2-5. Computational Fluid Dynamics was used to understand the complex flow fields and pressure coefficients around bipod strut. The flight conditions shown here approximate those present when the left bipod foam ramp was lost from External Tank 93 at Mach 2.46 at a 2.08-degree angle of attack.

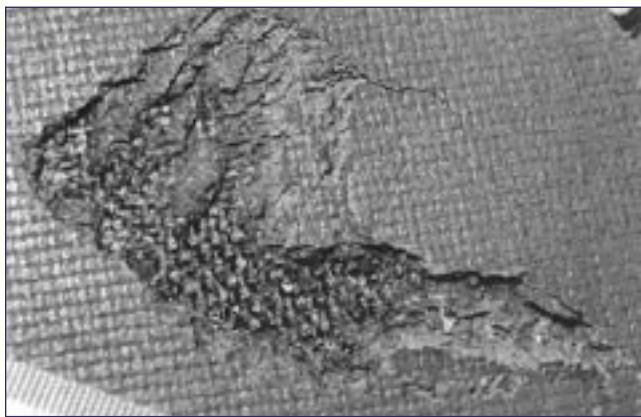
Figure 3.3-2. Damage on the outer surface of RCC panel 10-right from *Atlantis* after STS-45.

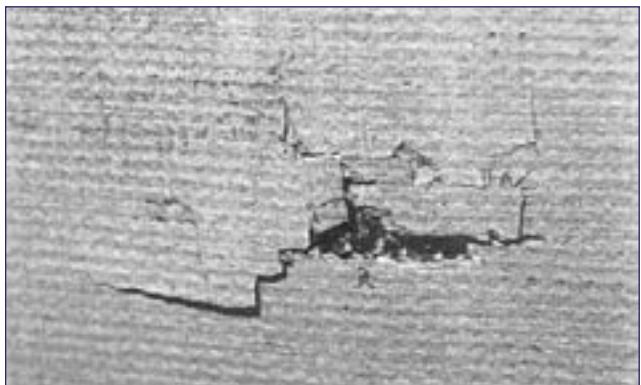
RCC components have been struck by objects throughout their operational life, but none of these components has been completely penetrated. A sampling of 21 post-flight reports noted 43 hypervelocity impacts, the largest being 0.2 inch. The most significant low-velocity impact was to *Atlantis'* panel 10-right during STS-45 in March and April 1992. The damaged area was 1.9 inches by 1.6 inches on the exterior surface and 0.5 inches by 0.1 inches in the interior surface. The substrate was exposed and oxidized, and the panel was scrapped. Analysis concluded that the damage was caused by a strike by a man-made object, possibly during ascent. Figures 3.3-2 and 3.3-3 show the damage to the outer and inner surfaces, respectively.

Figure 3.3-3. Damage on the inner surface of RCC panel 10-right from *Atlantis* after STS-45.

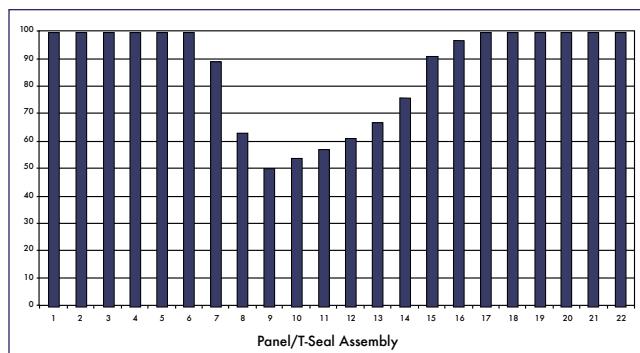
For the first five missions of *Columbia*, the RCC components were not coated with Type A sealant, and had shorter mission service lives than the RCC components on the other Orbiters. (*Columbia*'s panel 9 has the shortest mission service life of 50 flights as shown in Figure 3.3-4.) The predicted life for panel/T-seals 7 through 16 range from 54 to 97 flights.⁷

Figure 3.3-4. The expected mission life for each of the wing leading edge RCC panels on Columbia. Note that panel 9 has the shortest life expectancy.

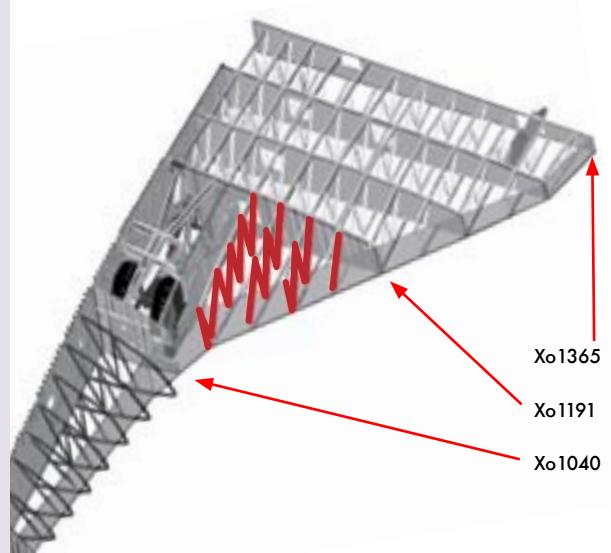
The major internal support structures in the mid-wing are constructed from aluminum alloy. Since aluminum melts at 1,200 degrees Fahrenheit, it is likely these truss tubes in the mid-wing were destroyed and wing structural integrity was lost.

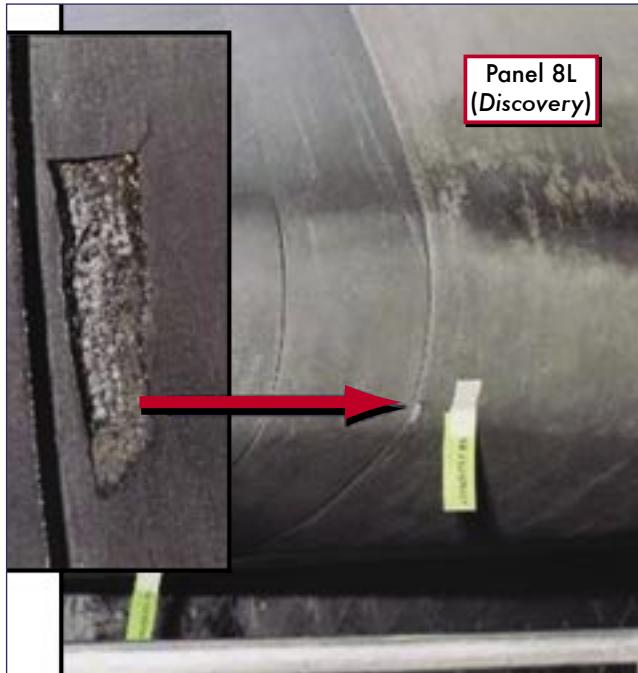
Figure 3.3-5. RCC panel 8-left from *Discovery* had to be scrapped after STS-103 because of the damage shown here.

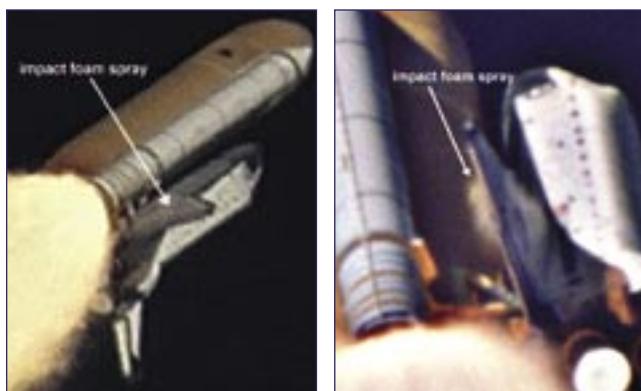
Figure 3.4-1 (color enhanced and "de-blurred" by Lockheed Martin Gaithersburg) and Figure 3.4-2 (processed by the National Imagery and Mapping Agency) are samples of the type of visual data used to establish the time of the impact (81.9 seconds), the altitude at which it occurred (65,860 feet), and the object's relative velocity at impact (about 545 mph relative to the Orbiter).

A 35-mm film camera, E212, which recorded the foam strike from 17 miles away, and video camera E208, which recorded it from 26 miles away, provided the best of the available evidence. Analysis of this visual evidence (see Figures 3.4-1 and 3.4-2) along with computer-aided design analysis, refined the potential impact area to less than 20 square feet in RCC panels 6 through 9 (see Figure 3.4-3), including a portion of the corresponding carrier panels and adjacent tiles. The investigation image analysis team found no conclusive visual evidence of post-impact debris flowing over the top of the wing.

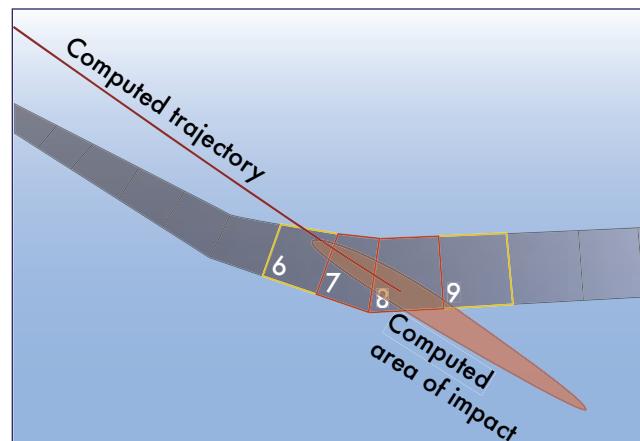
Figure 3.4-3: The best estimate of the site of impact by the center of the foam.

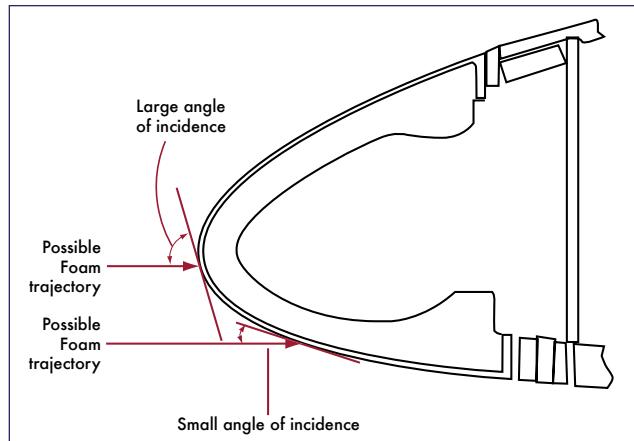
Image analysis determined that the foam was moving almost parallel to the Orbiter's fuselage at impact, with about a five-degree angle upward toward the bottom of the wing and slight motion in the outboard direction. If the foam had hit the tiles adjacent to the leading edge, the angle of incidence would have been about five degrees (the angle of incidence is the angle between the relative velocity of the projectile and the plane of the impacted surface). Because the wing leading edge curves, the angle of incidence increases as the point of impact approaches the apex of an RCC panel. Image and transport analyses estimated that for impact on RCC panel 8, the angle of incidence was between 10 and 20 degrees (see Figure 3.4-4).⁹ Because the total force delivered by the impact depends on the angle of incidence, a foam strike near the apex of an RCC panel could have delivered about twice the force as an impact close to the base of the panel.

Figure 3.4-4. This drawing shows the curve of the wing leading edge and illustrates the difference the angle of incidence has on the effect of the foam strike.

The precise impact location of the foam determined the impact angle because the debris was moving almost parallel to the Orbiter's fuselage at impact. Tile areas would have been hit at very small angles (approximately five degrees), but the curvature of the leading edge created angles closer to 20 degrees (see Figure 3.4-4).

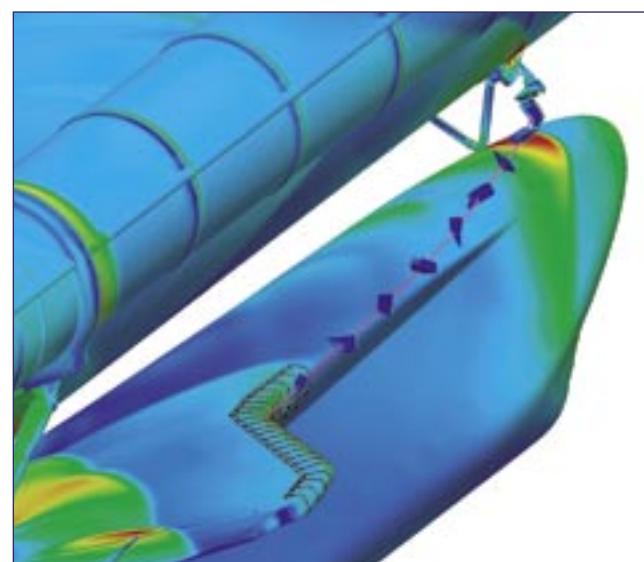
Figure 3.4-6. These are the results of a trajectory analysis that used a computational fluid dynamics approach in a program called CART-3D, a comprehensive (six-degree-of-freedom) computer simulation based on the laws of physics. This analysis used the aerodynamic and mass properties of bipod ramp foam, coupled with the complex flow field during ascent, to determine the likely position and velocity histories of the foam.

The undetermined and yet certainly irregular shape of the foam introduced substantial uncertainty about its estimated aerodynamic characteristics. Appendix D.8 contains an independent analysis conducted by the Board to confirm that the estimated range of ballistic coefficients of the foam in Figure 3.4-6 was credible, given the foam dimension results from the image analyses and the expected range of the foam density. Based on the results in Figure 3.4-7, the physical dimensions of the bipod ramp, and the sizes and shapes of the available barrels for the compressed-gas gun used in the impact test program described later in this chapter, the Board and the NASA Accident Investigation Team decided that a foam projectile 19 inches by 11.5 inches by 5.5 inches, weighing 1.67 pounds, and with a weight density of 2.4 pounds per cubic foot, would best represent the piece of foam that separated from the External Tank bipod ramp and was hit by the Orbiter's left wing. See Section 3.8 for a full discussion of the foam impact testing.

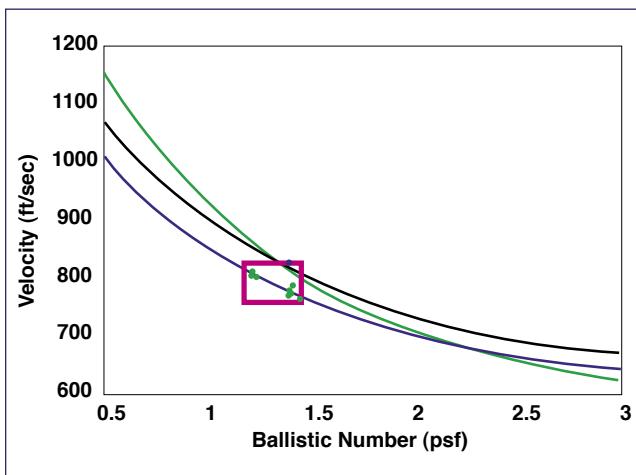
Figure 3.4-7. The results of numerous possible trajectories based on various assumed sizes, shapes, and densities of the foam. Either the foam had a slightly higher ballistic coefficient and the Orbiter struck the foam at a lower speed relative to the Orbiter, or the foam was more compact and the wing struck the foam at a higher speed. The "best fit" box represents the overlay of the data from the image analysis with the transport analysis computations. This data enabled a final selection of projectile characteristics for impact testing.

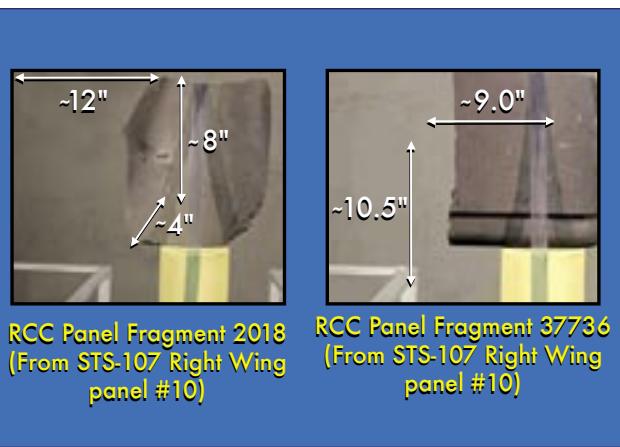
Figure 3.5-1. These representative RCC acreage pieces matched the radar cross-section of the Flight Day 2 object.

In the Advanced Compact Range at the Air Force Research Laboratory in Dayton, Ohio, analysts tested 31 materials from the Orbiter's exterior and payload bay. Additional supercomputer radar cross-section predictions were made for Reinforced Carbon-Carbon T-seals. After exhaustive radar cross-section analysis and testing, coupled with ballistic analysis of the object's orbital decay, only a fragment of RCC panel would match the UHF radar cross-section and ballistic coefficients observed by the Space Surveillance network. Such an RCC panel fragment must be approximately 140 square inches or greater in area to meet the observed radar cross-section characteristics. Figure 3.5-1 shows RCC panel fragments from *Columbia*'s right wing that represent those meeting the observed characteristics of object 2003-003B.¹⁰

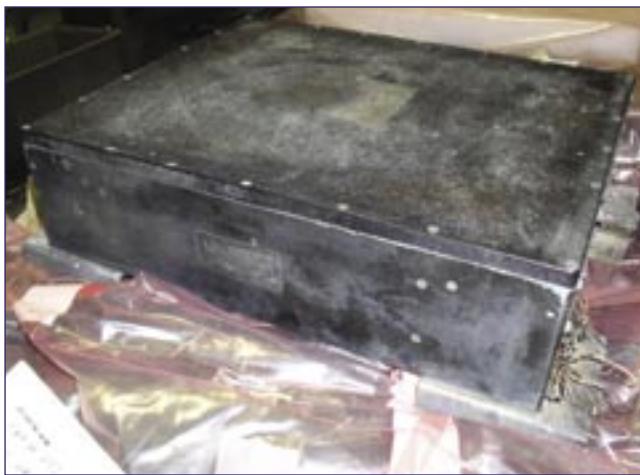
Figure 3.6.1. The Modular Auxiliary Data System recorder, found near Hemphill, Texas. While not designed to withstand impact damage, the recorder was in near-perfect condition when recovered on March 19, 2003.

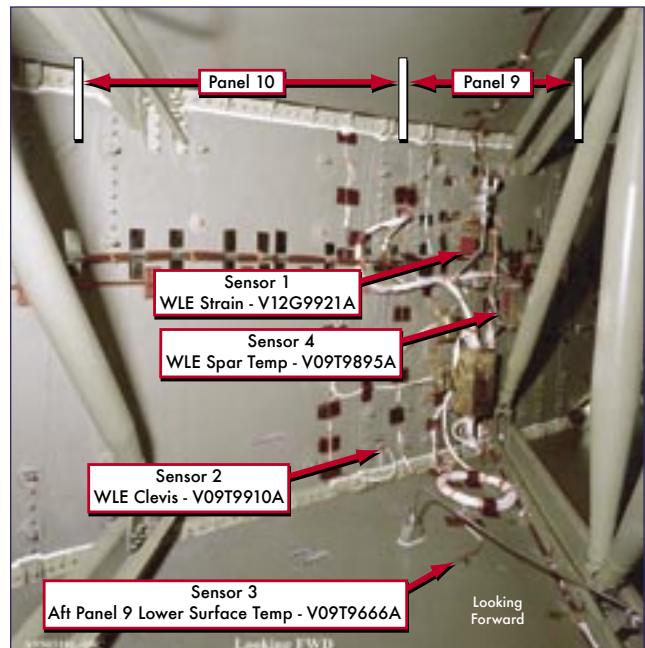
Figure 3.6.2. Location of sensors on the back of the left wing leading edge spar (vertical aluminum structure in picture). Also shown are the round truss tubes and ribs that provided the structural support for the mid-wing in this area.

or outside the wing leading edge spar near Reinforced Carbon-Carbon (RCC) panel 9-left, helped tell the story of what happened on the left wing of the Orbiter early in the re-entry. These four sensors were: strain gauge V12G9921A (Sensor 1), resistance temperature detector V09T9910A on the RCC clevis between panel 9 and 10 (Sensor 2), thermocouple V07T9666A, within a Thermal Protection System tile (Sensor 3), and resistance temperature detector V09T9895A (Sensor 4), located on the back side of the wing leading edge spar behind RCC panels 8 and 9 (see Figure 3.6-2).

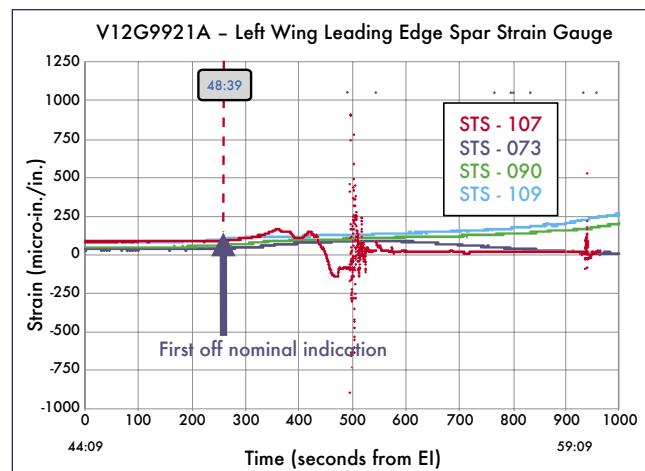
Figure 3.6.3. The strain gauge (Sensor 1) on the back of the left wing leading edge spar was the first sensor to show an anomalous reading. In this chart, and the others that follow, the red line indicates data from STS-107. Data from other Columbia re-entries, similar to the STS-107 re-entry profile, are shown in the other colors.

Sensor 1 provided the first anomalous reading (see Figure 3.6-3). From EI+270 to EI+360, the strain is higher than that on previous *Columbia* flights. At EI+450, the strain reverses, and then peaks again in a negative direction at EI+475. The strain then drops slightly, and remains constant and negative until EI+495, when the sensor pattern becomes unreliable, probably due to a propagating soft short, or “burn-through” of the insulation between cable conductors caused by heating or combustion. This strain likely indicates significant damage to the aluminum honeycomb spar. In particular, strain reversals, which are unusual, likely mean there was significant high-temperature damage to the spar during this time.

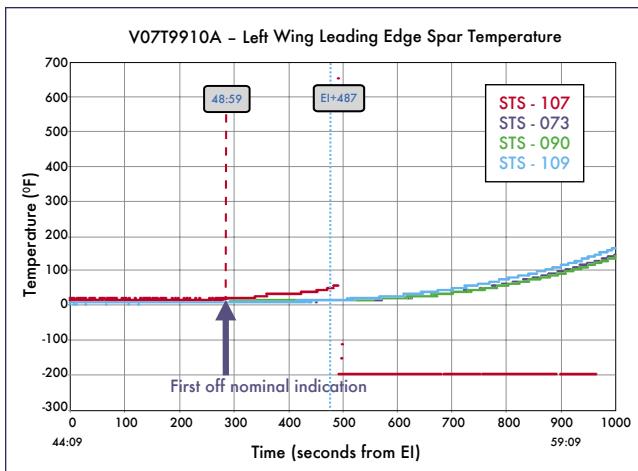
Figure 3.6-4. This temperature thermocouple (Sensor 2) was mounted on the outside of the wing leading edge spar behind the insulation that protects the spar from radiated heat from the RCC panels. It clearly showed an off-nominal trend early in the re-entry sequence and began to show an increase in temperature much earlier than the temperature sensor behind the spar.

left wing leading edge spar, recorded the beginning of a gradual and abnormal rise in temperature from an expected 30 degrees Fahrenheit to 65 degrees at EI+493, when it then dropped to “off-scale low,” a reading that drops off the scale at the low end of the sensor’s range (see Figure 3.6-4). Sensor 2, one of the first to fail, did so abruptly. It had indicated only a mild warming of the RCC attachment clevis before the signal was lost.

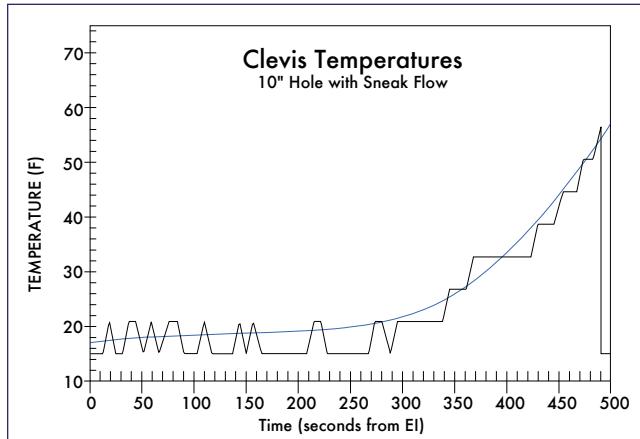
Figure 3.6-5. The analysis of the effect of a 10-inch hole in RCC panel 8 on Sensor 2 from EI to EI+500 seconds. The jagged line shows the actual flight data readings and the smooth line the calculated result for a 10-inch hole with some sneak flow of superheated air behind the spar insulation.

A series of thermal analyses were performed for different sized holes in RCC panel 8 to compute the time required to heat Sensor 2 to the temperature recorded by the Modular Auxiliary Data System. To heat the clevis, various insulators would have to be bypassed with a small amount of leakage, or “sneak flow.” Figure 3.6-5 shows the results of these calculations for, as an example, a 10-inch hole, and demonstrates that with sneak flow around the insulation, the temperature profile of the clevis sensor was closely matched by the engineering calculations. This is consistent with the same sneak flow required to match a similar but abnormal ascent temperature rise of the same sensor, which further supports the premise that the breach in the leading edge of the wing occurred during ascent. While the exact size of the breach will never be known, and may have been smaller or larger than 10 inches, these analyses do provide a plausible explanation for the observed rises in temperature sensor data during re-entry.

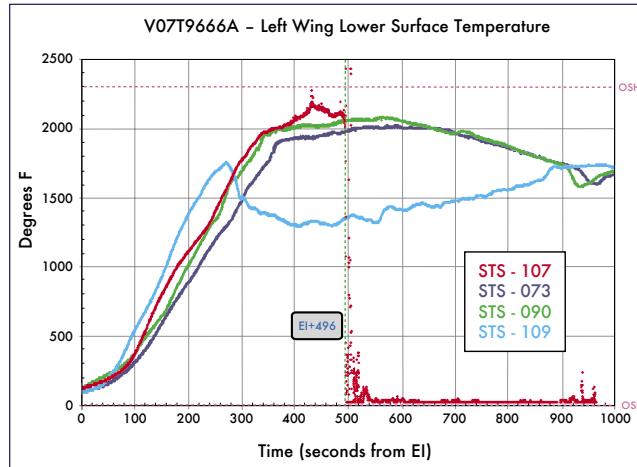
Figure 3.6-6. As early as EI+370, Sensor 3 began reading significantly higher than on previous flights. Since this sensor was located in a thermal tile on the lower surface of the left wing, its temperatures are much higher than those for the other sensors.

The readings of Sensor 3, which was in a thermal tile, began rising abnormally high and somewhat erratically as early as EI+370, with several brief spikes to 2,500 degrees Fahrenheit, significantly higher than the 2,000-degree peak temperature on a normal re-entry (Figure 3.6-6). At EI+496, this reading became unreliable, indicating a failure of the wire or the sensor. Because this thermocouple was on the wing lower surface, directly behind the junction of RCC panel 9 and 10, the high temperatures it initially recorded were almost certainly a result of air jetting through the damaged area of RCC panel 8, or of the normal airflow being disturbed by the damage. Note that Sensor 3 provided an external temperature measurement, while Sensors 2 and 4 provided internal temperature measurements.

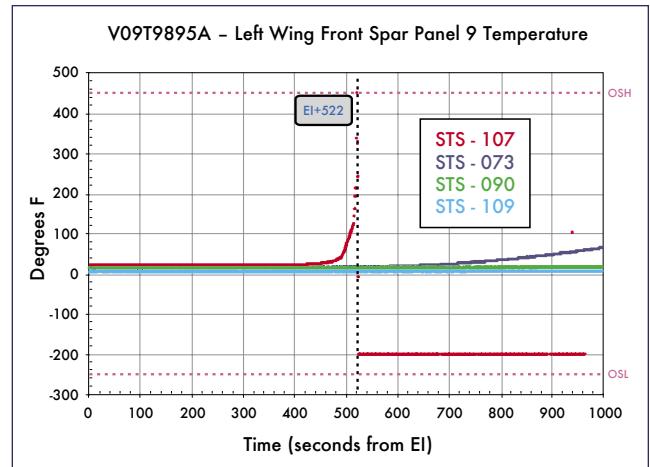
Figure 3.6-7. Sensor 4 also began reading significantly higher than previous flights before it fell off-scale low. The relatively late reaction of this sensor compared to Sensor 2, clearly indicated that superheated air started on the outside of the wing leading edge spar and then moved into the mid-wing after the spar was burned through. Note that immediately before the sensor (or the wire) fails, the temperature is at 450 degrees Fahrenheit and climbing rapidly. It was the only temperature sensor that showed this pattern.

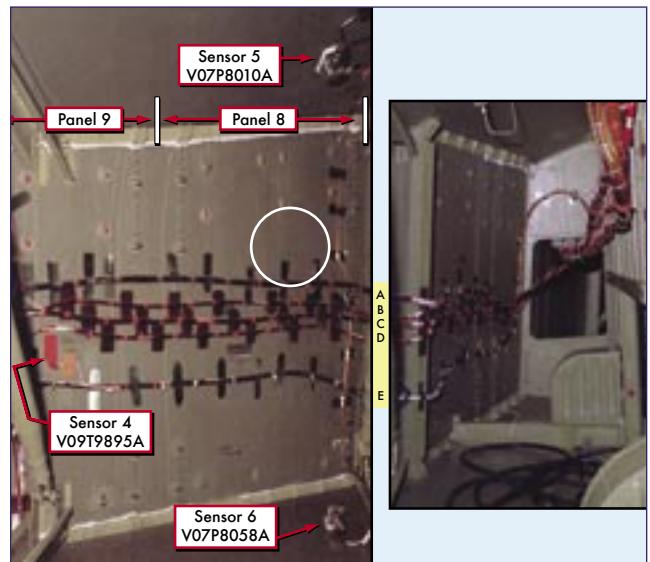
Figure 3.6-8. The left photo above shows the wiring runs on the backside of the wing leading edge behind RCC panel 8 – the circle marks the most likely area where the burn through of the wing leading edge spar initially occurred at EI+487 seconds. The right photo shows the wire bundles as they continue forward behind RCC panels 7 and 6. The major cable bundles in the upper right of the right photo carried the majority of the sensor data inside the wing. As these bundles were burned, controllers on the ground began seeing off-nominal sensor indications.

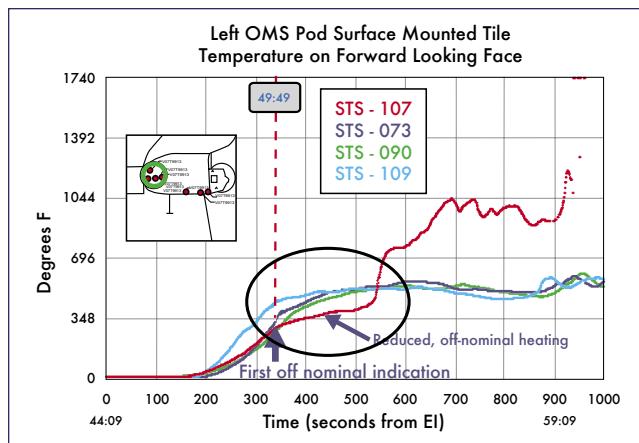
Figure 3.6-9. Orbital Maneuvering System (OMS) pod heating was initially significantly lower than that seen on previous Columbia missions. As wing leading edge damage later increased, the OMS pod heating increased dramatically. Debris recovered from this area of the OMS pod showed substantial pre-breakup heat damage and imbedded drops of once-molten metal from the wing leading edge in the OMS pod thermal tiles.

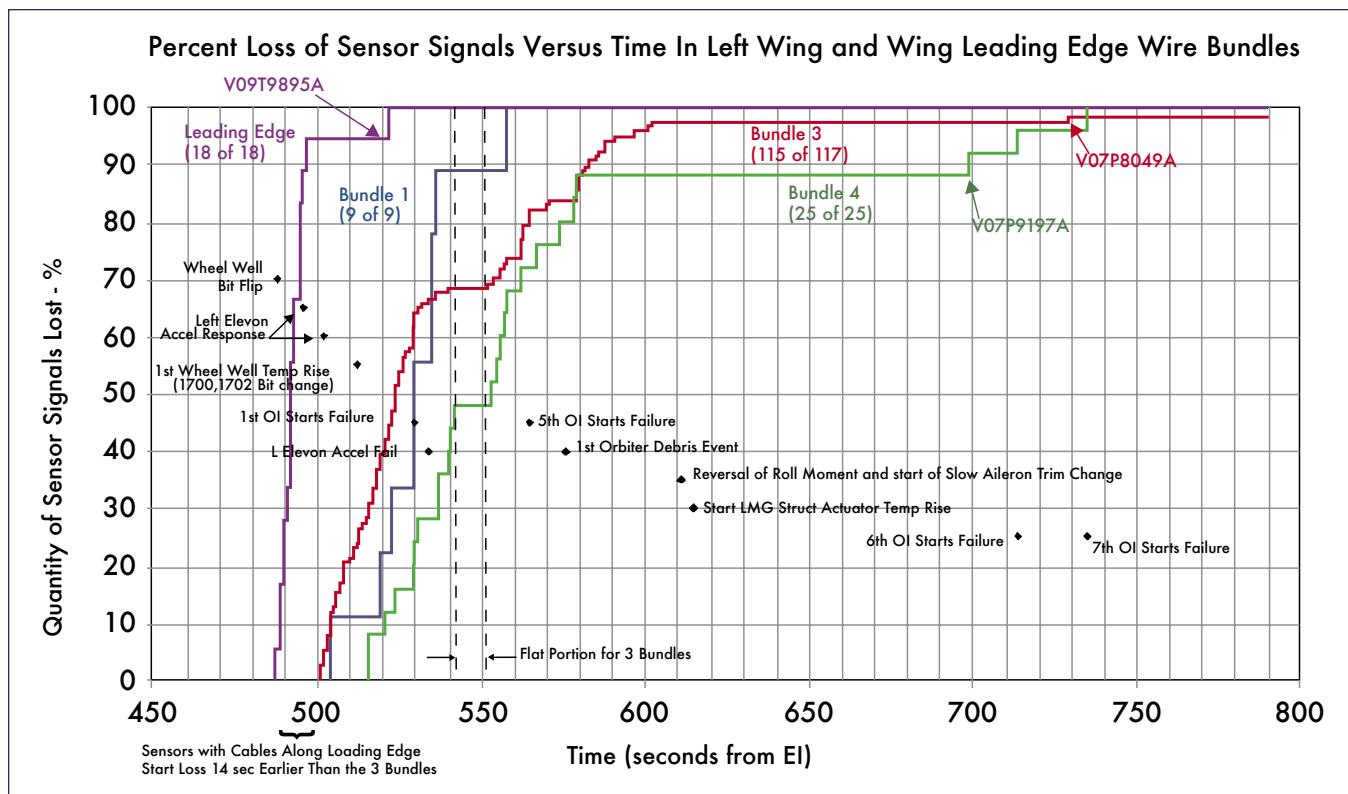
Figure 3.6-10. This chart shows how rapidly the wire bundles in the left wing were destroyed. Over 70 percent of the sensor wires in the wiring bundles burned through in under a minute. The black diamonds show the times of significant timeline sensor events.

ing that the burn-throughs had to occur in an area that nearly every wire ran through. To sustain this type of damage, the wires had to be close enough to the breach for the gas plume to hit them. Arc jet testing (in a wind tunnel with an electrical arc that provides up to a 2,800-degree Fahrenheit airflow) on a simulated wing leading edge spar and simulated wire bundles showed how the leading edge spar would burn through in a few seconds. It also showed that wire bundles would burn through in a timeframe consistent with those seen in the Modular Auxiliary Data System information and the telemetered data.

Later computational fluid dynamics analysis of the mid-wing area behind the spar showed that superheated air flowing into a breached RCC panel 8 and then interacting with the internal structure behind the RCC cavity (RCC ribs and spar insulation) would have continued through the wing leading edge spar as a jet, and would have easily allowed superheated air to traverse the 56.5 inches from the spar to the outside of the wheel well and destroy the cables (Figure 3.6-11). Controllers on the ground saw these first anomalies in the telemetry data at EI+613, when four hydraulic sensor cables that ran from the aft part of the left wing through the wiring bundles outside the wheel well failed.

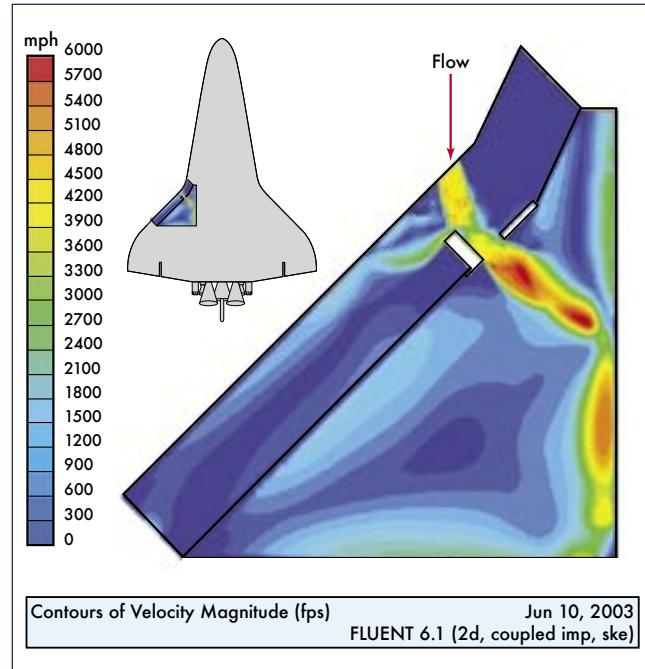
Figure 3.6-11. The computational fluid dynamics analysis of the speed of the superheated air as it entered the breach in RCC panel 8 and then traveled through the wing leading edge spar. The darkest red color indicates speeds of over 4,000 miles per hour. Temperatures in this area likely exceeded 5,000 degrees Fahrenheit. The area of detail is looking down at the top of the left wing.

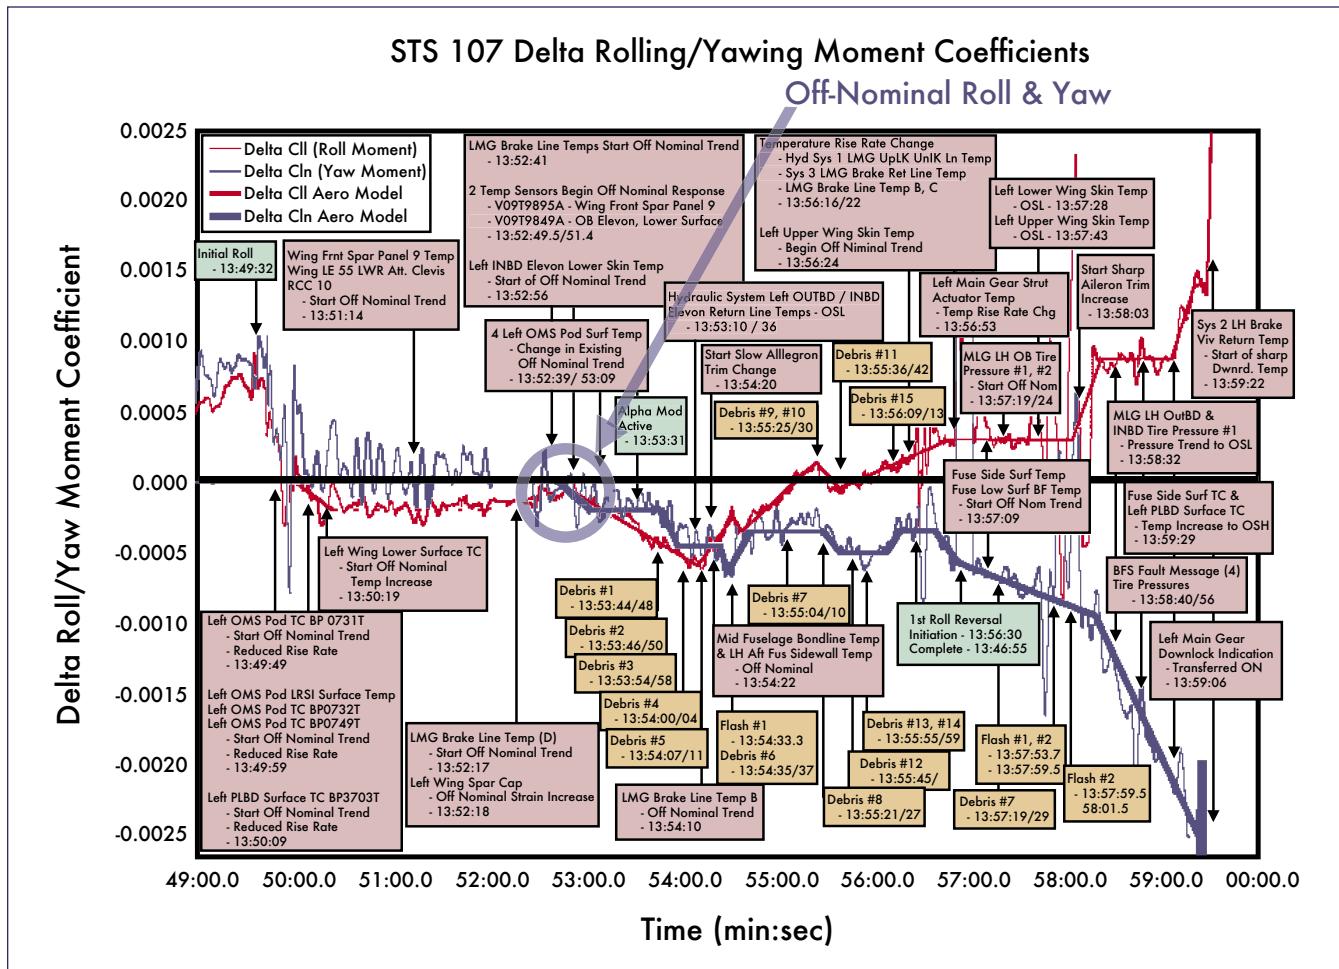
Aerodynamic roll and yaw forces began to differ from those on previous flights at about EI+500 (see Figure 3.6-12). Investigators used flight data to reconstruct the aerodynamic forces acting on the Orbiter. This reconstructed data was then compared to forces seen on other similar flights of *Columbia*

Figure 3.6-12. At approximately EI+500 seconds, the aerodynamic roll and yaw forces began to diverge from those observed on previous flights. The blue line shows the Orbiter's tendency to yaw while the red line shows its tendency to roll. Nominal values would parallel the solid black line. Above the black line, the direction of the force is to the right, while below the black line, the force is to the left.

and to the forces predicted for STS-107. In the early phase of flight, these abnormal aerodynamic forces indicated that *Columbia*'s flight control system was reacting to a change in the external shape of the wing, which was caused by progressive RCC damage that caused a continuing decrease in lift and a continuing increase in drag on the left wing.

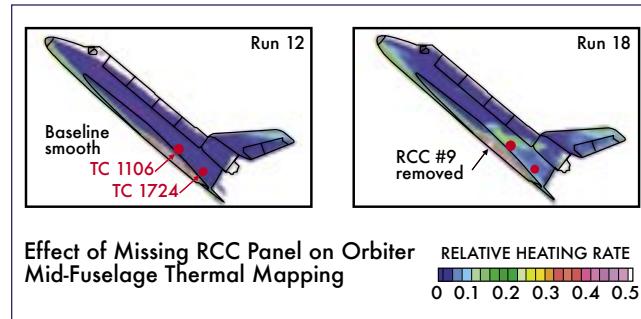
Figure 3.6-13 shows the comparison of surface temperature distribution with an undamaged Orbiter and one with an entire panel 9 removed. With panel 9 removed, a strong vortex flow structure is positioned to increase the temperature on the leading edge of the Orbital Maneuvering System pod. The aim is not to demonstrate that all of panel 9 was missing at this point, but rather to indicate that major damage to panels near panel 9 can shift the strong vortex flow pattern and change the Orbiter's temperature distribution to match the Modular Auxiliary Data System information. Wind tunnel tests also demonstrated that increasing damage to leading edge RCC panels would result in increasing drag and decreasing lift on the left wing.

Figure 3.6-13. The effects of removing RCC panel 9 are shown in this figure. Note the brighter colors on the front of the OMS pod show increased heating, a phenomenon supported by both the OMS pod temperature sensors and the debris analysis.

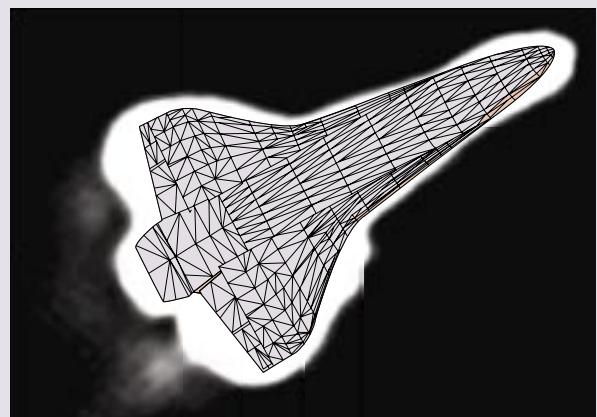
THE KIRTLAND IMAGE

As *Columbia* passed over Albuquerque, New Mexico, during re-entry (around EI+795), scientists at the Air Force Starfire Optical Range at Kirtland Air Force Base acquired images of the Orbiter. This imaging had not been officially assigned, and the photograph was taken using commercial equipment located at the site, not with the advanced Starfire adaptive-optics telescope.

The image shows an unusual condition on the left wing, a leading-edge disturbance that might indicate damage. Several analysts concluded that the distortion evident in the image likely came from the modification and interaction of shock waves due to the damaged leading edge. The overall appearance of the leading-edge damage at this point on the trajectory is consistent with the scenario.

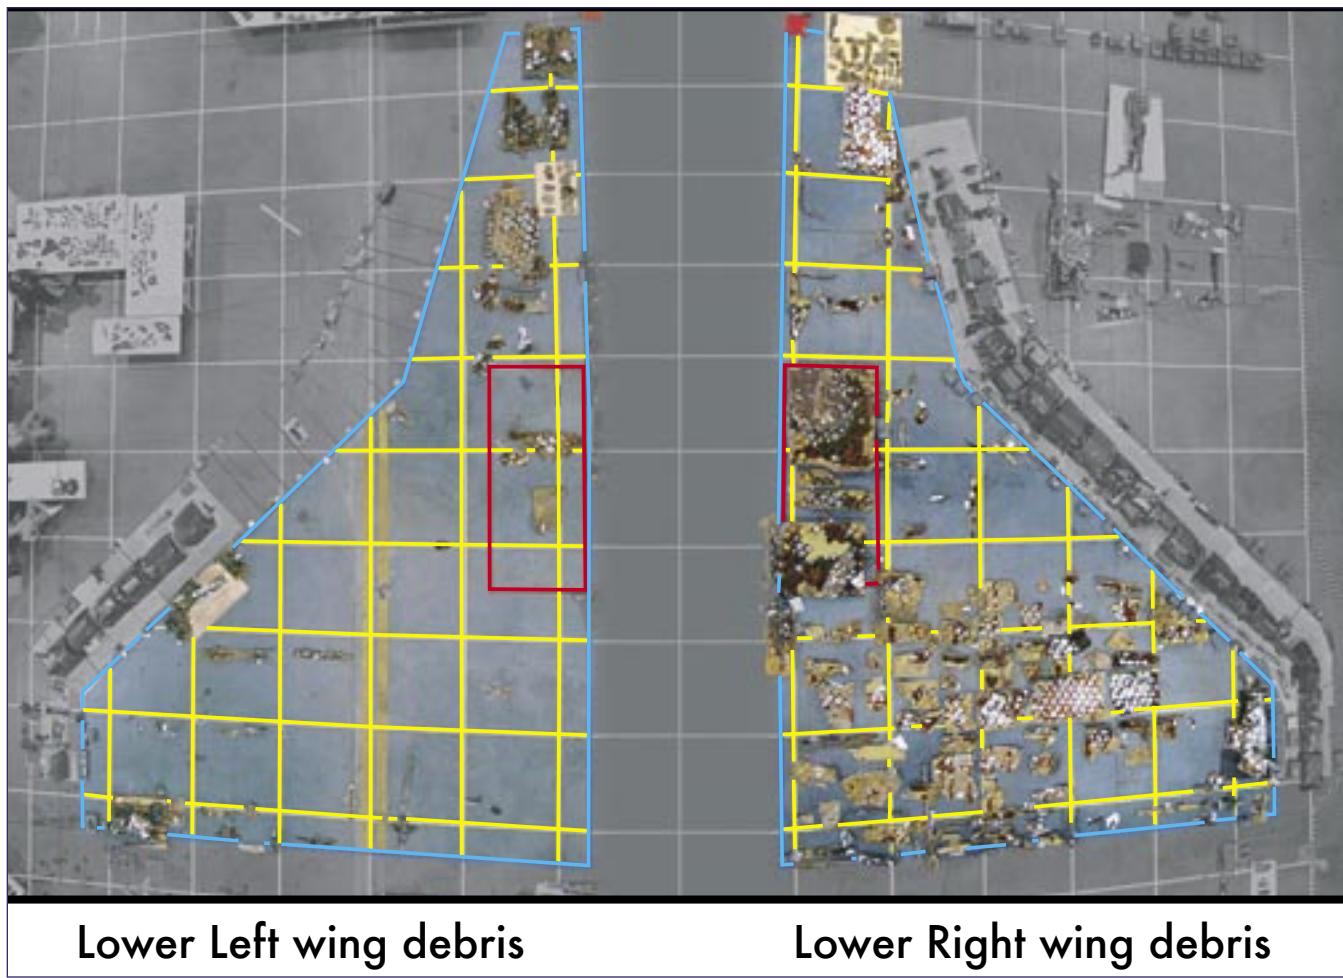
Figure 3.7-1. Comparison of amount of debris recovered from the left and right wings of Columbia. Note the amount of debris recovered from areas in front of the wheel well (the red boxes on each wing) were similar, but there were dramatic differences in the amount of debris recovered aft of each wheel well.

Detailed analysis of the debris revealed unique features and convincing evidence that the damage to the left wing differed significantly from damage to the right, and that significant differences existed in pieces from various areas of the left wing. While a substantial amount of upper and lower right wing structure was recovered, comparatively little of the upper and lower left wing structure was recovered (see Figure 3.7-1).

The difference in recovered debris from the Orbiter's wings clearly indicates that after the breakup, most of the left wing succumbed to both high heat and aerodynamic forces, while the right wing succumbed to aerodynamic forces only. Because the left wing was already compromised, it was the first area of the Orbiter to fail structurally. Pieces were exposed to higher heating for a longer period, resulting in more heat damage and ablation of left wing structural material. The left wing was also subjected to superheated air that penetrated directly into the mid-body of the wing for a substantial period. This pre-heating likely rendered those components unable to absorb much, if any, of the post-breakup heating. Those internal and external structures were likely vaporized during post-breakup re-entry. Finally, the left wing likely lost significant amounts of the Thermal Protection System prior to breakup due to the effect of internal wing heating on the Thermal Protection System bonding materials, and this further degraded the left wing's ability to resist the high heat of re-entry after it broke up.

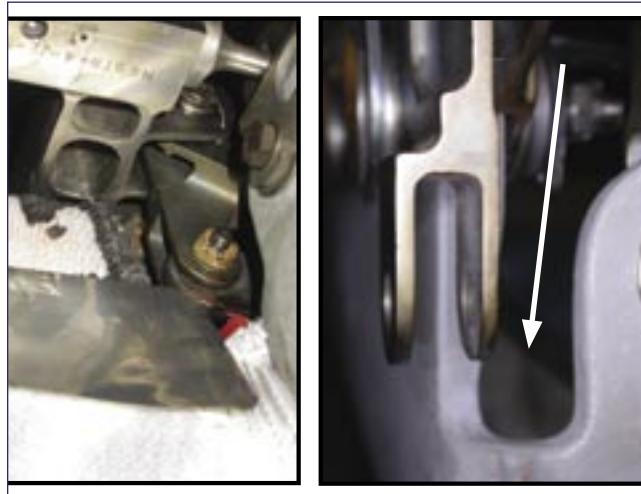
Figure 3.7-2. Each RCC panel has a U-shaped slot (see arrow) in the back of the panel. Once superheated air entered the breach in RCC panel 8, some of that superheated air went through this slot and caused substantial damage to the Thermal Protection System tiles behind this area.

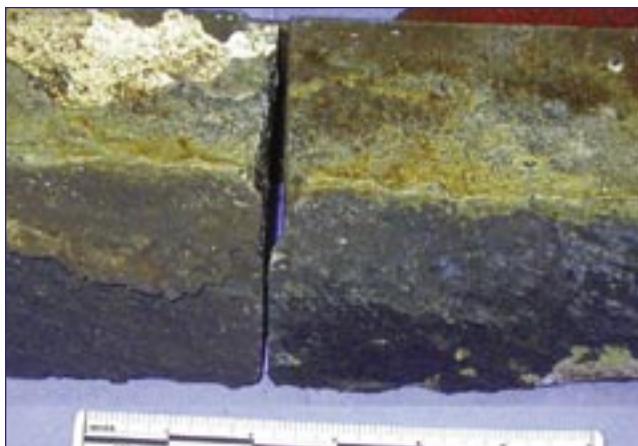
Figure 3.7-3. Superheated airflow caused erosion in tiles around the RCC panel 8 and 9 interface. The tiles shown are from behind the area where the superheated air exited from the slot in Figure 3.7-2. These tiles showed much greater thermal damage than other tiles in this area and chemical analysis showed the presence of metals only found in wing leading edge components.

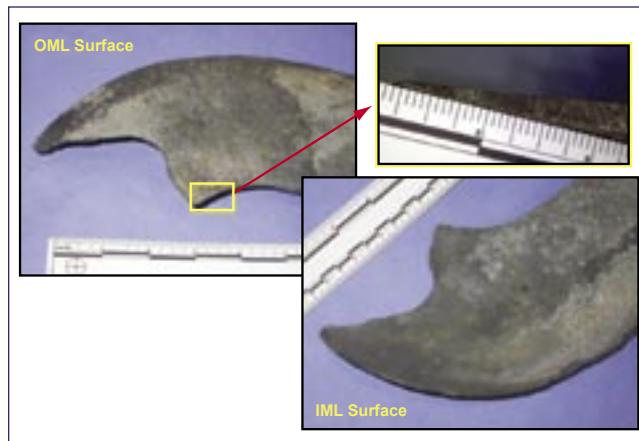
Figure 3.7-4. The outboard rib of panel 8 and the inboard rib of panel 9 showed signs of extreme heating and erosion. RCC erosion of this magnitude was not observed in any other location on the Orbiter.
