COLUMBIA

ACCIDENT INVESTIGATION BOARD

REPORT VOLUME I
AUGUST 2003

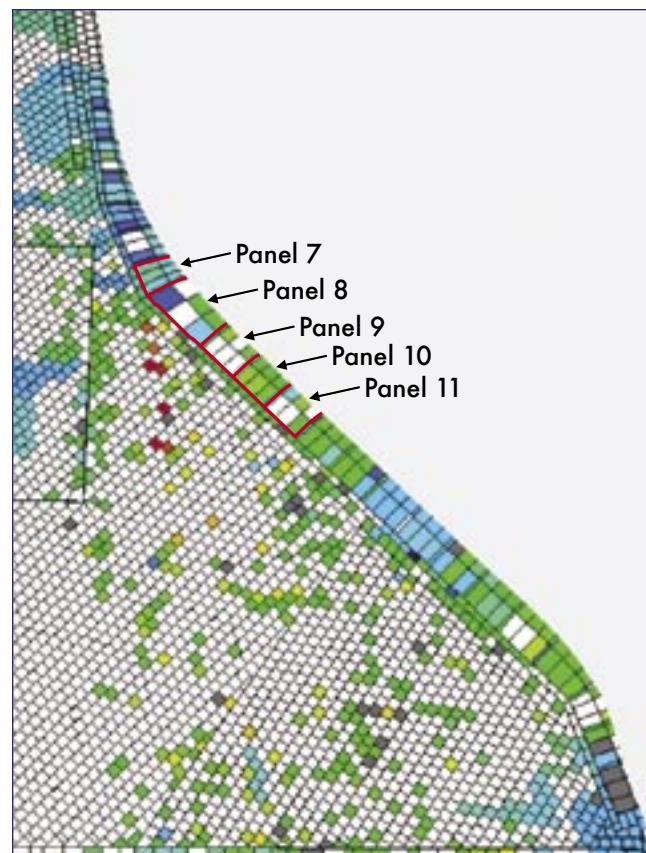
Figure 3.7-6. The tiles recovered farthest west all came from the area immediately behind left wing RCC panels 8 and 9. In the figure, each small box represents an individual tile on the lower surface of the left wing. The more red an individual tile appears, the farther west it was found.

An analysis of where tiles were found on the ground also yielded significant evidence of the breach location. Since most of the tiles are of similar size, weight, and shape, they would all have similar ballistic coefficients and would have behaved similarly after they separated from the Orbiter. By noting where each tile fell and then plotting its location on the Orbiter tile map, a distinctive pattern emerged. The tiles recovered farthest west all came from the area immediately behind the left wing RCC panel 8 and 9 (see Figure 3.7-6), which suggests that these tiles were released earlier than those from other areas of the left wing. While it is not conclusive evidence of a breach in this area, this pattern does suggest unique damage around RCC panels 8 and 9 that was not seen in other areas. Tiles from this area also showed evidence of a brown deposit that was not seen on tiles from any

other part of the Orbiter. Chemical analysis revealed it was an Inconel-based deposit that had come from inside the RCC cavity on the left wing (Inconel is found in wing leading edge attachment fittings). Since the streamlines from tiles with the brown deposit originate near left RCC panels 8 and 9, this brown deposit likely originated as an outflow of superheated air and molten metal from the panel 8 and 9 area.

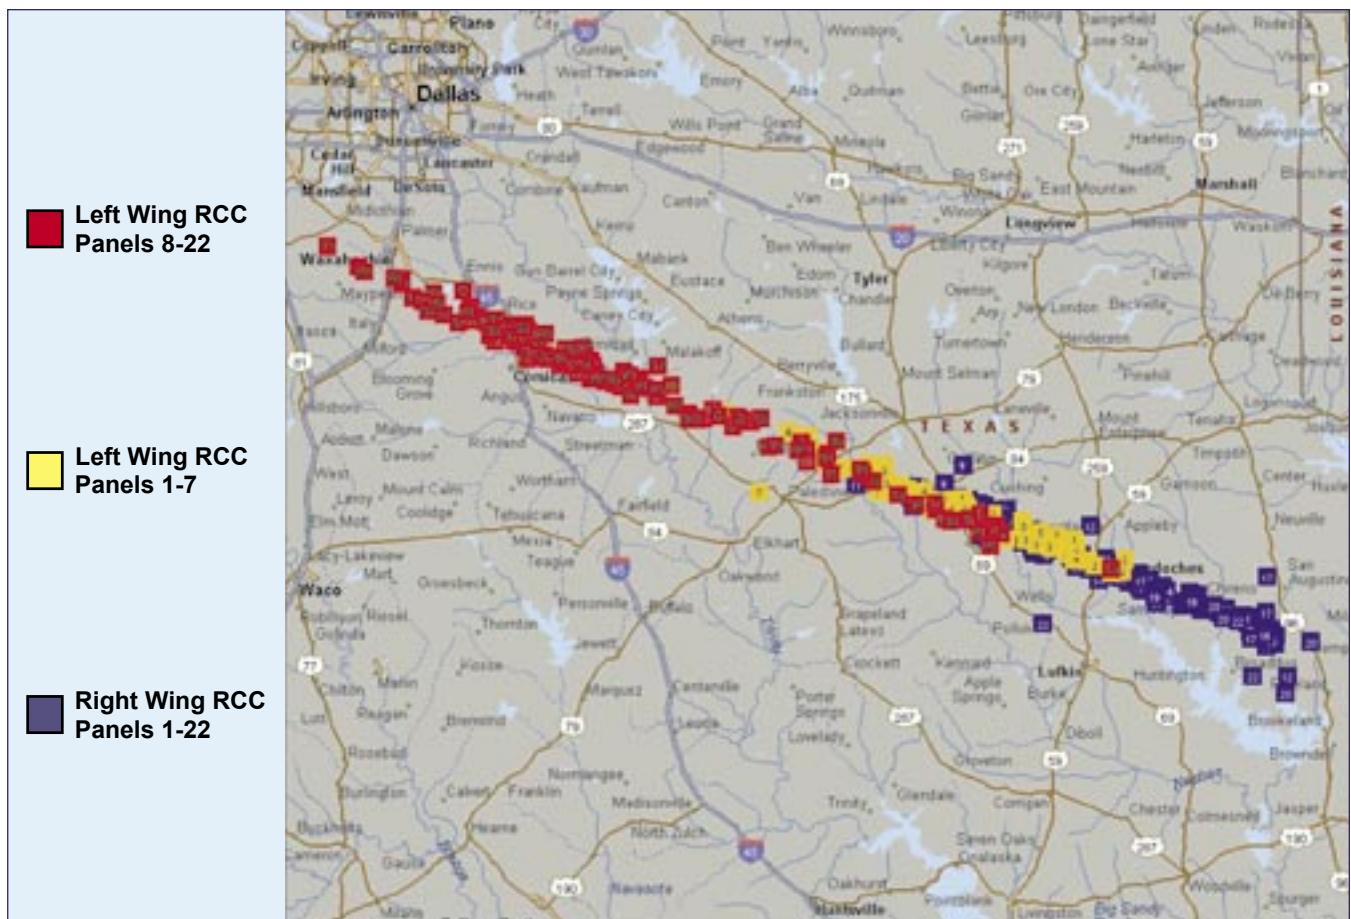
The location of debris on the ground also provided evidence of where the initial breach occurred. The location of every piece of recovered RCC was plotted on a map and labeled according to the panel the piece originally came from. Two distinct patterns were immediately evident. First, it was clear that pieces from left wing RCC panels 9 through 22 had fallen the farthest west, and that RCC from left wing panels 1 through 7 had fallen considerably farther east (see Figure 3.7-5). Second, pieces from left wing panel 8 were

Figure 3.7-5. The location of RCC panel debris from the left and right wings, shown where it was recovered from in East Texas. The debris pattern suggested that the left wing failed before the right wing, most likely near left RCC panels 8 and 9.

found throughout the debris field, which suggested that the left wing likely failed in the vicinity of RCC panel 8. The early loss of the left wing from RCC panel 9 and outboard caused the RCC from that area to be deposited well west of the RCC from the inboard part of the wing. Since panels 1 through 7 were so much farther to the east, investigators concluded that RCC panels 1 through 7 had stayed with the Orbiter longer than had panels 8 through 22.

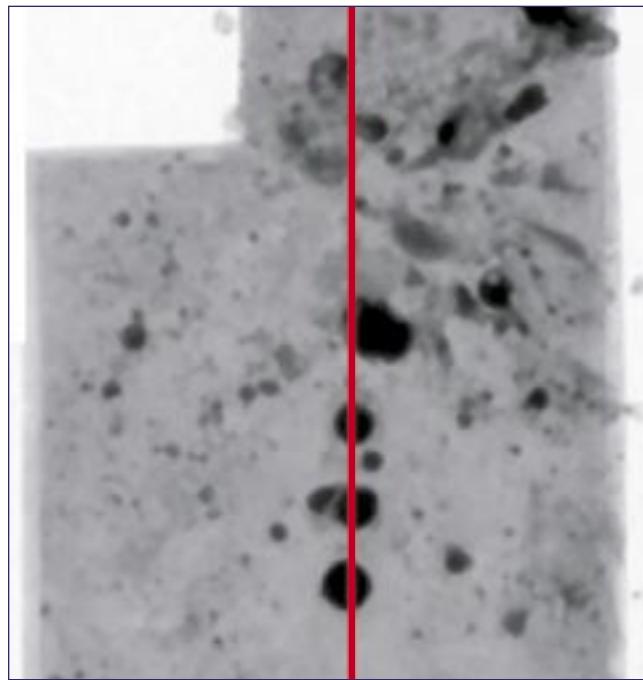
The X-ray analysis of left wing RCC panel 8 (see Figure 3.7-7) showed a bottom-to-top pattern of slag deposits. In some areas, small spheroids of heavy metal were aligned vertically on the recovered pieces, which indicated a superheated airflow from the bottom of the panel toward the top in the area of RCC panel 8-left. These deposits were later determined by chemical analysis to be Inconel 718, probably from the wing leading edge attachment fittings on the spanner beams on RCC panels 8 and 9. Computational fluid dynamics modeling of the flow behind panel 8 indicated that the molten deposits would be laid down in this manner.

Figure 3.7-7. X-ray analysis of RCC panel 8-left showed a bottom-to-top pattern of slag deposits.

The layered deposits on panel 8 were also markedly different from those on all other left- and right-wing panels. There was much more material deposited on RCC panel 8-left. These deposits had a much rougher overall structure, including rivulets of Cerachrome slag deposited directly on the RCC. This indicated that Cerachrome, the insulation that protects the wing leading edge spar, was one of the first materials to succumb to the superheated air entering through the breach in RCC panel 8-left. Because the melting temperature of Cerachrome is greater than 3,200 degrees Fahrenheit, analysis indicated that materials in this area were exposed to extremely

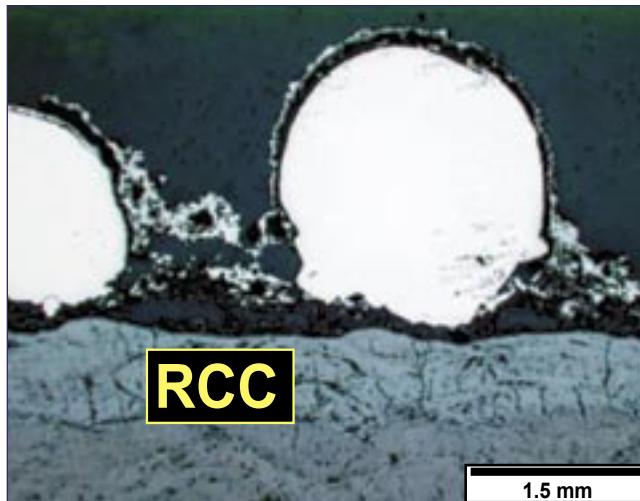
Figure 3.7-8. Spheroids of Inconel 718 and Cerachrome were deposited directly on the surface of RCC panel 8-left. This slag deposit pattern was not seen on any other RCC panels.

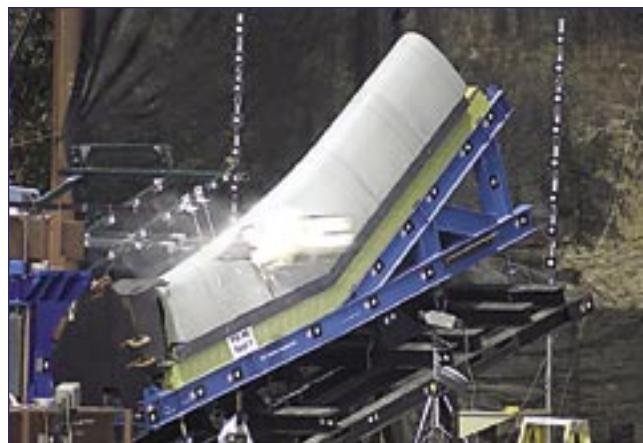
Five engineering tests on fiberglass panels (see Figure 3.8-5) established the test parameters of the impact tests on RCC panels. Details of the fiberglass tests are in Appendix D.12.

Figure 3.8-5. A typical foam strike leaves impact streaks, and the foam projectile breaks into shards and larger pieces. Here the foam is striking Panel 6 on a fiberglass test article.

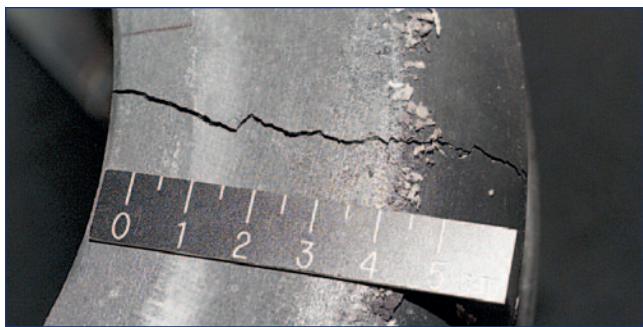
RCC panel 6 was tested first to begin to establish RCC impact response, although by the time of the test, other data had indicated that RCC panel 8-left was the most likely site of the breach. RCC panel 6 was impacted using the same parameters as the test on fiberglass panel 6 and developed a 5.5-inch crack on the outboard end of the panel that extended through the rib (see Figure 3.8-6). There was also a crack through the "web" of the T-seal between panels 6 and 7 (see Figure 3.8-7). As in the fiberglass test, the foam block deflected, or moved, the face of the RCC panel, creating a slit between the panel and the adjacent T-seal, which ripped the projectile and stuffed pieces of foam into the slit (see Figure 3.8-8). The panel rib failed at lower stresses than predicted, and the T-seal failed closer to predictions, but overall, the stress pattern was similar to what was predicted, demonstrating the need to incorporate more complete RCC failure criteria in the computational models.

Without further crack growth, the specific structural damage this test produced would probably not have allowed enough superheated air to penetrate the wing during re-entry to cause serious damage. However, the test did demonstrate that a foam impact representative of the debris strike at 81.9 seconds after launch could damage an RCC panel. Note that

Figure 3.8-6. A 5.5-inch crack on the outboard portion of RCC Panel 6 during testing.

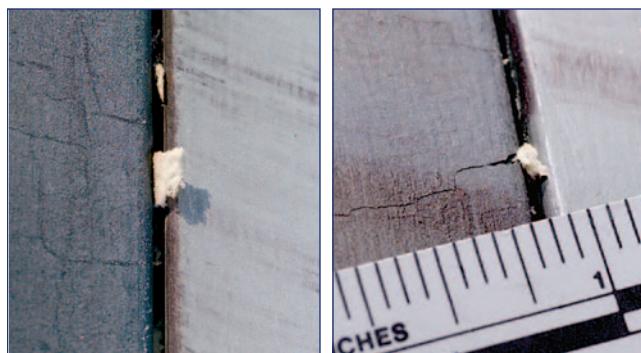
Figure 3.8-8. Two views of foam lodged into the slit during tests.

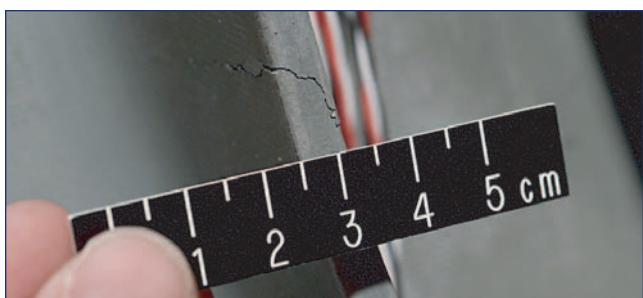
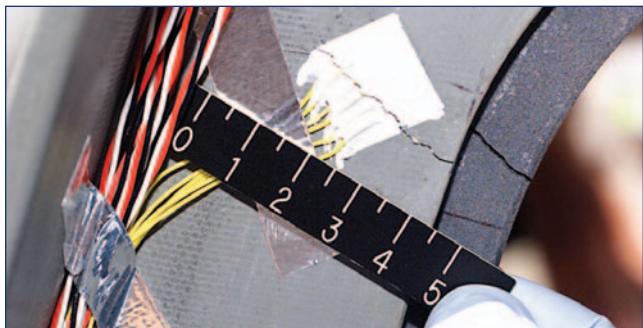
Figure 3.8-7. Two views of the crack in the T-seal between RCC Panels 6 and 7.

the RCC panel 6-left test used fiberglass panels and T-seals in panel 7, 8, 9, and 10 locations. As seen later in the RCC panel 8-left test, this test configuration may not have adequately reproduced the flight configuration. Testing of a full RCC panel 6, 7, and 8 configuration might have resulted in more severe damage.

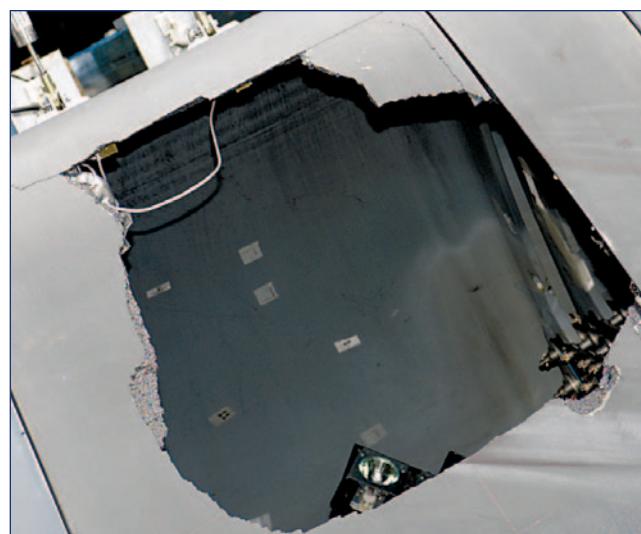
Figure 3.8-9. The large impact hole in Panel 8 from the final test.

The impact created a hole roughly 16 inches by 17 inches, which was within the range consistent with all the findings of the investigation (see Figure 3.8-9). Additionally, cracks in the panel ranged up to 11 inches in length (Figure 3.8-10). The T-seal between panels 8 and 9 also failed at the lower outboard mounting lug.

Three large pieces of the broken panel face sheet (see Figure 3.8-11) were retained within the wing. The two largest pieces had surface areas of 86 and 75 square inches. While this test cannot exactly duplicate the damage *Columbia* incurred, pieces such as these could have remained in the wing cavity for some time, and could then have floated out of the damaged wing while the Orbiter was maneuvering in space. This scenario is consistent with the event observed on Flight Day 2 (see Section 3.5).

- R3.8-1 Obtain sufficient spare Reinforced Carbon-Carbon panel assemblies and associated support components to ensure that decisions related to Reinforced Carbon-Carbon maintenance are made on the basis of component specifications, free of external pressures relating to schedules, costs, or other considerations.
- R3.8-2 Develop, validate, and maintain physics-based computer models to evaluate Thermal Protection System damage from debris impacts. These tools should provide realistic and timely estimates of any impact damage from possible debris from any source that may ultimately impact the Orbiter. Establish impact damage thresholds that trigger responsive corrective action, such as on-orbit inspection and repair, when indicated.

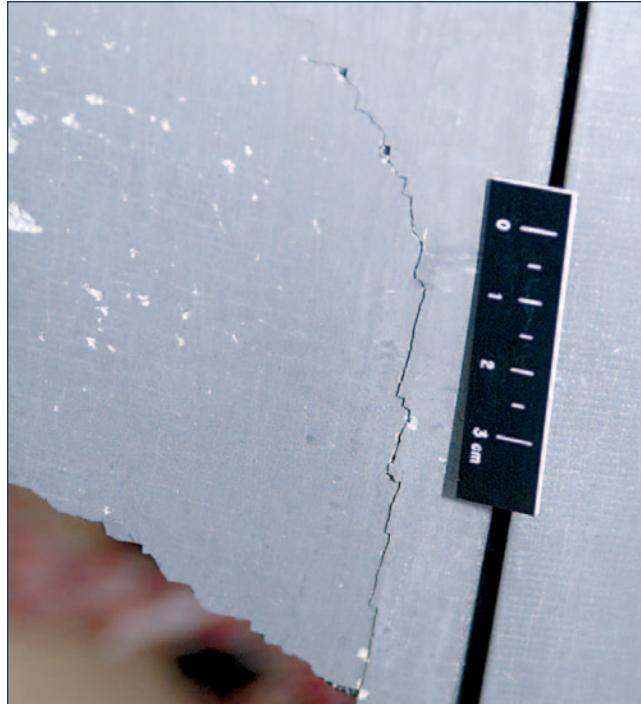
Figure 3.8-10. Numerous cracks were also noted in RCC Panel 8.

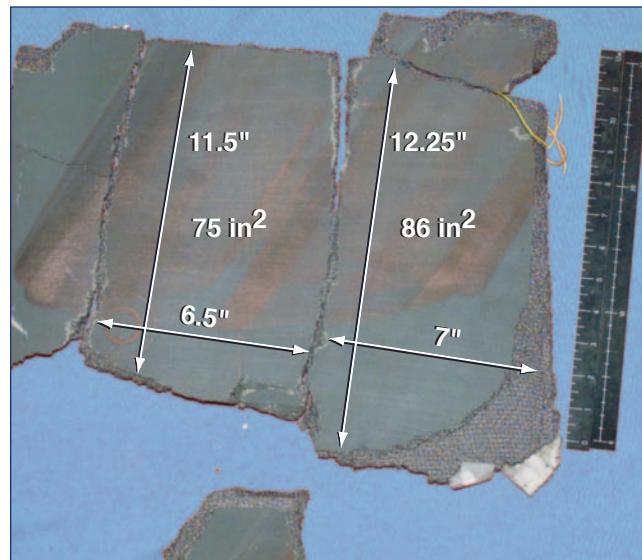
Figure 3.8-11. Three large pieces of debris from the panel face sheet were lodged within the hollow area behind the RCC panel.

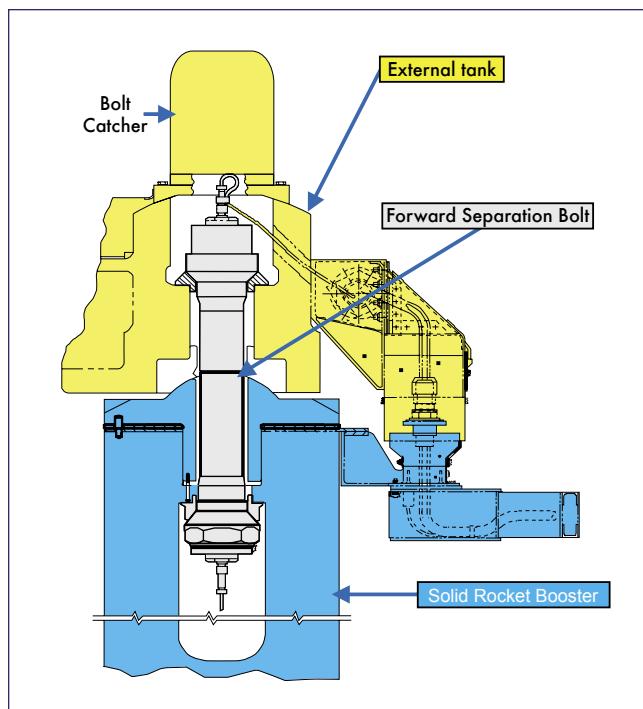
If one of the bolt catchers failed during STS-107, the resulting debris could have damaged *Columbia*'s wing leading edge. Concerns that the bolt catchers may have failed, causing metal debris to ricochet toward the Orbiter, arose because the configuration of the bolt catchers used on Shuttle missions differs in important ways from the design used in

Figure 4.2-1. A cutaway drawing of the forward Solid Rocket Booster bolt catcher and separation bolt assembly.

initial qualification tests.¹ First, the attachments that currently hold bolt catchers in place use bolts threaded into inserts rather than through-bolts. Second, the test design included neither the Super Lightweight Ablative material applied to the bolt catcher apparatus for thermal protection, nor the aluminum honeycomb configuration currently used. Also, during these initial tests, temperature and pressure readings for the bolt firings were not recorded.

Due to these testing deficiencies, the Board recognized that bolt catchers could have played a role in damaging *Columbia*’s left wing. The aluminum dome could have failed catastrophically, ablative coating could have come off in large quantities, or the device could have failed to hold to its mount point on the External Tank. To determine whether bolt catchers should be eliminated as a source of debris, investigators conducted tests to establish a performance baseline for bolt catchers in their current configuration and also reviewed radar data to see whether bolt catcher failure could be observed. The results had serious implications: Every bolt catcher tested failed well below the expected load range of 68,000 pounds. In one test, a bolt catcher failed at 44,000 pounds, which was two percent below the 46,000 pounds

Although bolt catchers can be neither definitively excluded nor included as a potential cause of left wing damage to *Columbia*, the impact of such a large object would likely have registered on the Shuttle stack's sensors. The indefinite data at the time of Solid Rocket Booster separation, in tandem with overwhelming evidence related to the foam debris strike, leads the Board to conclude that bolt catchers are unlikely to have been involved in the accident.

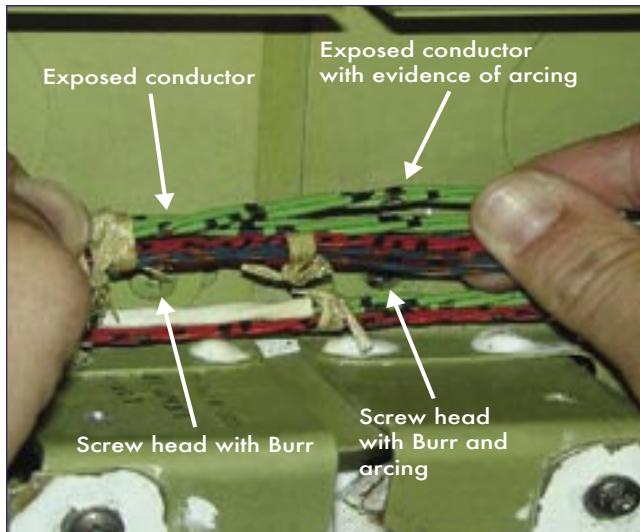
Figure 4.2-2. Arc tracking damage in Kapton wiring.

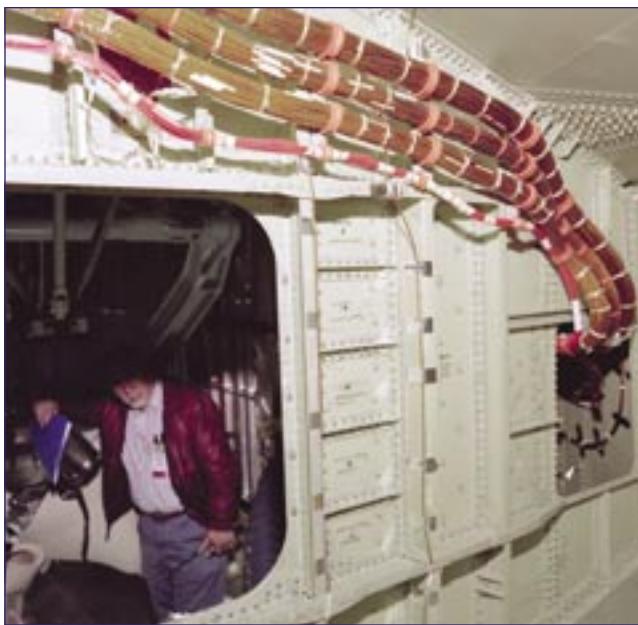
Figure 4.2-3. Typical wiring bundle inside Orbiter wing.

A typical wiring bundle is shown in Figure 4.2-3. Wiring nonconformances are corrected by rerouting, reclamping, or installing additional insulation such as convoluted tubing, insulating tape, insulating sheets, heat shrink sleeving, and abrasion pads (see Figure 4.2-4). Testing has shown that wiring bundles usually stop arc tracking when wires are physically separated from one another. Further testing under conditions simulating the Shuttle's wiring environment demonstrated that arc tracking does not progress beyond six inches. Based on these results, Boeing recommended that NASA separate all critical paths from larger wire bundles and individually protect them for a minimum of six inches beyond their separation points.⁴ This recommendation is being adopted through modifications performed during scheduled Orbiter Major Modifications. For example, analysis of telemetered data from 14 of *Columbia*'s left wing sensors (hydraulic line/wing skin/wheel temperatures, tire pressures, and landing gear downlock position indication) provided failure signatures supporting the scenario of left-wing thermal intrusion, as opposed to a catastrophic failure (extensive arc tracking) of Kapton wiring. Actual NASA testing in the months following the accident, during which wiring bundles were subjected to intense heat (ovens, blowtorch, and arc jet), verified the failure signature analyses. Finally, extensive testing and analysis in years prior to STS-107 showed that, with the low currents and low voltages associated with the Orbiter's instrumentation system (such as those in the left wing), the probability of arc tracking is commensurately low.

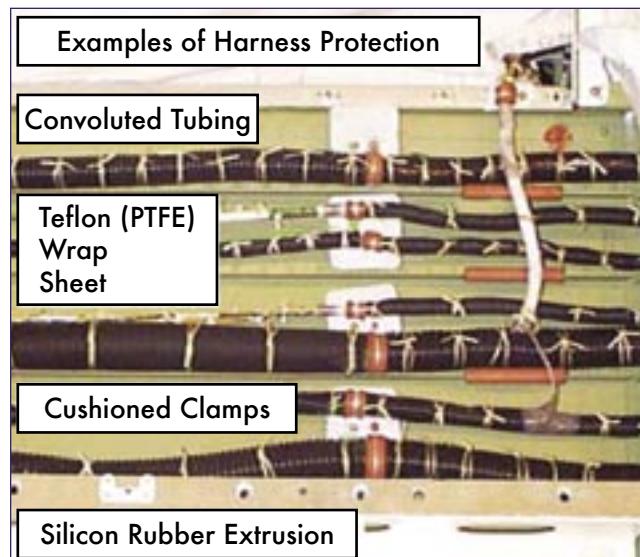
Figure 4.2-4. Typical wiring harness protection methods.

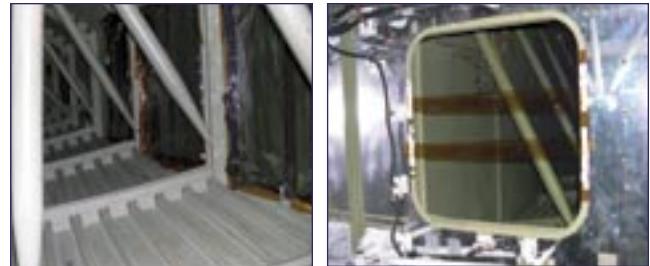
Figure 4.2-5. At left, a wing section open for inspection; at right, wing access closed off after inspection.

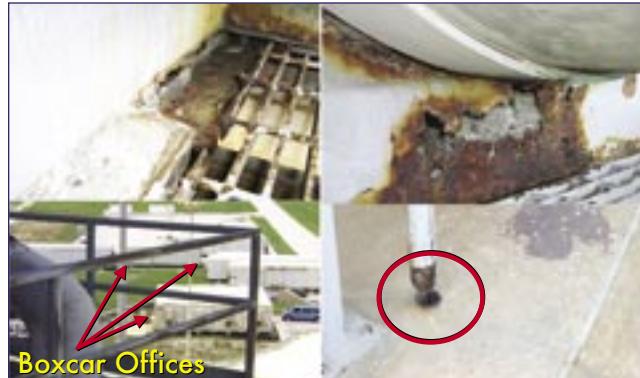
Board investigators have identified deteriorating infrastructure associated with the launch pads, Vehicle Assembly Building, and the crawler transporter. Figures 5.5-5 and 5.5-6 depict some of this deterioration. For example, NASA has installed nets, and even an entire sub-roof, inside the Vehicle Assembly Building to prevent concrete from hitting the Orbiter and Shuttle stack. In addition, the corrosion-control challenge results in zinc primer

on certain launch pad areas being exposed to the elements. When rain falls on these areas, it carries away zinc, runs onto the leading edge of the Orbiter's wings, and causes pinholes in the Reinforced Carbon-Carbon panels (see Chapter 3).

Figure 5.5-5 and 5.5-6. Examples of the seriously deteriorating infrastructure used to support the Space Shuttle Program. At left is Launch Complex 39A, and at right is the Vehicle Assembly building, both at the Kennedy Space Center.

In Fiscal Year 2002, Congress added \$25 million to NASA's budget for Vehicle Assembly Building repairs. NASA has reallocated limited funds from the Shuttle budget to pressing infrastructure repairs, and intends to take an integrated look at infrastructure as part of its new Shuttle Service Life Extension Program. Nonetheless, like Space Shuttle upgrades, infrastructure revitalization has been mired by the uncertainty surrounding the Shuttle Program's lifetime. Considering that the Shuttle will likely be flying for many years to come, NASA, the White House, and Congress alike now face the specter of having to deal with years of infrastructure neglect.

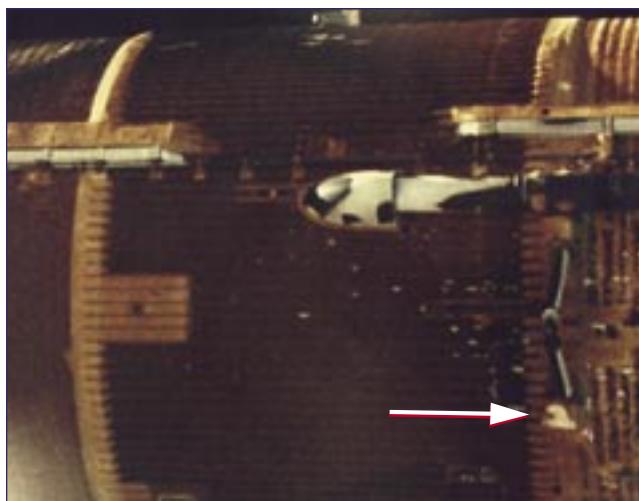
Figure 6.1-2. The first known instance of bipod ramp shedding occurred on STS-7 which was launched on June 18, 1983.

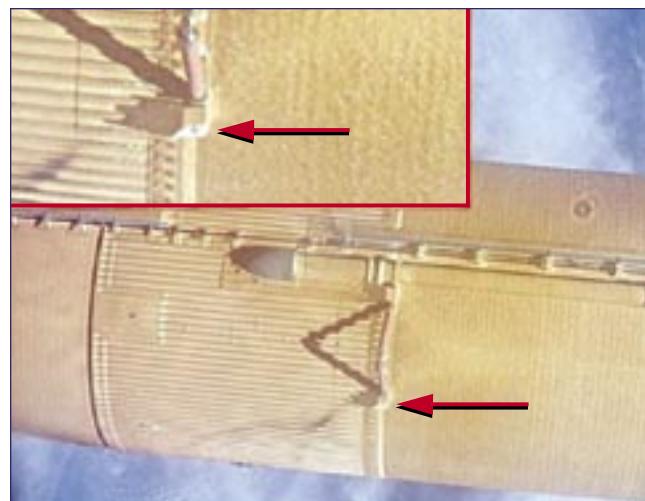
Figure 6.1-3. Only three months before the final launch of Columbia, the bipod ramp foam had come off during STS-112.

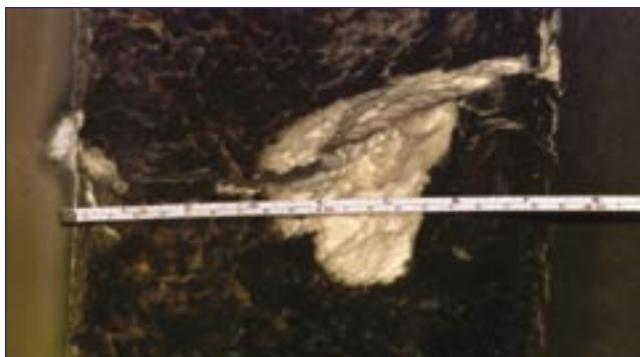
The sixth and final bipod ramp event before STS-107 occurred during STS-112 on October 7, 2002 (see Figure 6.1-3). At 33 seconds after launch, when *Atlantis* was at 12,500 feet and traveling at Mach 0.75, ground cameras observed an object traveling from the External Tank that subsequently impacted the Solid Rocket Booster/External Tank Attachment ring (see Figure 6.1-4). After impact, the debris broke into multiple pieces that fell along the Solid Rocket Booster exhaust plume.¹⁵ Post-mission inspection of the Solid Rocket Booster confirmed damage to foam on the forward face of the External Tank Attachment ring. The impact was approximately 4 inches wide and 3 inches deep. Post-External Tank separation photography by the crew showed that a 4- by 5- by 12-inch (240 cubic-inch) corner section of the left bipod ramp was missing, which exposed the super lightweight ablator coating on the bipod housing. This missing chunk of foam was believed to be the debris that impacted the External Tank Attachment ring during ascent. The post-launch review of photos and video identified these debris events, but the Mission Evaluation Room logs and Mission Management Team minutes do not reflect any discussions of them.

Figure 6.1-4. On STS-112, the foam impacted the External Tank Attach ring on the Solid Rocket Booster, causing this tear in the insulation on the ring.

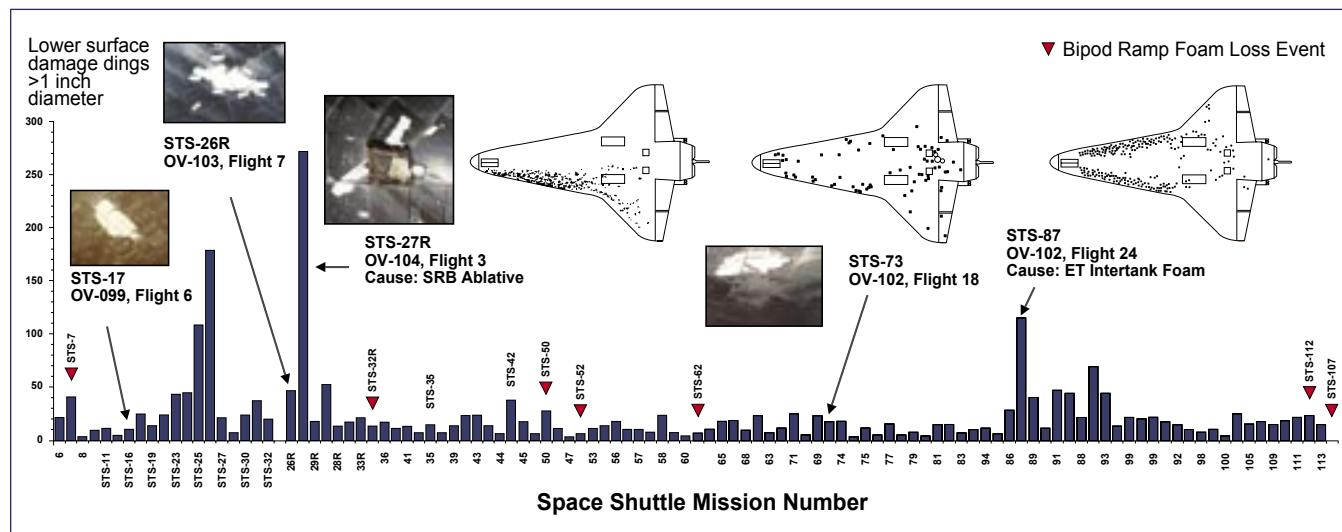
To better understand how NASA's treatment of debris strikes evolved over time, the Board investigated missions where debris was shed from locations other than the External Tank bipod ramp. The number of debris strikes to the Orbiters' lower surface Thermal Protection System that resulted in tile damage greater than one inch in diameter is shown in Figure 6.1-6.¹⁷ The number of debris strikes may be small, but a single strike could damage several tiles (see Figure 6.1-7).

Figure 6.1-6. This chart shows the number of dings greater than one inch in diameter on the lower surface of the Orbiter after each mission from STS-6 through STS-113. Flights where the bipod ramp foam is known to have come off are marked with a red triangle.

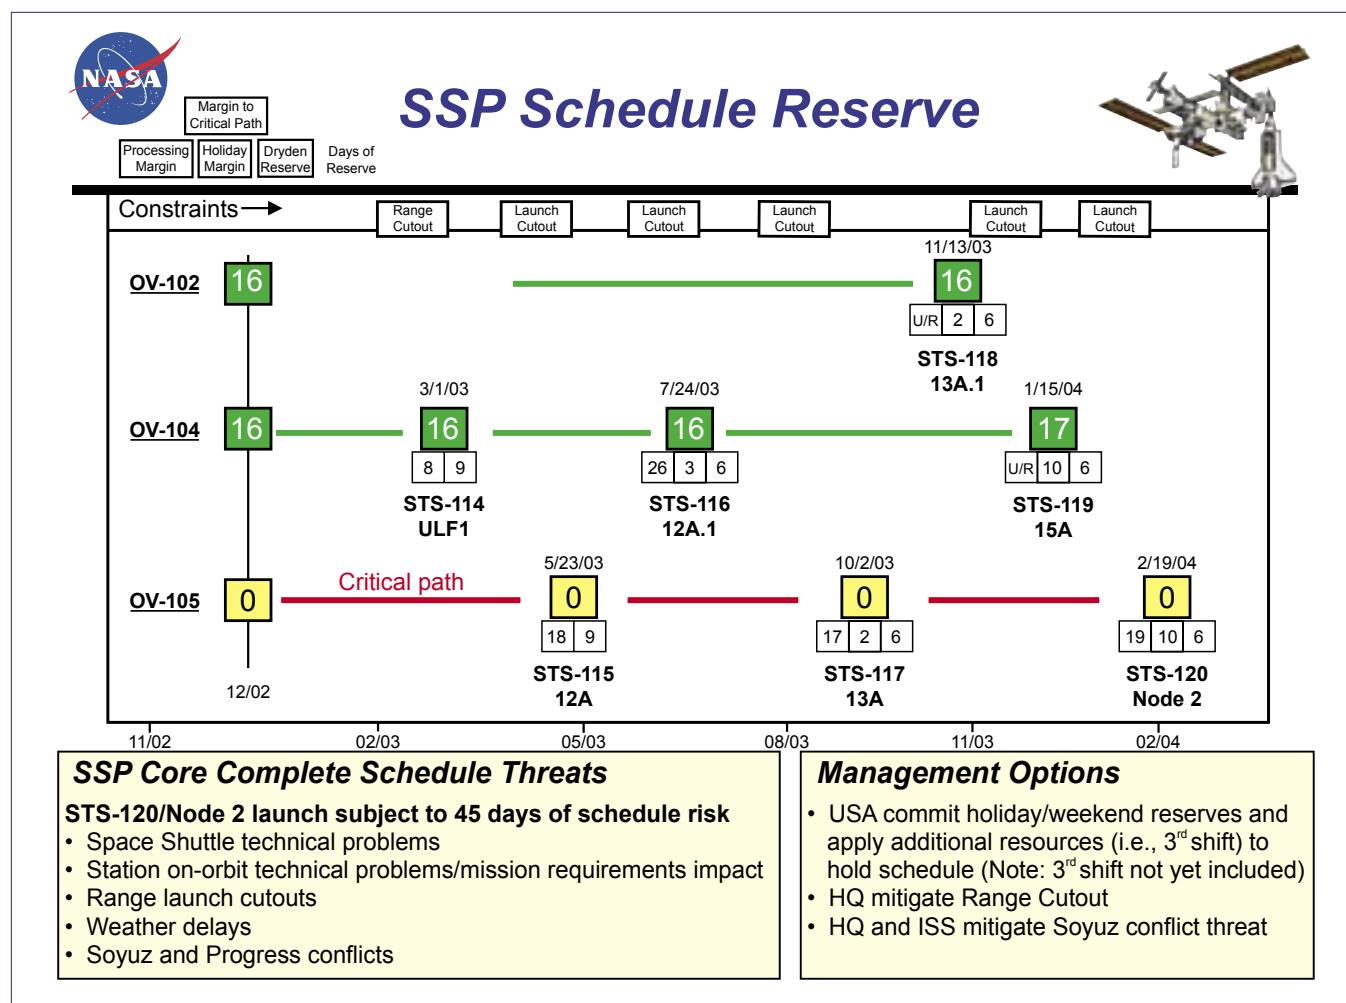
Figure 6.2-5 shows the margin for each vehicle (*Discovery*, OV-103, was in extended maintenance). The large boxes indicate the “margin to critical path” (to Node 2 launch date). The three smaller boxes underneath indicate (from

Figure 6.2-5. This slide shows the margin for each Orbiter. The large boxes show the number of days margin to the Node 2 launch date, while the three smaller boxes indicate vehicle processing margin, holiday margin, and the margin if a Dryden landing was not required.

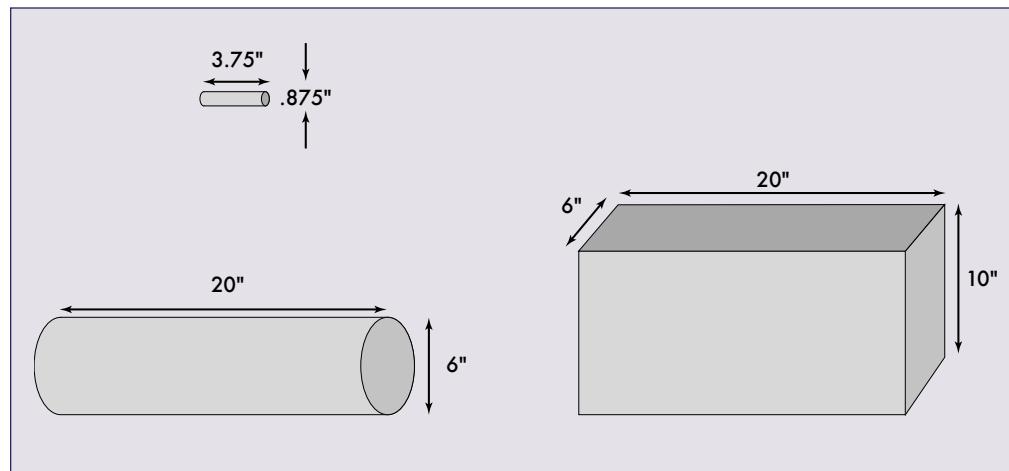
Until STS-107, Crater was normally used only to predict whether small debris, usually ice on the External Tank, would pose a threat to the Orbiter during launch. The use of Crater to assess the damage caused by foam during the launch of STS-107 was the first use of the model while a mission was on orbit. Also of note is that engineers used Crater during STS-107 to analyze a piece of debris that was at maximum 640 times larger in volume than the pieces of debris used to calibrate and validate the Crater model (the Board's best estimate is that it actually was 400 times larger). Therefore, the use of Crater in this new and very different situation compromised NASA's ability to accurately predict debris damage in ways that Debris Assessment Team engineers did not fully comprehend (see Figure 6.3-1).

Figure 6.3-1. The small cylinder at top illustrates the size of debris Crater was intended to analyze. The larger cylinder was used for the STS-107 analysis; the block at right is the estimated size of the foam.

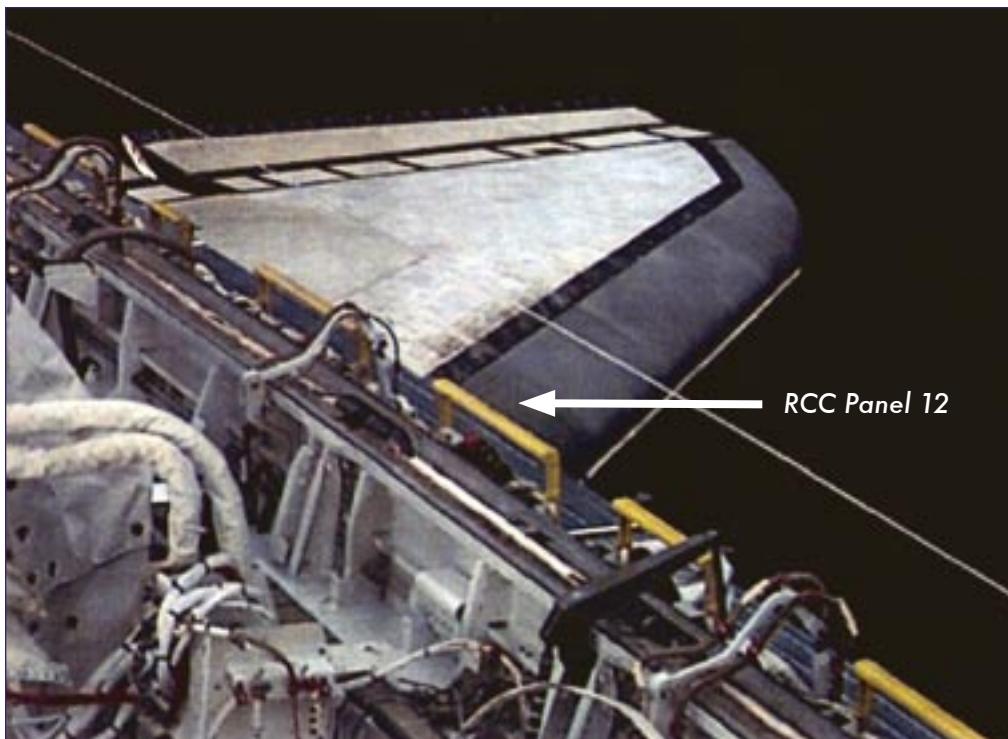
This photo from the aft flight deck window of an Orbiter shows that RCC panels 1 – 11 are not visible from inside the Orbiter. Since Columbia did not have a manipulator arm for STS-107, it would have been necessary for an astronaut to take a spacewalk to visibly inspect the inboard leading edge of the wing.

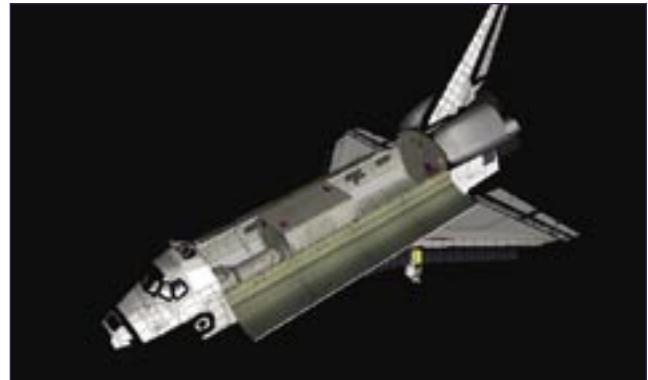
Figure 6.4-1. The speculative repair option would have sent astronauts hanging over the payload bay door to reach the left wing RCC panels using a ladder scavenged from the crew module.

The repair option (see Figure 6.4-1), while logistically viable using existing materials onboard *Columbia*, relied on so many uncertainties that NASA rated this option "high risk." To complete a repair, the crew would perform a spacewalk to fill an assumed 6-inch hole in an RCC panel with heavy metal tools, small pieces of titanium, or other metal scavenged from the crew cabin. These heavy metals, which would help protect the wing structure, would be held in place during

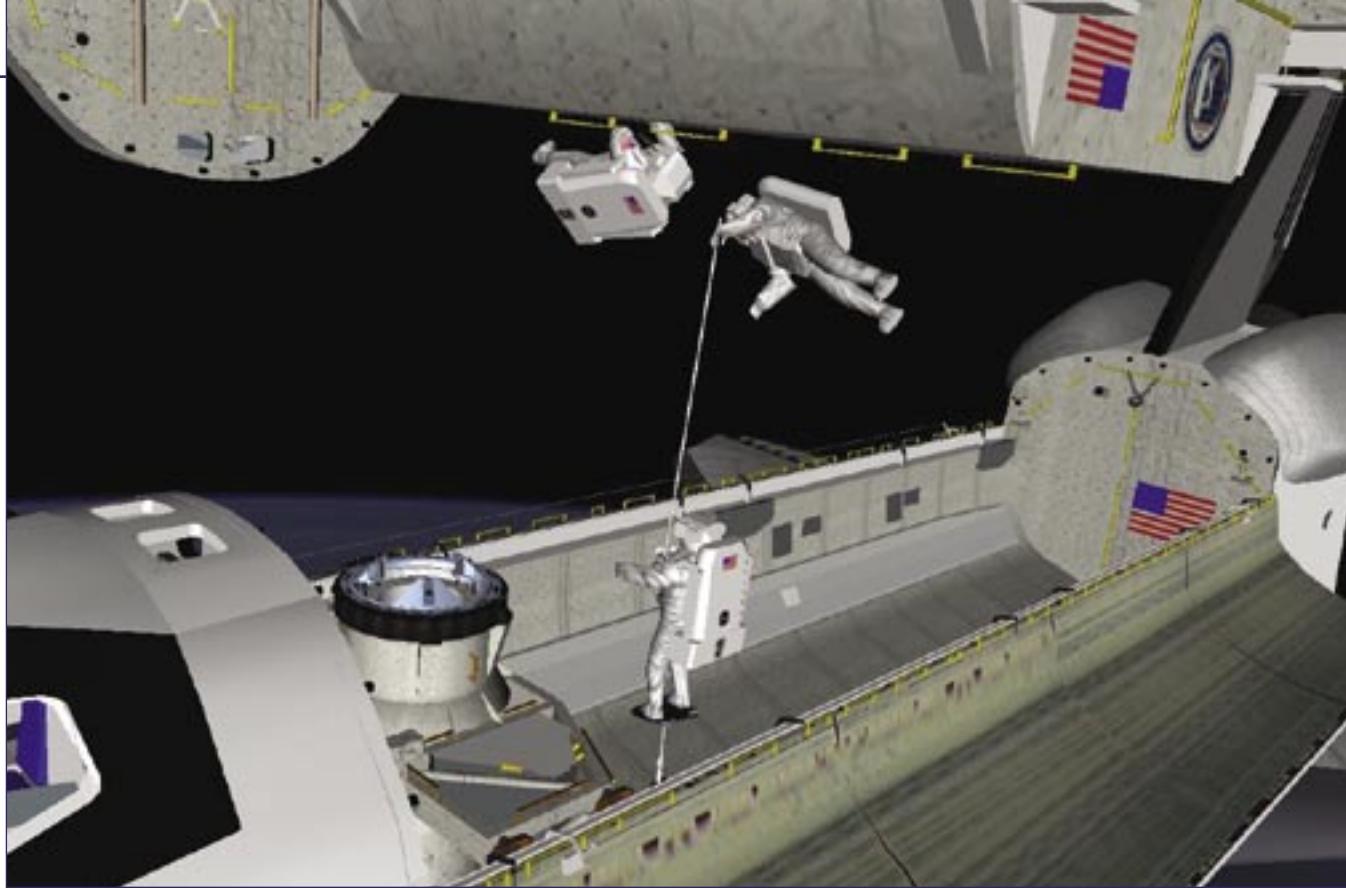
Figure 6.4-2. The rescue option had *Atlantis* (lower vehicle) rendezvousing with *Columbia* and the STS-107 crew transferring via ropes. Note that the payload bay of *Atlantis* is empty except for the external airlock/docking adapter.

er, pilot, and two astronauts trained for spacewalks. In January, seven commanders, seven pilots, and nine spacewalk-trained astronauts were available. During the rendezvous on *Atlantis*'s first day in orbit, the two Orbiters would maneuver to face each other with their payload bay doors open (see Figure 6.4-2). Suited *Columbia* crew members would then be transferred to *Atlantis* via spacewalks. *Atlantis* would return with four crew members on the flight deck and seven in the mid-deck. Mission Control would then configure *Columbia* for a de-orbit burn that would ditch the Orbiter in the Pacific Ocean, or would have the *Columbia* crew take it to a higher orbit for a possible subsequent repair mission if more thorough repairs could be developed.

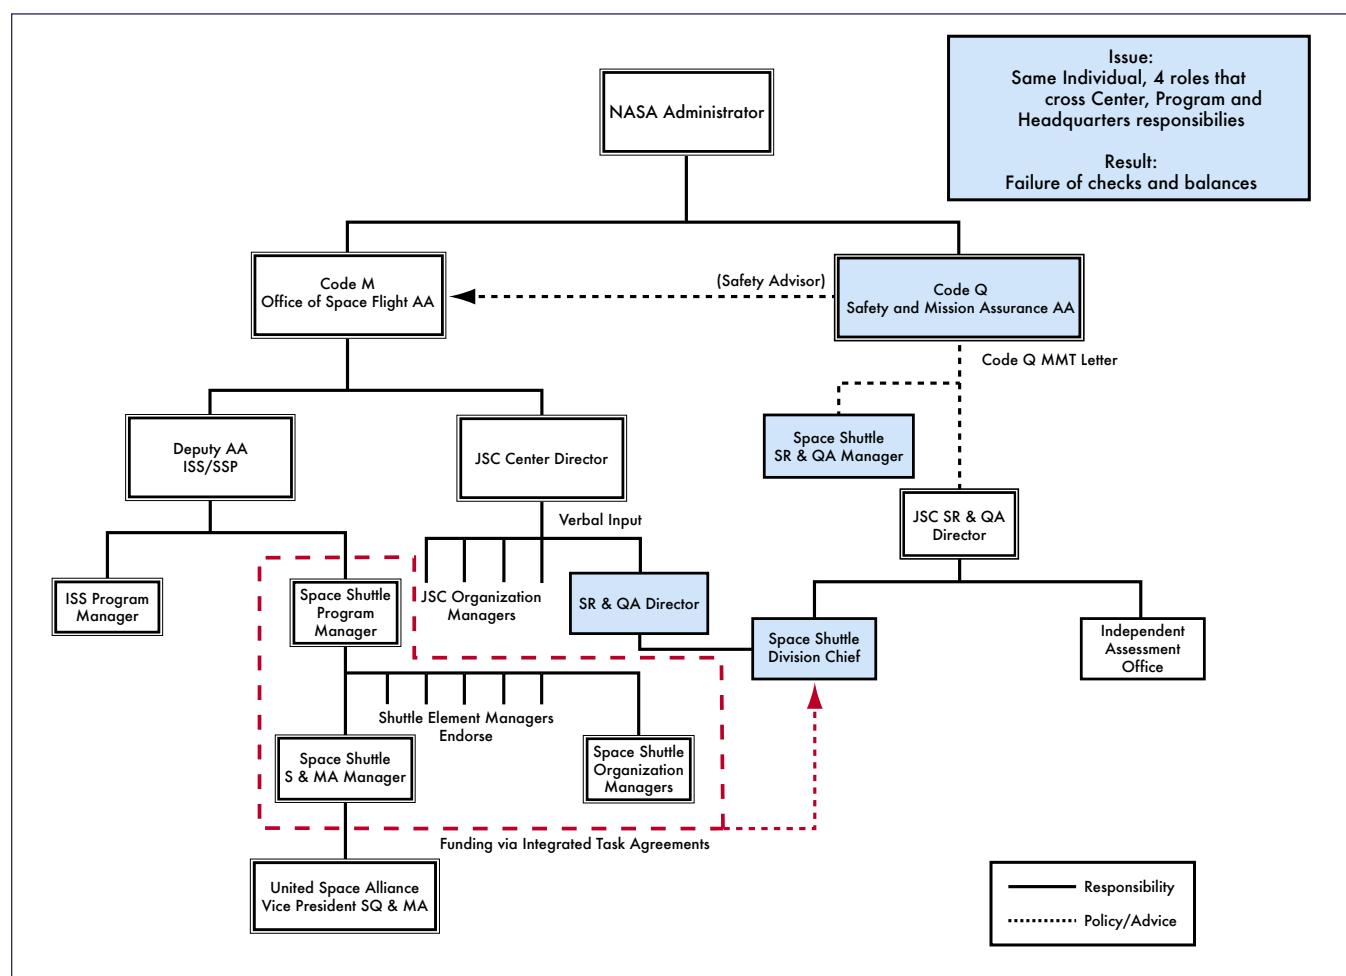
Figure 7.4-1. Independent safety checks and balance failure.

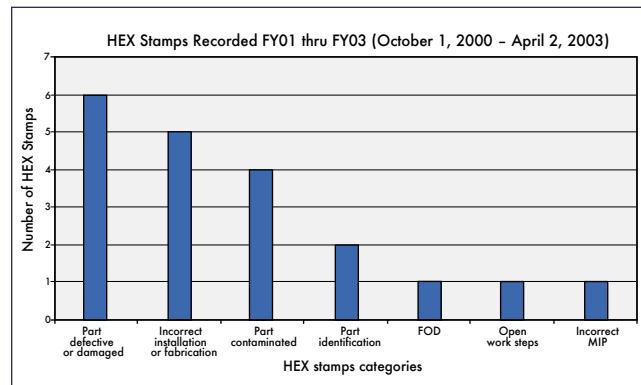
Figure 10.4.4. Rejection, or "Hex" stamps issued from October 2000 through April 2003.

Of the 141,127 inspections subject to rejection from October 2000 through March 2003, only 20 rejections, or "hexes," were recorded, resulting in a statistically improbable discrepancy rate of .014 percent (see Figure 10.4.4). In interviews, technicians and inspectors alike confirmed the dubiousness of this rate. NASA's published rejection rate therefore indicates either inadequate documentation or an underused system. Testimony further revealed incidents of quality assurance inspectors being played against each other to accept work that had originally been refused.
