Structural Survey

Phoenix House

Union Street, Sunderland, SR1 3BT

September 2014

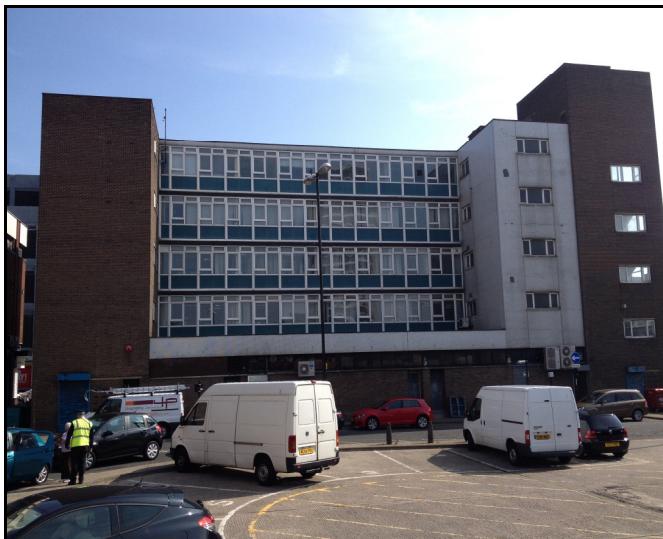
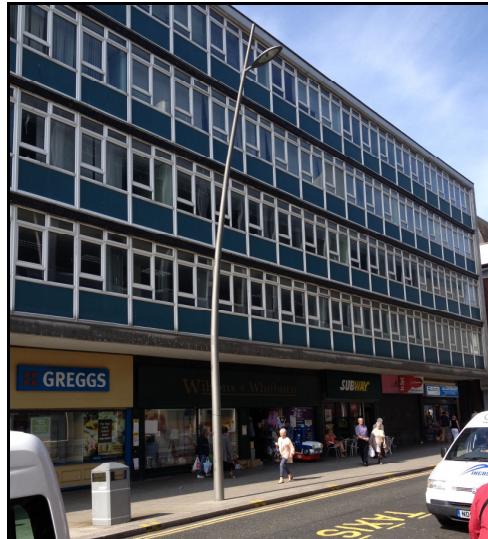
Fig 1 & 2:- Showing Elevations West (rear) and East (front)

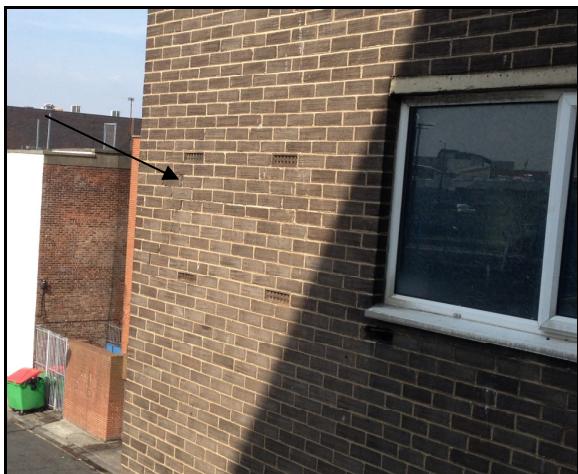
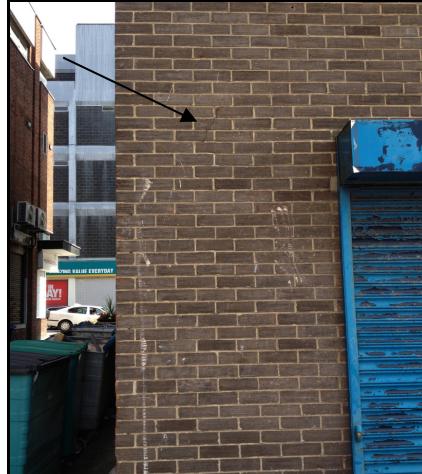
Figure 3 & 4:- showing thermal movement cracks to masonry

Our survey revealed a hairline diagonal crack local to the left side of the south facing window of the north wing, 3rd floor (see fig. 3). Also, a hair line diagonal crack local to the left side of the door head on the north wing, rear elevation (see fig. 4). We consider the cracks have been caused as a result of thermal movement. This occurs as the brickwork expands and contracts in conjunction with variations in external temperatures. Figure 3 has captured sunlight to one side of the brickwork, this is causing contrasting temperatures in the brickwork which causes the brickwork to expand and contract at different rates.

Thermal movement as described above would not normally be considered a significant structural issue. The cracked brickwork can be cut out and replaced along with re-pointing the affected mortar joints accordingly.

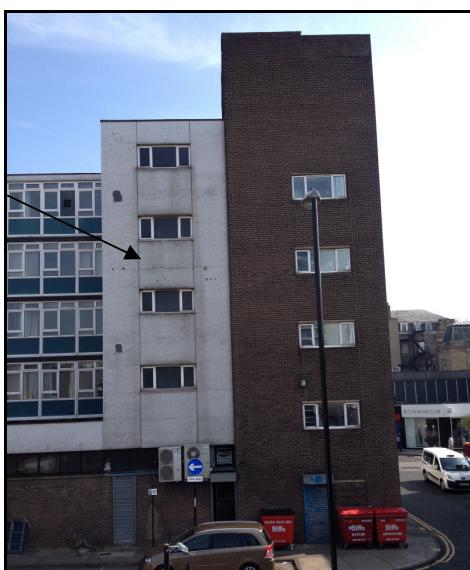
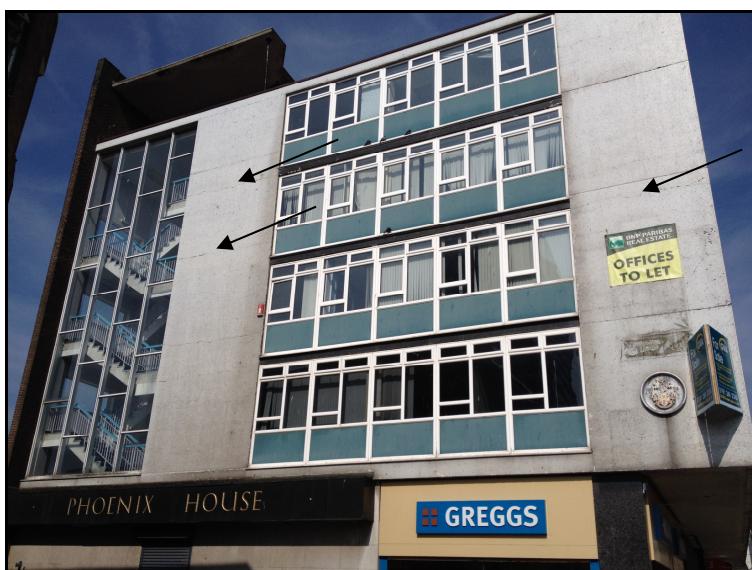
Figure 5 & 6:- showing horizontal cracking to mosaic panels on south wing and south elevation

Horizontal cracks were noted through the mosaic panel's local to the south elevation and south wing (see fig. 5 & 6). The fractures typically run through the intermediate floor junction spanning horizontally across the masonry, approximately 3mm wide. There are also further cracks which run approximately 500mm parallel the immediate floor junctions. The nature of these cracks is consistent on floors 1 – 4.

We consider the horizontal cracking noted both externally and internally are associated with wind load deflection due to a lack of top edge restraint to the masonry. The extent of horizontal cracking, being local to the west and south of the building, is due to high exposure to prevailing winds. The east and north elevations are more sheltered from wind load and hence do not appear to have been affected by wind deflection. It is our recommendation that the provision of adequate head restraint is made during the refurbishment works. This can be achieved by spanning steel members across column locations situated above the masonry. BGP can provide details and calculations for this provision under separate instruction.

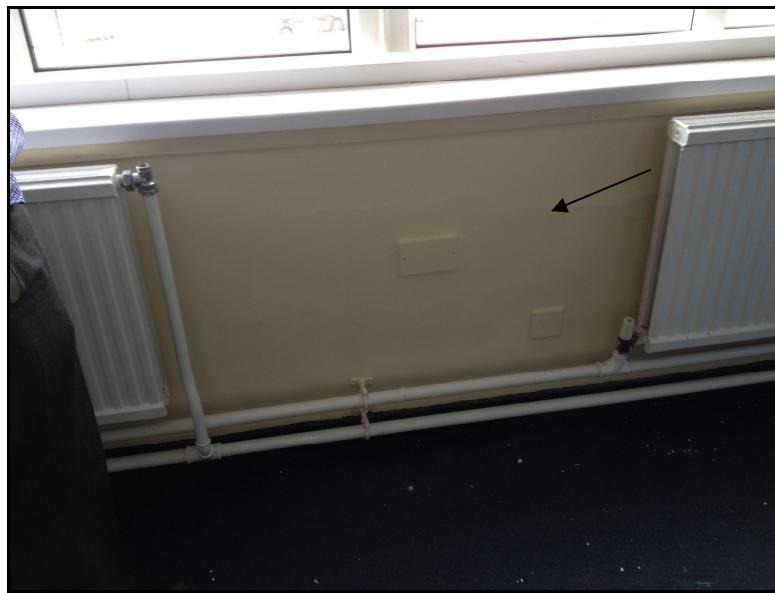
Figure. 7:- showing typical nature of cracking local to inner leaf on west elevation

Hairline horizontal cracks were also noted on the inner leaf of masonry local to the west elevation (see fig. 7). The size and location of these cracks are consistent on floors 1 – 4.

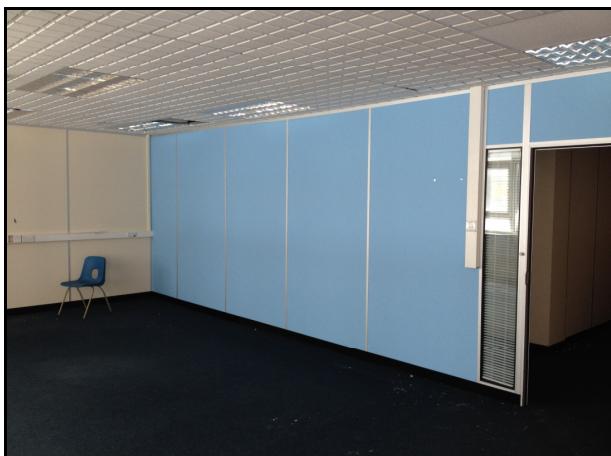
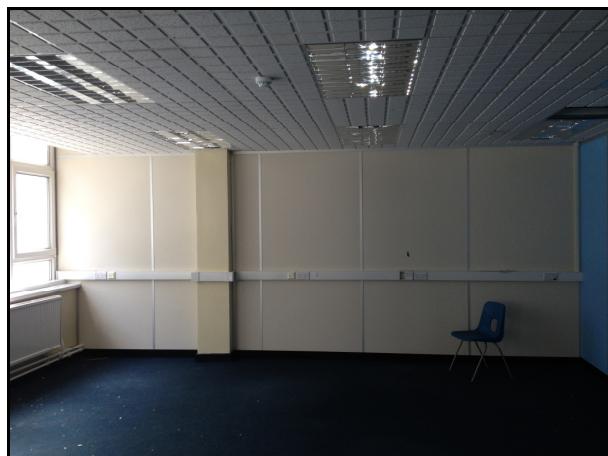
Internal walls on floors 1 – 4 typically comprise demountable partitions (see fig. 8), with the exception of masonry walls which are local to the north and south stairwell. The demountable partitions are non-loading bearing and we presume are fixed to the concrete floor/ underside of ceiling.

Figure. 8 & 9:- showing typical internal partition present on floors 1-4

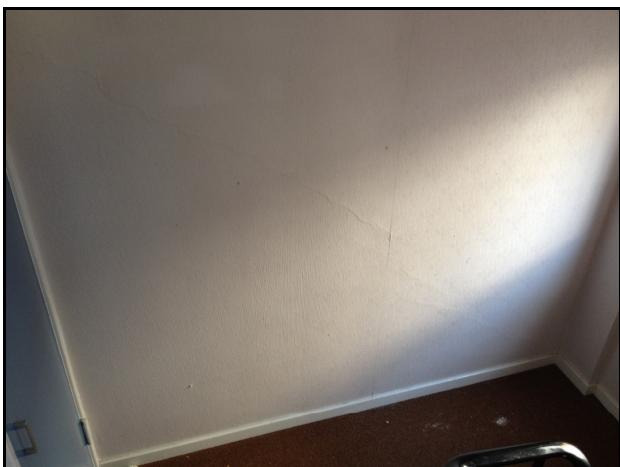
A diagonal fracture was identified local to the half landing, second floor of the north stairwell (see fig. 10). The crack is hairline in nature and runs diagonally across the wall from right to left. In addition, a similar crack in size and nature, was identified on the third floor half landing and also on the fourth floor, south wing (see fig. 10). We consider the cracks to be non-structural and caused as a result of failure in the plaster.

Figure 10 & 11:- showing diagonal cracks local to north and south stairwell
