## Tensile strength test

By commission of Texsolv AB tensile tests were performed on ropes.

Test place: SP Structural and Solid Mechanics in Borås.

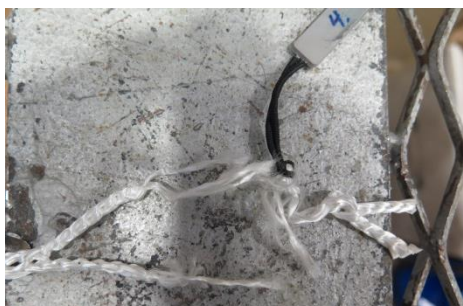
| Test marking | Breaking-force kN | Breaking-force kg | Total length mm | Elongation % | Remarks |
|---|---|---|---|---|---|
| No 4 | 2.05 | 209 | 1068 | 20.8 | Fracture at the loop, see photo 4 |

Photo 4. Fracture, test object marked No 4.

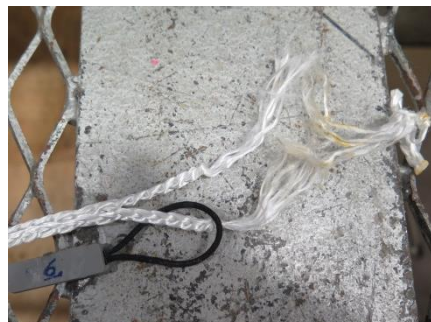
| Test marking | Breaking-force kN | Breaking-force kg | Total length mm | Elongation % | Remarks |
|---|---|---|---|---|---|
| No 6 | 2.93 | 299 | 1027 | 21.3 | Fracture at the loop, see photo 5 |

Photo 5. Fracture, test object marked No 6.

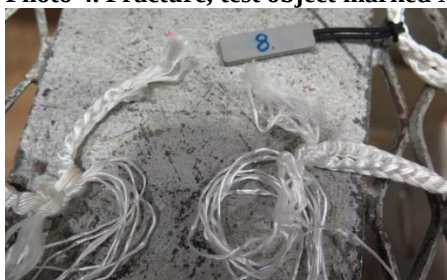
| Test marking | Breaking-force kN | Breaking-force kg | Total length mm | Elongation % | Remarks |
|---|---|---|---|---|---|
| No 8 | 3.44 | 351 | 1057 | 22.3 | Fracture at the loop, see photo 6 |

Photo 6. Fracture, test object marked No 8.

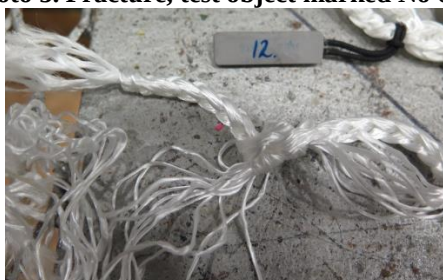
| Test marking | Breaking-force kN | Breaking-force kg | Total length mm | Elongation % | Remarks |
|---|---|---|---|---|---|
| No 12 | 4.80 | 489 | 1061 | 22.1 | Fracture at the loop, see photo 7 |

Photo 7. Fracture, test object marked No 12.

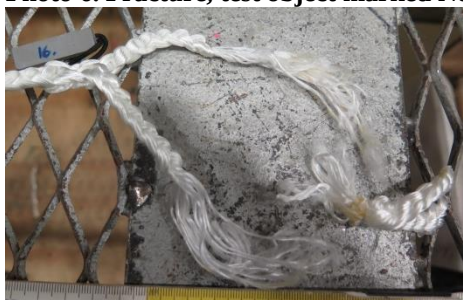
| Test marking | Breaking-force kN | Breaking-force kg | Total length mm | Elongation % | Remarks |
|---|---|---|---|---|---|
| No 16 | 6.30 | 642 | 1046 | 22.5 | Fracture at the loop, see photo 8 |

Photo 8 . Fracture, test object marked No 16.

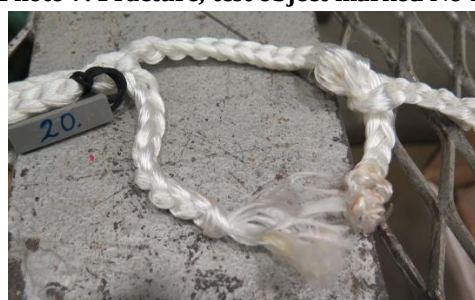
| Test marking | Breaking-force kN | Breaking-force kg | Total length mm | Elongation % | Remarks |
|---|---|---|---|---|---|
| No 20 | 8.27 | 843 | 1013 | 25.0 | Fracture at the loop, see photo 9 |

Photo 9. Fracture, test object marked No 20.
