## Foundering of fishing vessel

### *Kairos* (BF190)

## 70 nautical miles west of the Isles of Scilly

18 May 2015

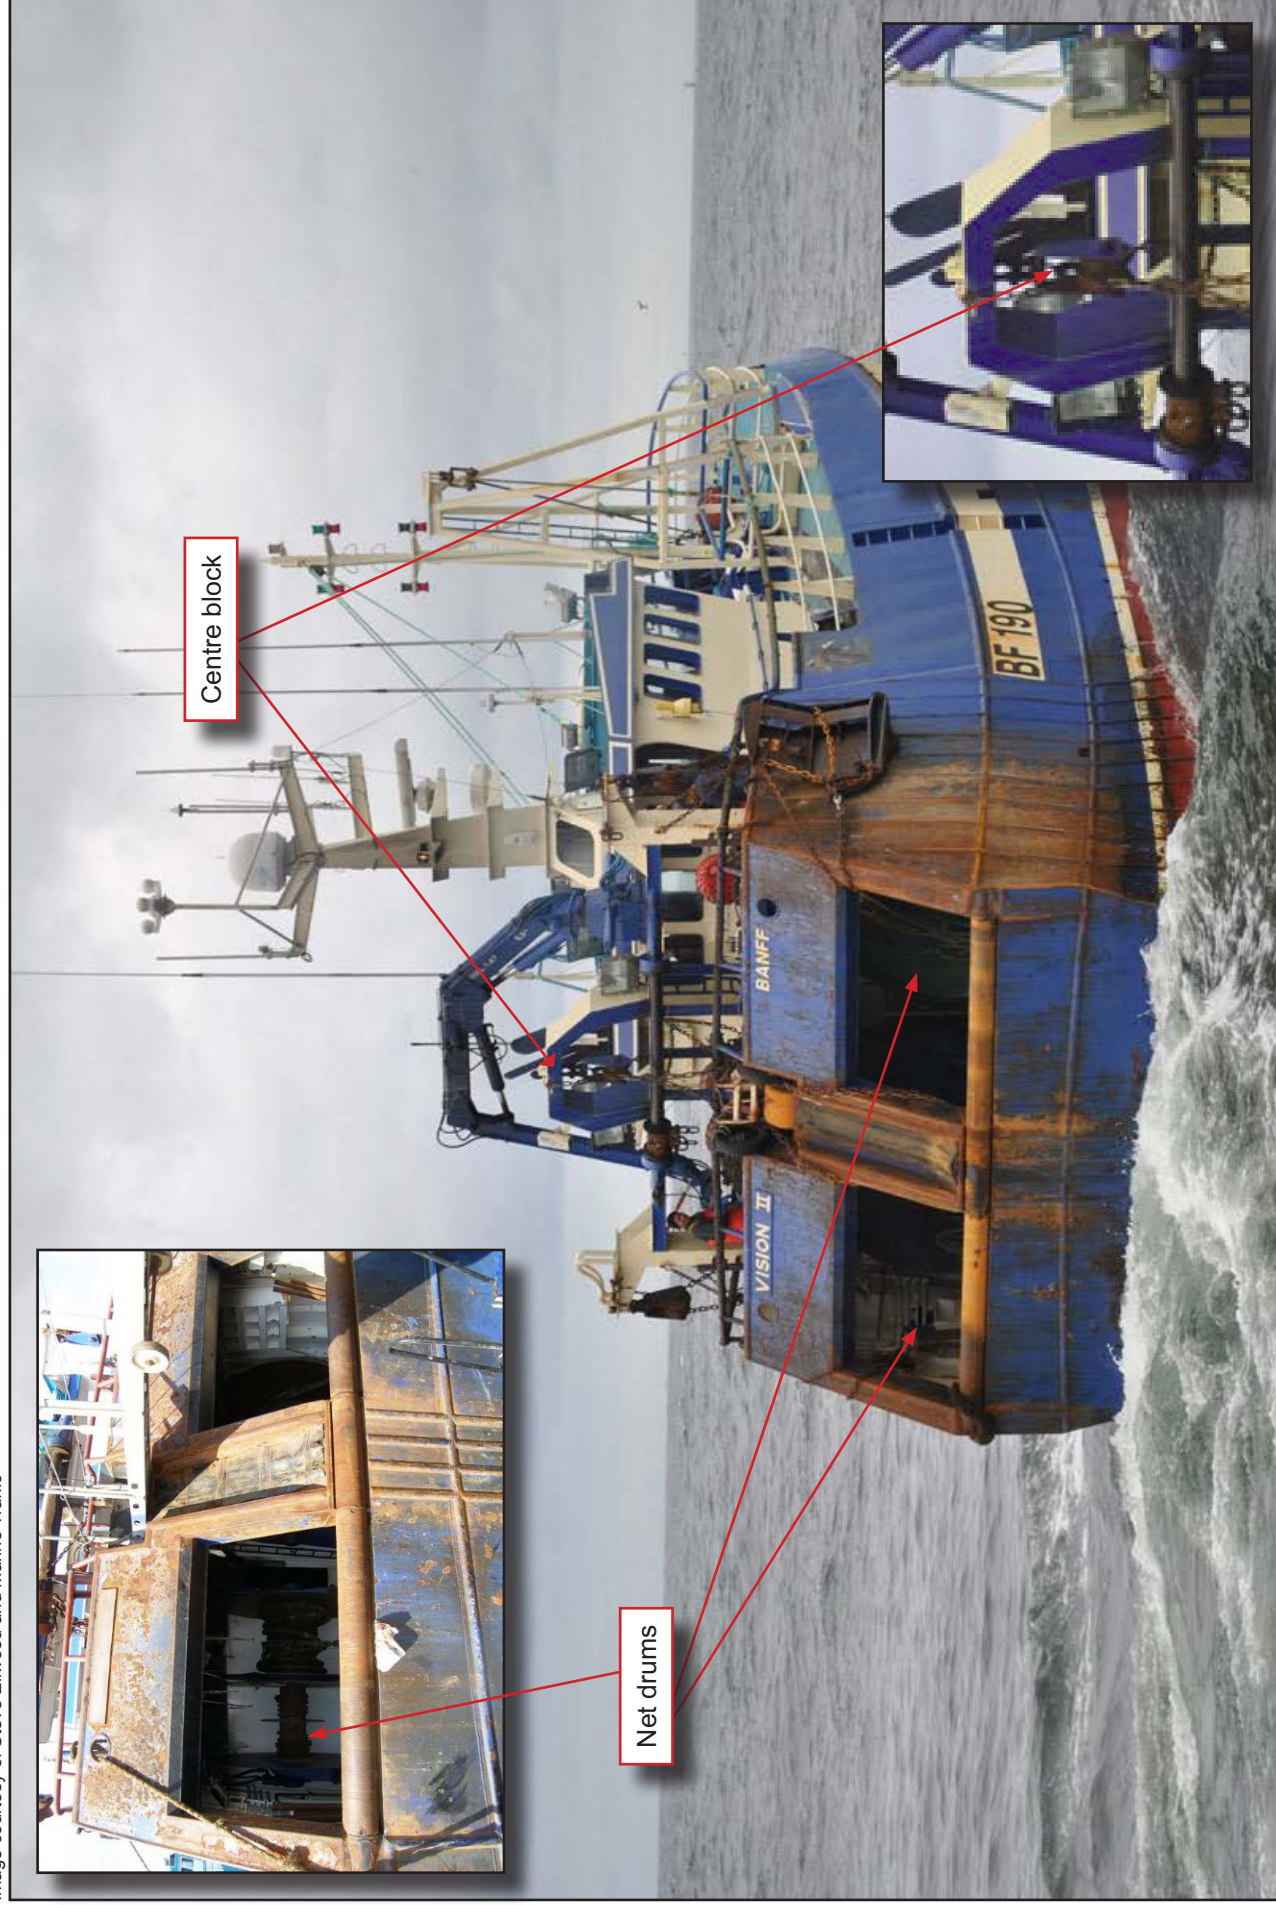
Figure 2: Stern of Kairos (as Vision II)

The port trawl was hauled and stowed. A creeper<sup>2</sup> was then rigged on a wire leading from the centre block (**Figure 2**) and lowered to the seabed. *Kairos* was then manoeuvred ahead in the vicinity of the position marked on the plotter to try and snag the lost net with the creeper. The vessel's two deckhands and two engineers tidied the net drum space. They then went inside the accommodation on the main deck. *Kairos* was rolling heavily in 4m seas and 30kts west-north-westerly winds. At 1717, the skipper advised the vessel's regular skipper by text message<sup>3</sup> that he was attempting to find a lost net.

- The vessel met all of the applicable stability criteria provided that the initial downflooding points were the engine room vents (**Figure 2**) (with the vessel at an angle of 60° list) and that the fuel tank cross-connection valve between port and starboard tanks was closed.
- The vessel did not meet six out of seven stability criteria with the cabin space vent open (**Figure 2**). The open vent reduced the angle of downflooding to 35°.

A number of vessel conditions were then assessed to reflect the circumstances that led to *Kairos*'s capsize. These conditions included: 5t of floodwater in the net drum space (**Figure 2**), floodwater depths of 0.61m, 1.53m and 2m in the cabin space and loads of 2t, 4t and 6t on the trawl wire. The resulting assessments identified:
