August 1, 2023

MIR-23-16

## Collision between Cargo Ship *Damgracht* and Cargo Ship *AP Revelin*

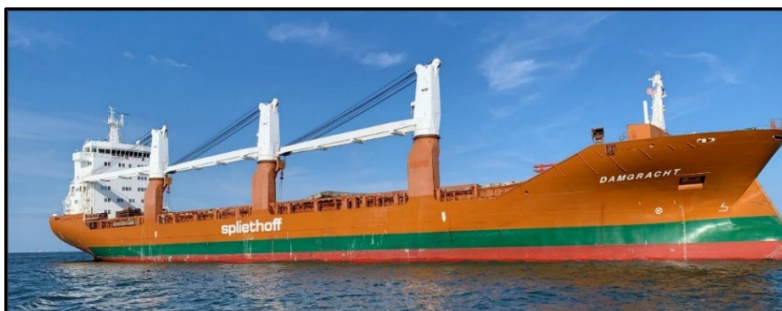
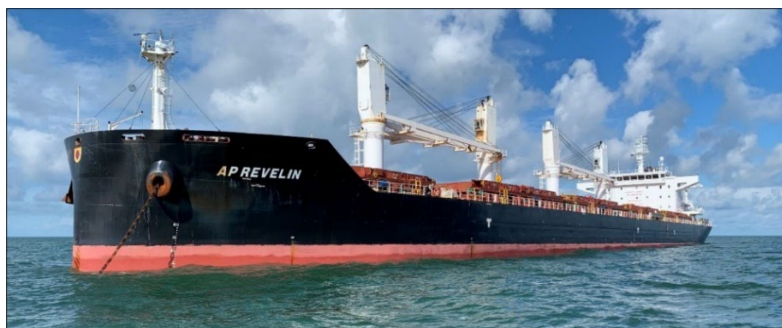
**Figure 1.** Cargo ships *Damgracht* (above) and *AP Revelin* (below) anchored after the collision.

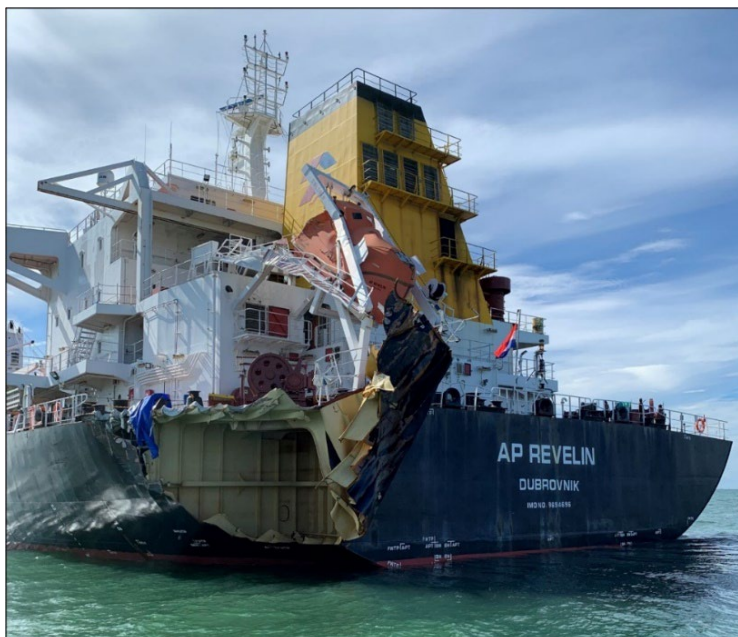
Following the collision, surveyors conducted damage assessments on both vessels. The *AP Revelin* sustained damage on the port, aft section of the stern deck, the freefall lifeboat and its davit structure, engine room store bulkhead, side shell and transom plating, and portside freshwater tank.

**Figure 5.** Damaged stern area of the *AP Revelin* after the collision.

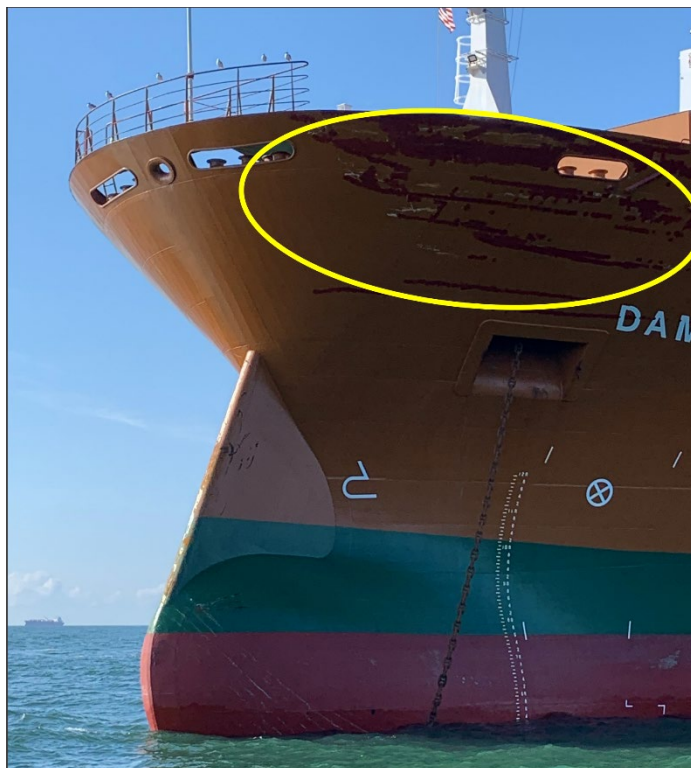
Surveyors inspected the bow of the *Damgracht* and found that the upper port side of the bow above the anchor pocket had indents that were “smooth without sharp knuckles” and that no cracks were revealed. They “evaluated and found acceptable” the damage in the supporting structure.

**Figure 6.** Port bow of the *Damgracht* after the collision with damage circled in yellow.
