MIR-24-23

## Flooding and Partial Sinking of Towing Vessel *Uncle Blue*

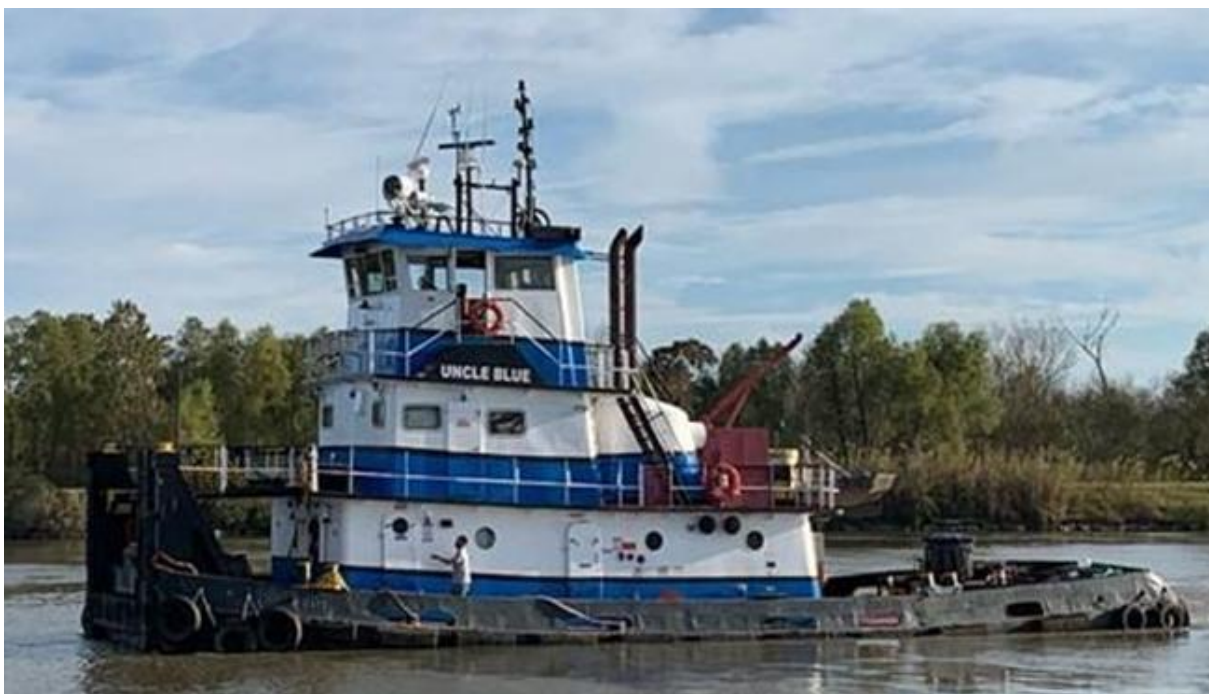
**Figure 1.** *Uncle Blue* underway in 2019. (Source: Michael Alexis)

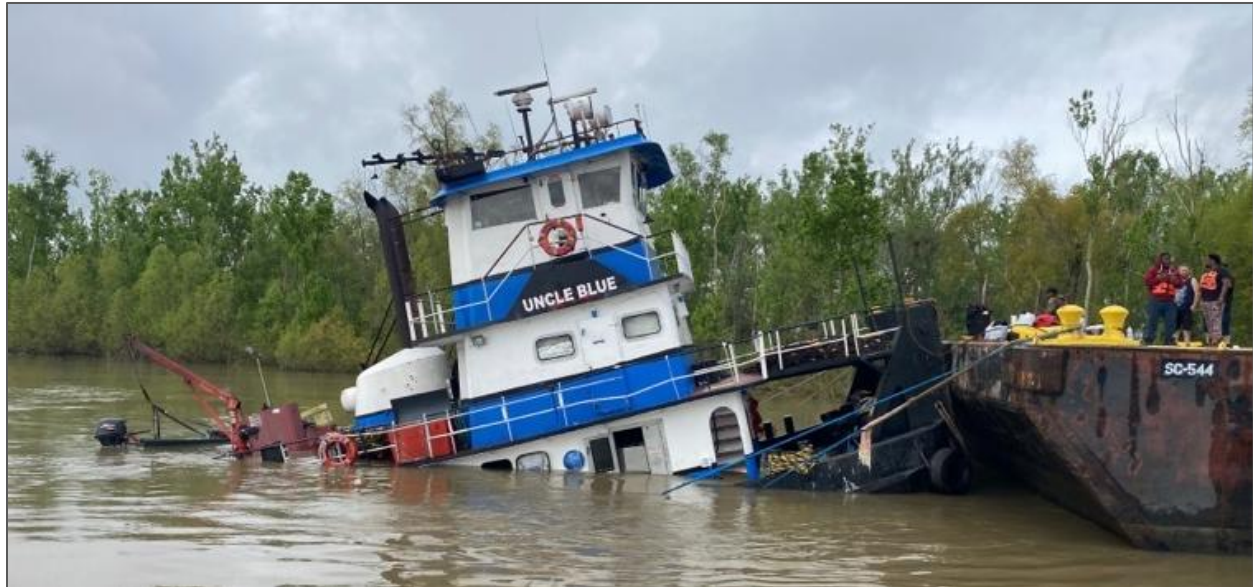
Because the suction hose for the *Uncle Blue*'s portable pump was stowed on the stern (which was now under water), the *CSS Richmond* crew provided pumps. However, efforts to dewater the engine room were unsuccessful, and the crew abandoned the vessel to the barge. The *Uncle Blue* continued to sink until it was partially submerged; the barge remained afloat (see Figure 4).

**Figure 4.** *Uncle Blue* partially sunken. (Source: US Coast Guard)

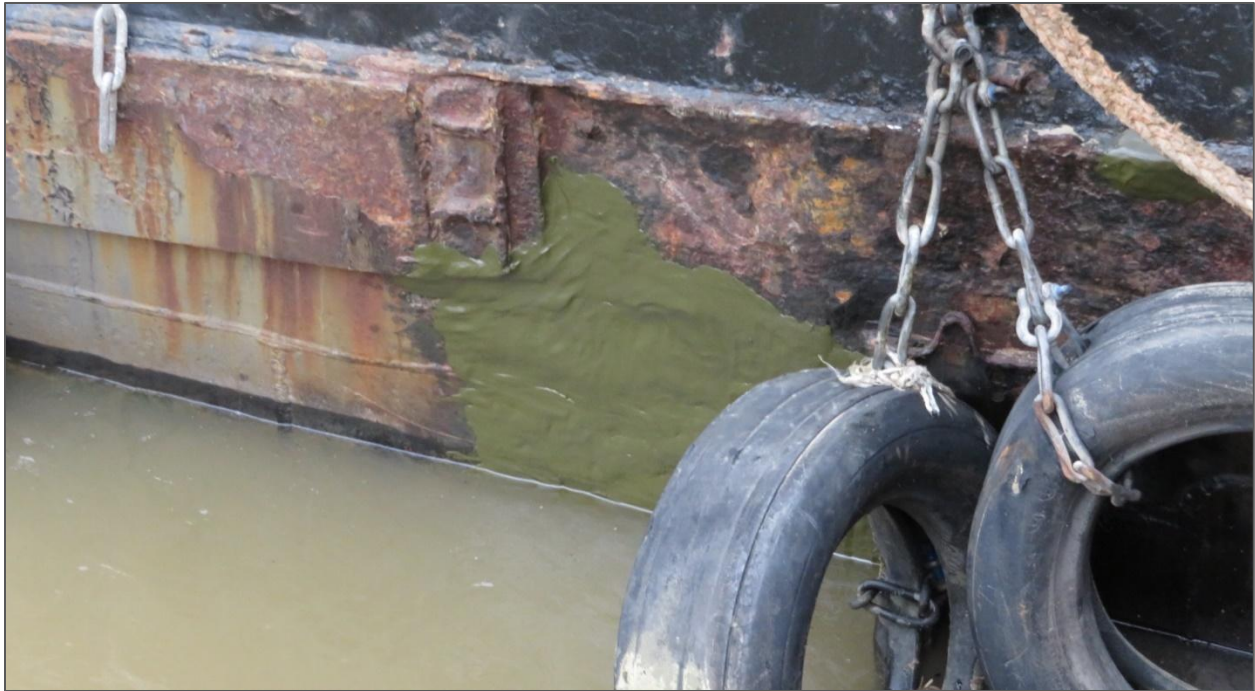
Salvors worked for 4 days to remove 1,400 gallons of fuel from the vessel and refloat the towboat. When the vessel was lifted by crane, NTSB investigators noted water pouring from holes in the portside shell plating of the flooded lazarette. Salvors made temporary epoxy repairs to keep the vessel afloat (see Figure 5).

**Figure 5.** Temporary epoxy repair, applied during the postcasualty salvage, on the port quarter, near the lazarette.

The *Uncle Blue* had been in service for almost 60 years. During salvage, investigators discovered numerous wastage holes in the hull on the port side of the lazarette. Given the vessel's age and the holes found in the hull, the vessel's hull had not been adequately maintained. Investigators did not identify other potential sources for the flooding; therefore, the wasted steel hull in the lazarette was the initial source of the flooding.

The National Transportation Safety Board determines that the probable cause of the flooding and partial sinking of the towing vessel *Uncle Blue* was a lack of watertight integrity due to the poor condition of the hull, which allowed water to ingress through wastage holes into the lazarette. Contributing to the sinking were unsealed penetrations in transverse bulkheads, which allowed for progressive flooding forward into the engine room, and the lack of a high-water bilge sensor in the lazarette, which prevented early detection of flooding into the space.

Steel hulls are susceptible to corrosion, erosion, and damage over time. To avoid flooding or weakening of the hull, it is good marine practice for owners to conduct regular oversight and maintenance of hulls, including between drydock periods. An effective maintenance and hull inspection program should proactively address potential steel wastage, identify hull and watertight integrity deficiencies, and ensure corrosion issues are repaired in a timely manner by permanent means.
