June 11, 2025

MIR-25-23

## Grounding of Towing Vessel *Tom Frazier*

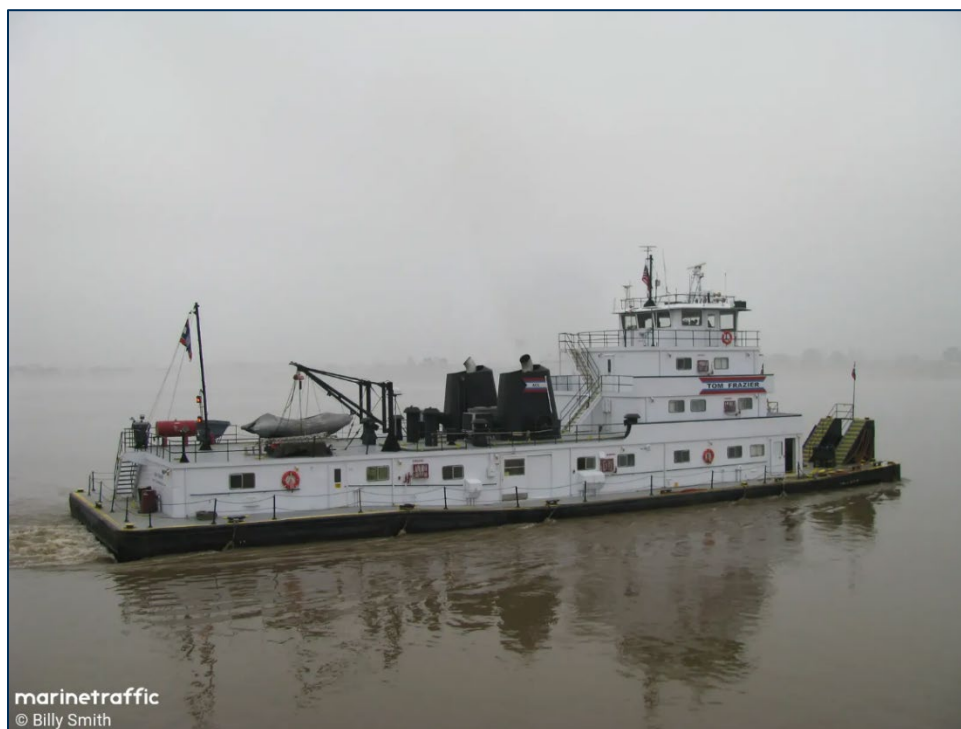
**Figure 1.** The *Tom Frazier* underway in 2008. (Source: Billy Smith)

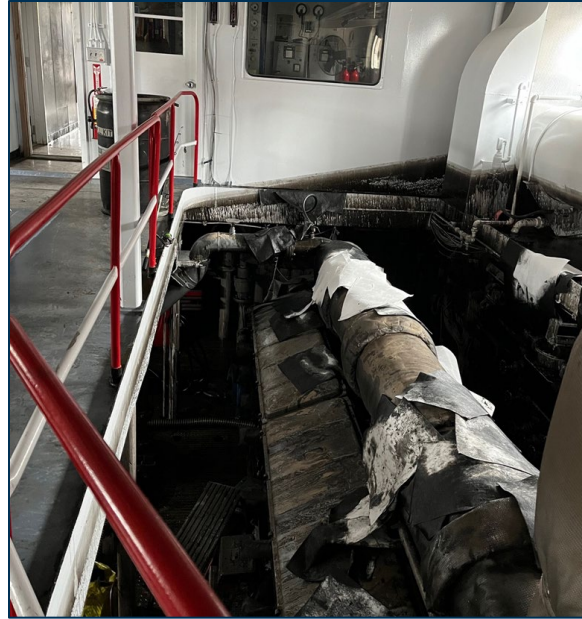
The *Tom Frazier* sustained damage to its bottom hull plating, deck plating, and headlog, as well as to transverse and longitudinal frames, inboard bulkheads, and a ballast tank (see figure 7). Damage was \$258,737.

**Figure 7.** *Tom Frazier's* engine room, looking forward. The oil-coated bulkheads show the height of water and angle of list before dewatering. (Source: Coast Guard)
