September 4, 2025

MIR-25-34

## Contact of Ferry *Ray Stoker, Jr.* with Floating Dock

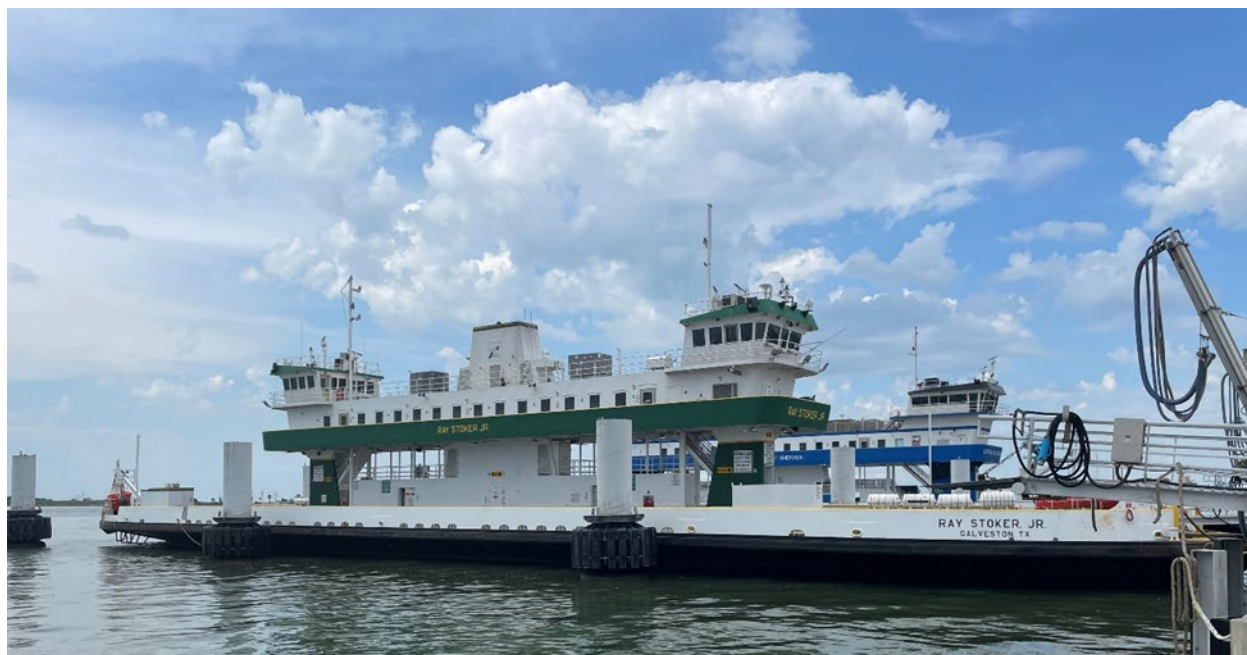
**Figure 1.** *Ray Stoker, Jr.* docked in Galveston, Texas, on September 25, 2024, after striking the floating dock at the Coast Guard Base Galveston.

Damage to the *Ray Stoker, Jr.* consisted of scraped paint about 1 foot above the waterline along the port side of the hull. Additionally, the portside rub rail had about 3 feet of white paint transferred to it from the floating dock pilings. Steel brackets under the lifeboat launching area were scraped, dented, and broken. Damage was estimated at \$5,000. The brackets were repaired or replaced by the ferry's shoreside maintenance team.

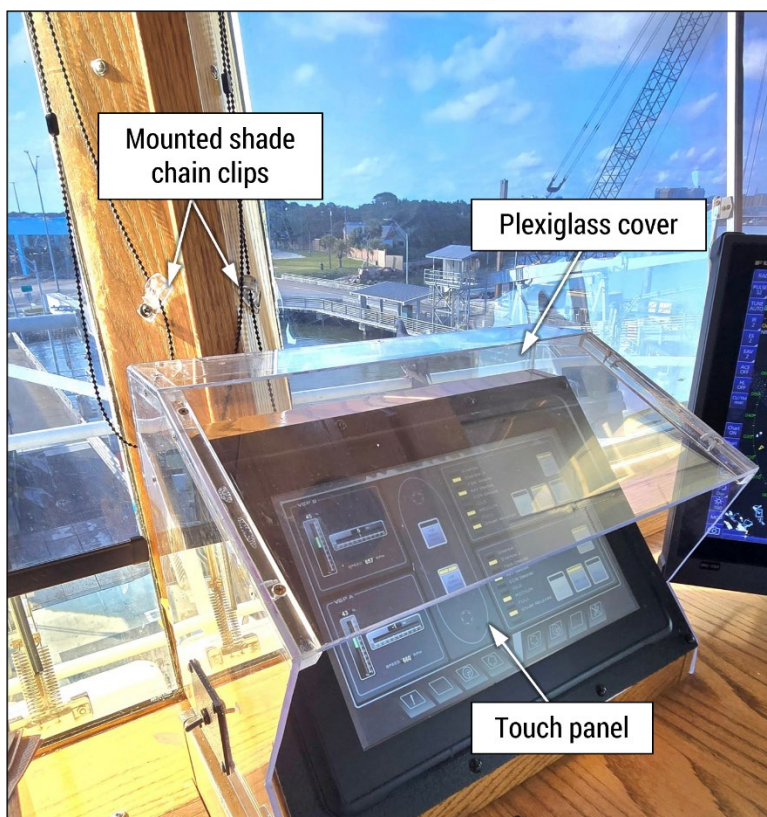
**Figure 7.** Touch panel with plexiglass cover. (Background source: Texas Department of Transportation)

In July 2025, transparent plexiglass covers were installed on the *Robert H. Dedman*, which had similar control arrangement. In August 2025, transparent plexiglass covers were installed on the *Ray Stoker, Jr* (see figure 7). As of the date of this report, installation was still pending on the remaining two ferries with similar control arrangements.
