MIR-26-26

## Contact of Bulk Carrier *Belle Mer* Anchor with Subsea Cable

On November 15, 2024, about 1211 local time, the cargo vessel *Belle Mer* was anchored in the Tongass Narrows, near Ketchikan, Alaska, when the ship dragged anchor and damaged a subsea fiber optic cable (see figure 1 and figure 2).<sup>1</sup> There were no injuries, and no pollution was reported. There was no damage to the vessel. Damage to the subsea cable was estimated at \$240,000.

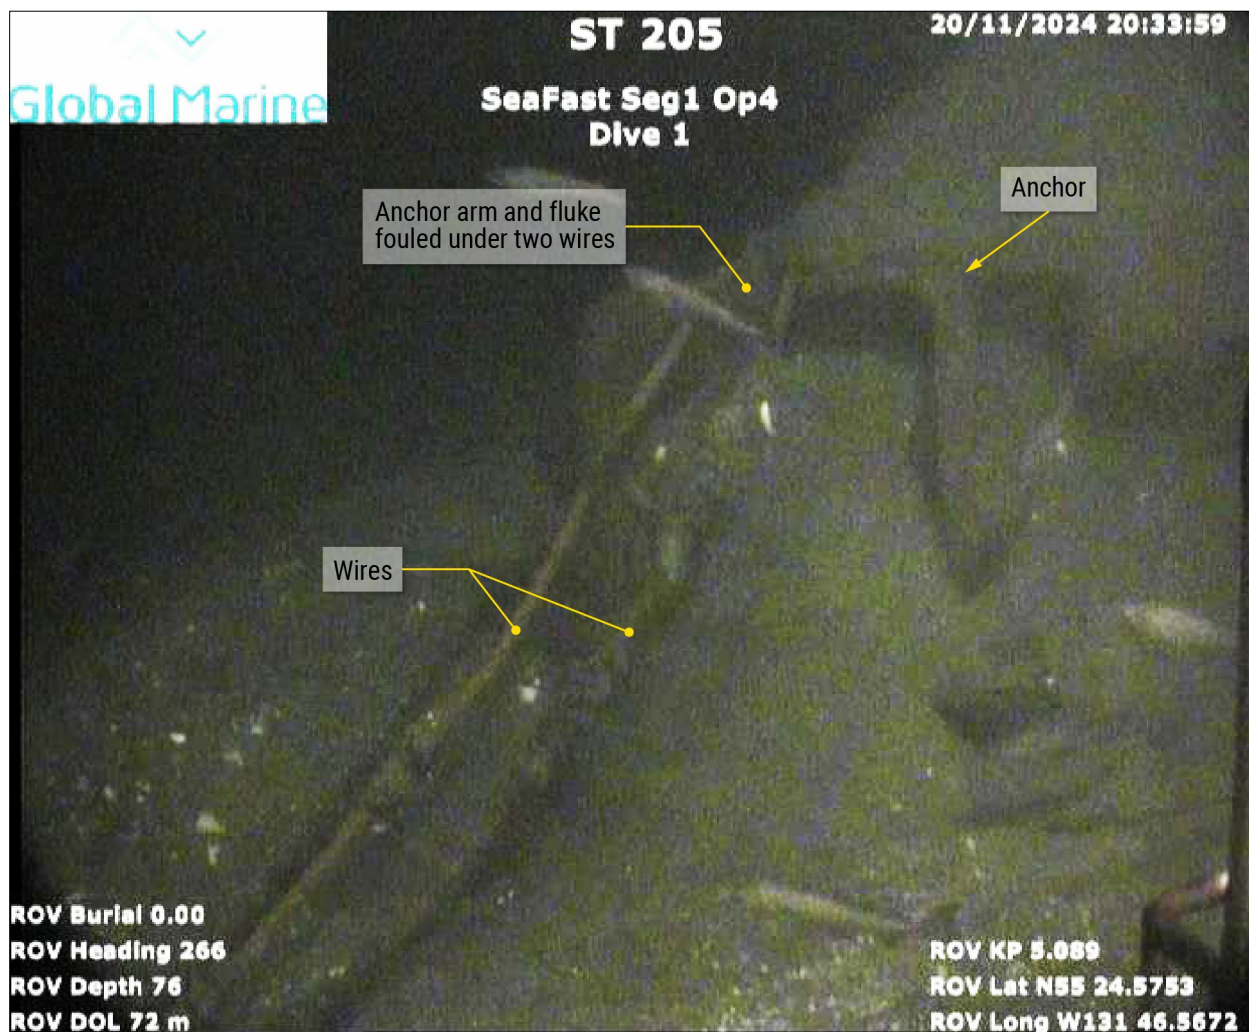
About 1300, cargo-loading operations concluded, and the *Belle Mer* remained at anchor while it awaited a cable repair ship to inspect the anchor and cable. On November 20, about 1245, the cable ship *Cable Innovator* arrived on scene and used a remotely operated vehicle (ROV) to confirm the anchor had become fouled on the

subsea cable (see figure 7). According to interviews, the ship's crew had not been aware the anchor had dragged. Later, the cable ship cut the cable and freed the anchor. That evening, about 2055, the *Belle Mer* departed for its next port of call in Prince Rupert, British Columbia, Canada.

**Figure 5.** Still from ROV footage showing the *Belle Mer*'s anchor fouled by cable wires. (Image brightness and contrast were adjusted for visibility.) (Background source: GCI)

The *Belle Mer* sustained no structural damage or damage to ground tackle equipment during the casualty. Nineteen of the 24 fibers in the AUSE-2 subsea fiber optic cable were damaged. GCI estimated repairs to the cable were \$240,000.
