## Interim report on the investigation of the collision between the high speed passenger craft *Seadogz* and a navigation buoy resulting in one fatality in Southampton Water on 22 August 2020

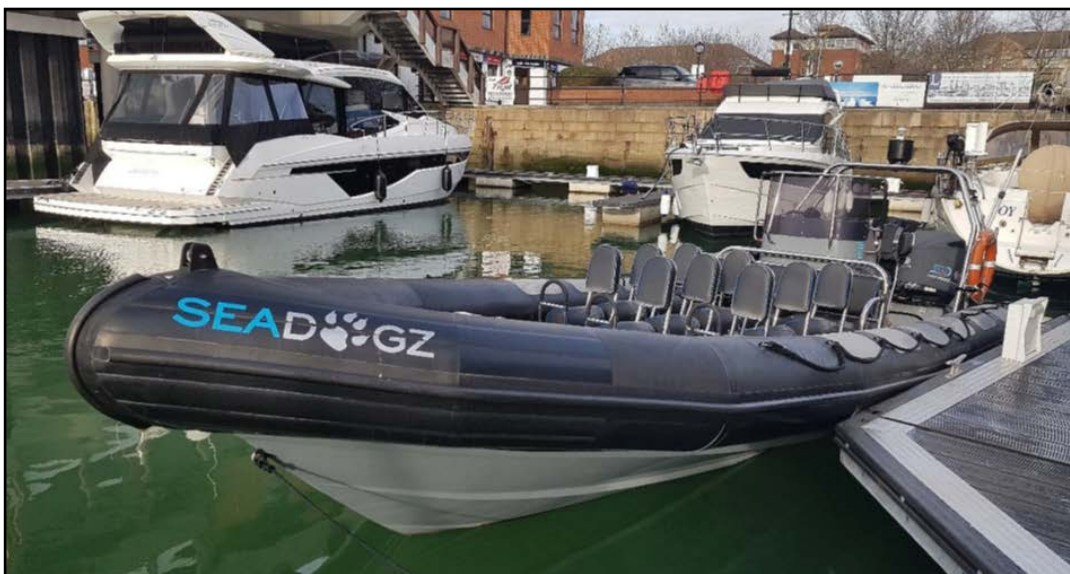
**Figure 1:** *Jack Black* at Ocean Village marina - illustrating a similar seating arrangement to *Seadogz*
