## SYNOPSIS

On 9 October 2001, the 1009gt motor vessel *Ash* was en route from Odense, Denmark, to the Spanish port of Pasajes, with a cargo of steel coils. She had six crew on board and was making a speed of about 6.25 knots over the ground in the south-west traffic lane of the Dover Strait TSS to the south-east of Hastings. The 4,671gt chemical tanker *Dutch Aquamarine* was also on passage in the same traffic lane, en route from Antwerp to Swansea. She had a mixed chemical cargo and a crew of 12 on board. She was making about 12.5 knots over the ground. A number of other vessels were in the vicinity, all of which were bunched towards the northern edge of the lane. Close passing was commonplace.

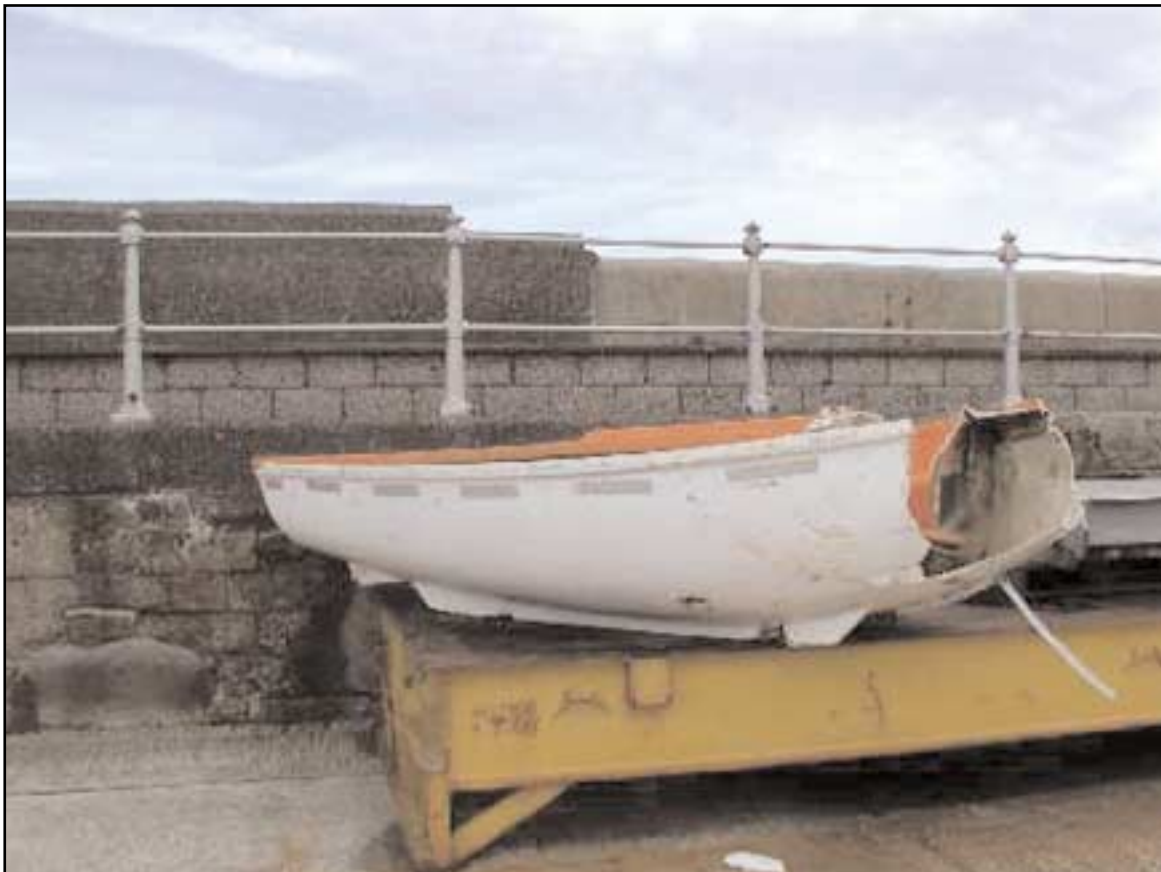
Photograph 3

Part of the lifeboat recovered after the accident

As the two vessels became very close it was apparent from witness observations that *Dutch Aquamarine*'s track was, in fact, a few metres to starboard of *Ash*'s. As *Dutch Aquamarine*'s bow approached *Ash*'s stern on her starboard quarter, hydrodynamic interaction caused *Ash*'s heading to alter to starboard. The flare on the port side of *Dutch Aquamarine*'s bow first made contact with the extreme starboard quarter of *Ash*'s bridge deck, causing damage to railings, the lifeboat and its davit arm.
