## SYNOPSIS

At 1320, on 19 June 2005, a 13 year old boy suffered serious head injuries when the powerboat in which he was co-driver was struck by another race boat during a K-200 class Junior Offshore National Championship race at Portland Harbour.

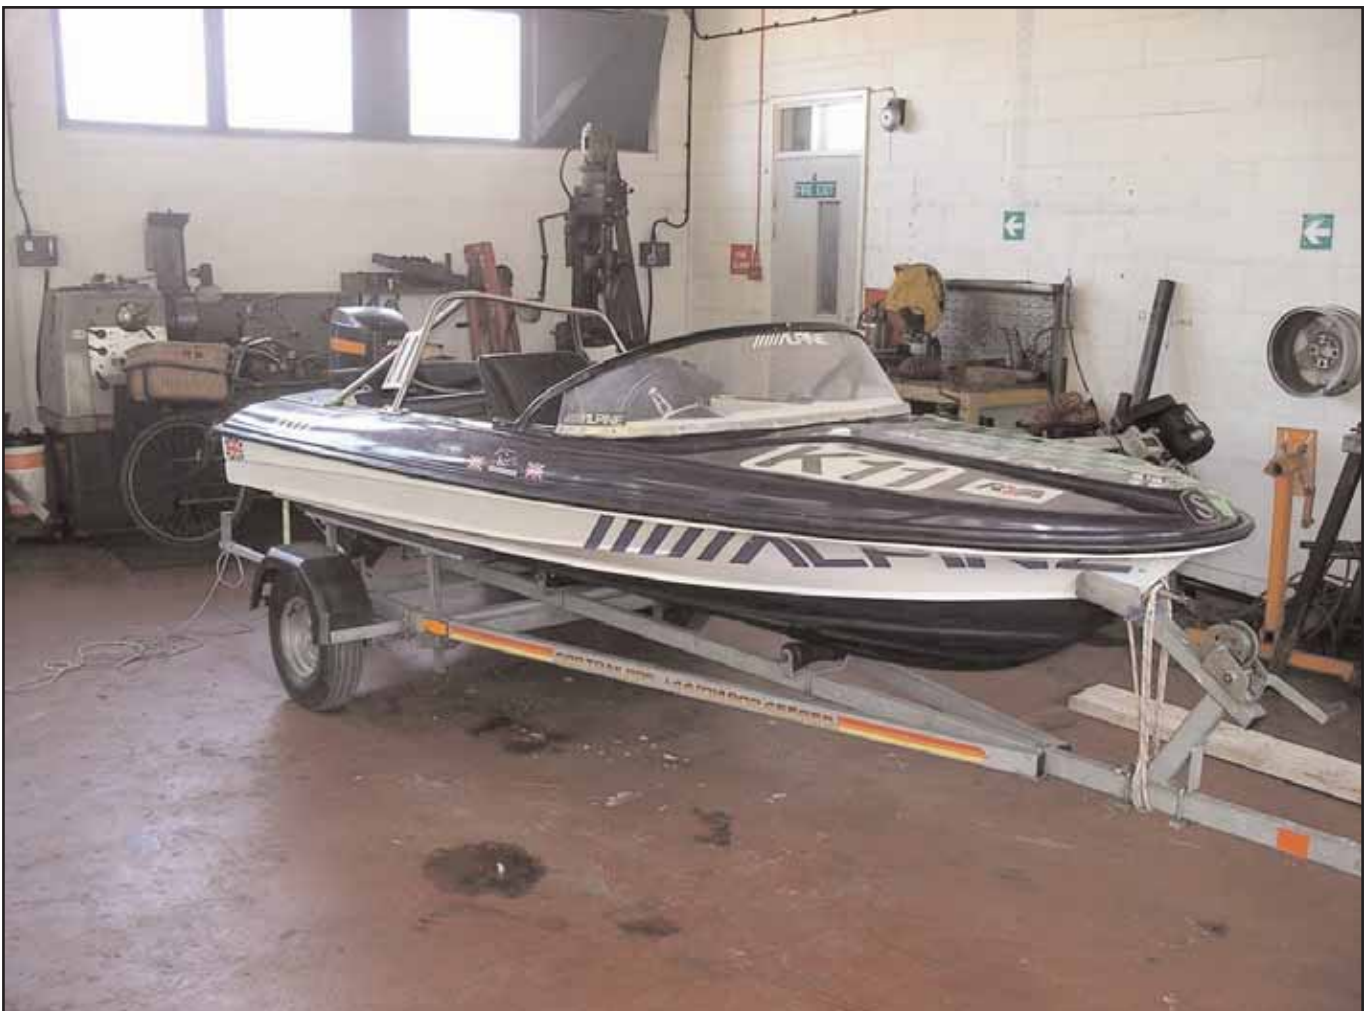
Figure 1

Photograph of powerboat K11

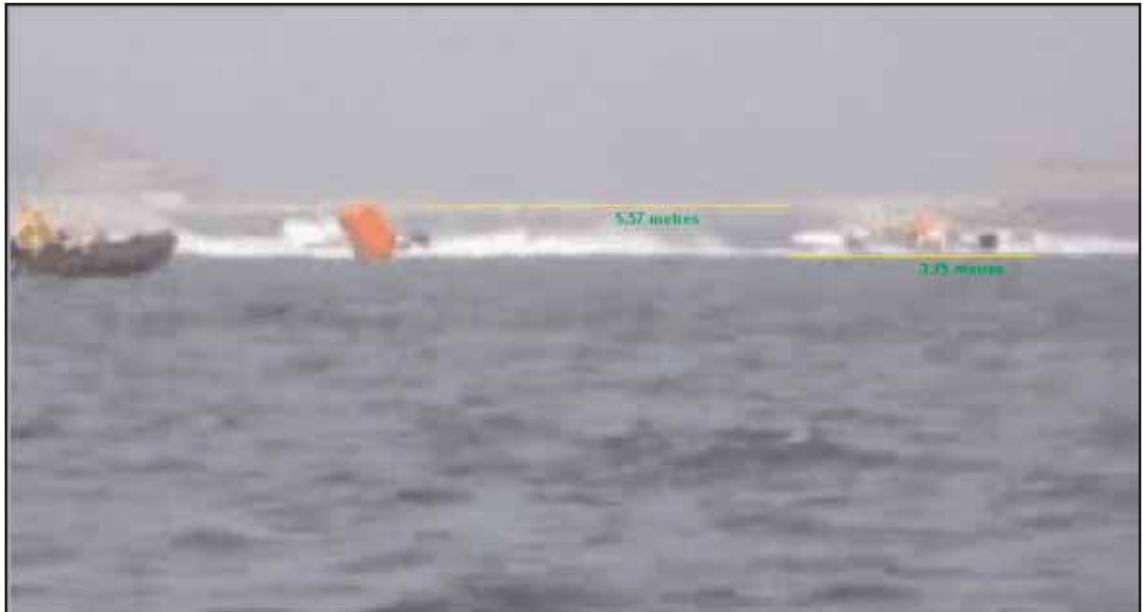
Figure 12

All class rules require the “overtaking boat” to be a minimum of two boat lengths ahead before changing course across and ahead of another boat. The children had been taught that the measurement was to be made between the bow of the leading boat and the bow of the trailing one, and this was the generally accepted interpretation.

Analysis of the video recording taken during the race showed the clear distance between the two boats to be 5.57m as they approached the first marker. In other words, more than two boat lengths bow to bow.

Position of K11 and K51 just before K11 hooked

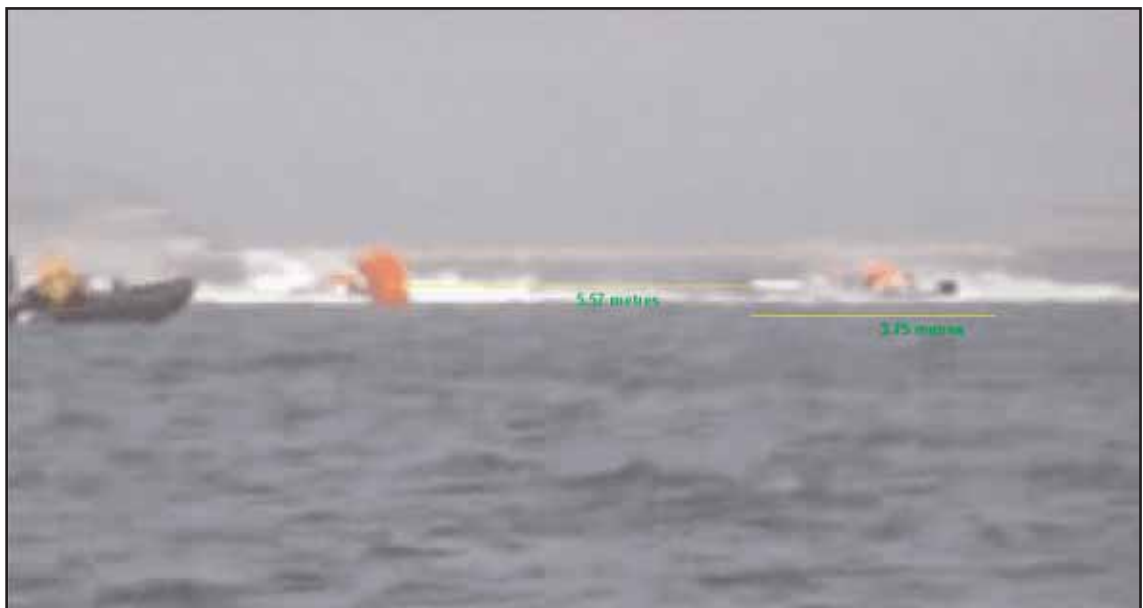
Figure 13

The collision took place at the first turn, when boat K11 violently hooked<sup>1</sup>, and K51, which was following immediately behind and on a slightly tighter course to the marker buoy, collided with her at full speed and at a near perpendicular angle. A number of boats had been bunched together as they approached the first turn and, when K11 hooked, it virtually stopped directly in the path of K51, giving its driver no time to take avoiding action.

The precise reason that K11 hooked cannot be ascertained with any certainty. However, the three leading boats had already passed the marker buoy, and their wake, combined with the choppy seas, would have left an area of broken water at the time and location of the collision.

Position of both boats as K11 hooked
