**Collision between fishing vessels *SAPPHIRE STONE* and  
*KAREN* resulting in the  
loss of *KAREN***

**11 miles south-east of Campbeltown  
22 January 2014**

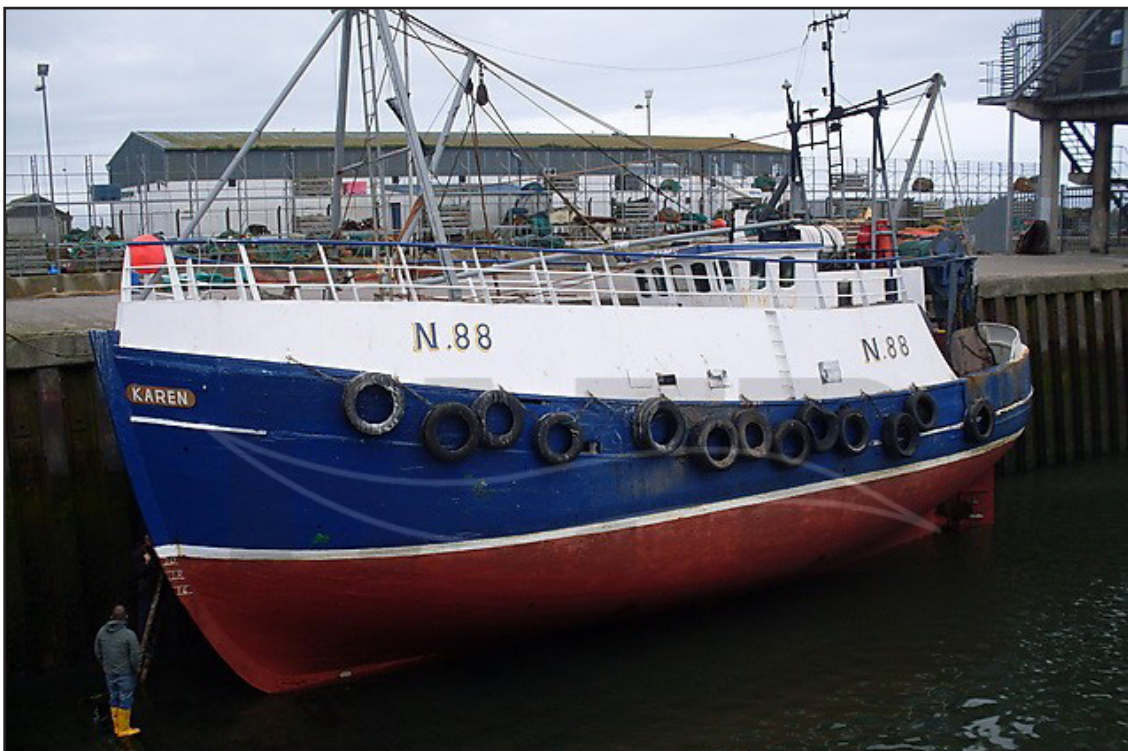
Figure 2: *Karen*

*Karen* was struck on its port quarter and was severely damaged. Its hull was opened to the sea, which caused the aft crew accommodation and main engine room to flood rapidly, resulting in the vessel foundering within 3 minutes of the collision. *Sapphire Stone* suffered minor damage to its stem post.

*Karen* (**Figure 2**) was a 17.58m stern trawler of wooden construction, and had been owned by its skipper for 5½ years. The vessel also fished for prawns and followed a similar pattern of day fishing to *Sapphire Stone*.

At 1637, *Sapphire Stone*'s stem collided with *Karen*'s port quarter, approximately where the shelter met the vessel's gunwale.
