## Collision between the motor yacht *Vision* and the anchored motor yacht *Minx*, resulting in one fatality at Île Sainte-Marguerite, near Cannes, France on 25 May 2019

### SUMMARY

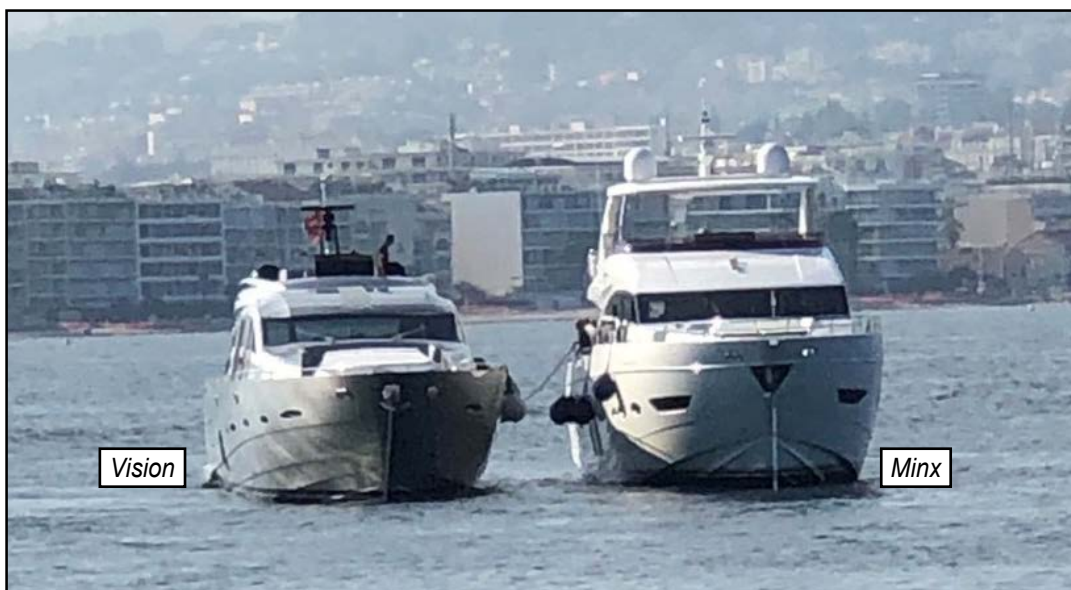
During their meal, the guests agreed to continue the party back on board, and *Vision*'s charterer called the skipper and asked him to raft up with *Minx*. *Vision*'s skipper contacted *Minx*'s skipper and discussed the plan, then let out more anchor chain and manoeuvred the yacht alongside *Minx* (**Figure 1**). By about 1830, everyone was back on board and the drinking and partying continued with most of the guests on board *Vision*.

**Figure 1:** *Vision* and *Minx* at anchor and rafted together near Île Sainte-Marguerite

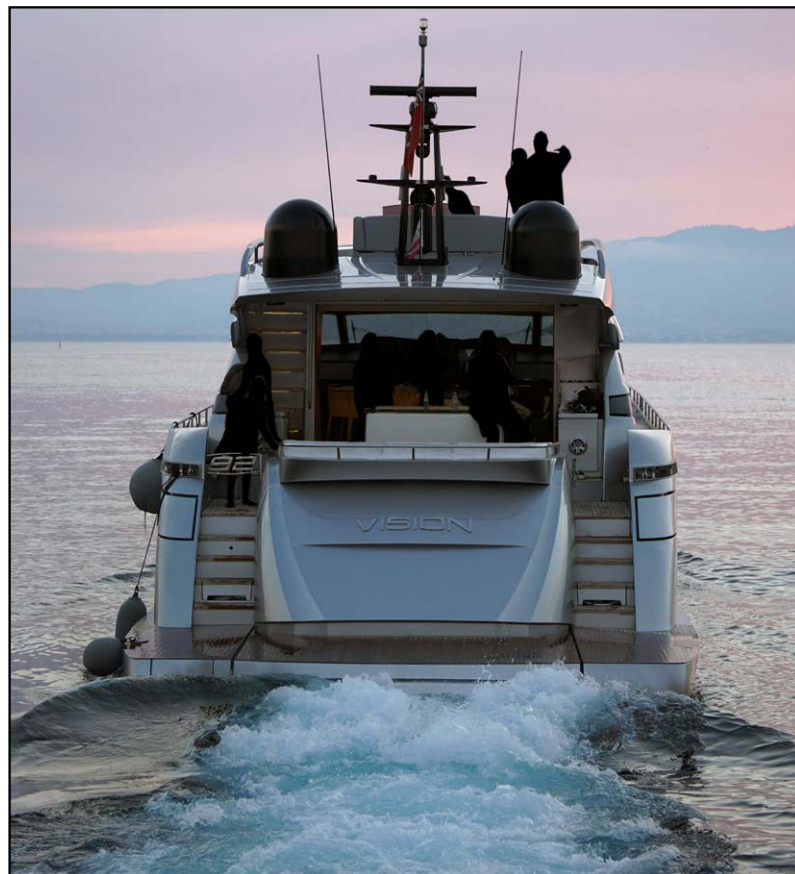
**Figure 2:** *Vision*, seen from *Minx*, initially opening to the west

After *Vision* had been manoeuvred clear of *Minx*, it was discovered that a guest's mobile phone had been left on board. *Vision*'s skipper then manoeuvred the yacht back close to *Minx* so the mobile phone could be returned, then *Vision* started opening away on a westerly heading (**Figure 2**). Having opened to a distance of 750 metres (m) from *Minx* (**Figure 3**), *Vision*'s skipper turned the yacht to an easterly heading, moved down from the flybridge to the internal wheelhouse, then began to accelerate ahead. The skipper's intention was to conduct a fast slalom-type manoeuvre close down the port side of the anchored *Minx*. As its speed increased, *Vision* started planing and its propellers were creating a 'rooster tail' water spray astern (**Figure 4**). As the distance between the two yachts rapidly decreased, *Vision*'s

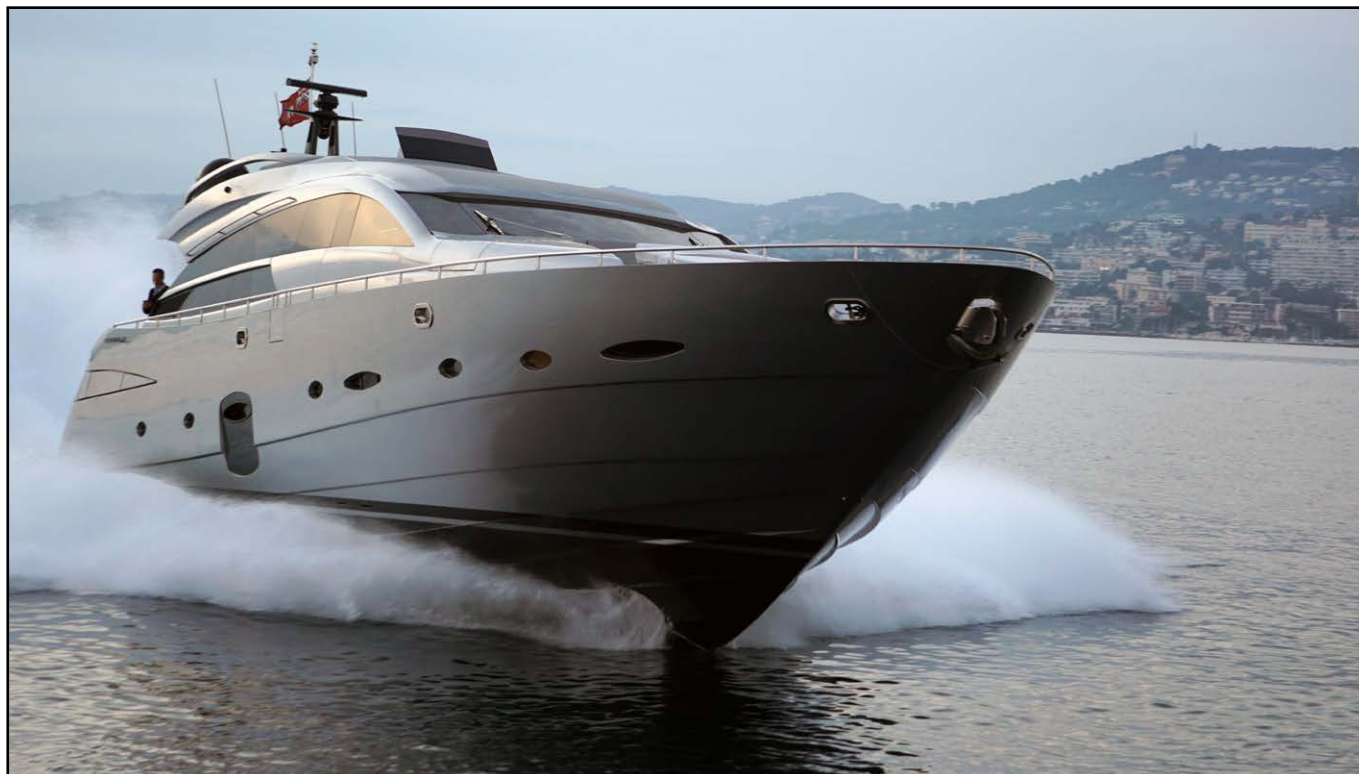
**Figure 4:** *Vision* immediately prior to collision with *Minx*

The image at **Figure 4** was taken immediately prior to collision and shows *Vision* planing<sup>10</sup> with a slight bow up angle, slight heel to port and rooster tail wake. In this condition, *Vision* would have been difficult to accurately steer because of a combination of hydrodynamic effects restricting the skipper's ability to turn significantly to port.

The turning force (or lever) achieved was a function of the distance between the surface-drives and the centre of lateral resistance; the larger the distance, the greater the turning lever or 'tightness' of the turn. The presence of the rooster tail wake (**Figure 4**) indicates that *Vision* was planing with the surface-drives almost certainly trimmed up; in this condition, the yacht would tend to adopt a bow up angle, reducing the 'wetted' hull surface area. In turn, this would cause the centre of lateral resistance to move aft, reducing the turning lever (**Figure 8**). When adjusting the surface-drives horizontally to turn significantly to port, *Vision* would have heeled to port, which would have resulted in the port surface-drive going lower into the water and developing a higher 'grip' and, therefore, more power, counter-intuitively creating a starboard turning force (**Figure 8**). Additionally, after the slight turn to starboard, the momentum of *Vision* was directly towards *Minx*, and the attempt to steer away, when planing, would almost certainly have resulted in a momentary 'lateral slip', where the yacht would tend to slide sideways over the surface, rather than turning through the water.
