## SYNOPSIS

At 0153 UTC on 7 June 2001, the Panamanian-registered refrigerated cargo vessel *Atlantic Mermaid*, collided with the Cypriot-registered general cargo vessel *Hampoel*, off the Varne in the south-west bound lane of the Dover Strait traffic separation scheme (TSS) (**Figure 1**). An MAIB investigation began that day.

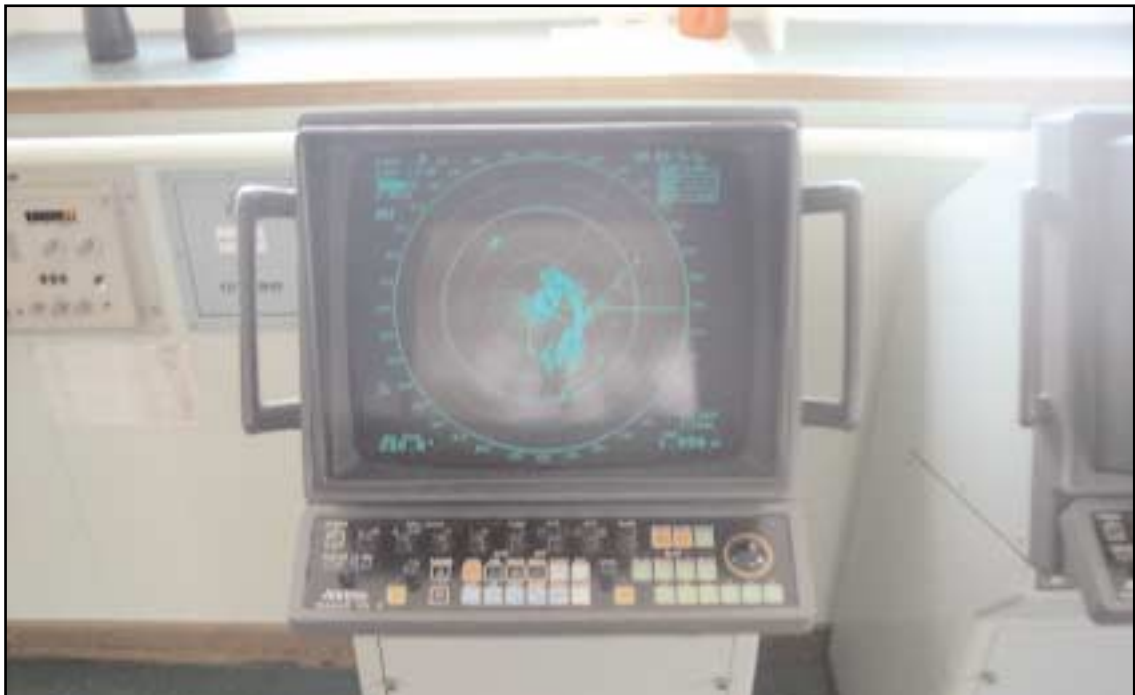
Figure 7

Although not ARPA radars they were capable of acquiring and tracking targets. They were situated next to each other at the front of the bridge, to starboard of the centreline. No 2 radar (port) (**see Figure 7**) had had an intermittent fault for at least the 12 months before the collision. The fault occurred apparently only on ranges below 12 miles and on short pulse. Stabilisation became lost and, with the heading marker remaining in the correct position, all targets rotated clockwise around the screen. Entries concerning No 2 radar were made in the radar logbook at periodic intervals; the last entry before the collision was made by the second officer at 0001 on 6 June stating: "*poor reception on short range*".

*Atlantic Mermaid* - radar no 2

No 2 radar (port) had an intermittent fault for at least the 12 months before the collision. Apparently the fault occurred only on ranges below 12 miles and on short pulse. Stabilisation became lost and, with the heading marker remaining in the correct position, all targets rotated clockwise around the screen. Attempts made to correct the fault had been unsuccessful. Entries were made in the radar logbook at periodic intervals concerning No 2 radar; the last entry before the collision was made by the second officer at 0001 on 6 June stating: “*poor reception on short range*”. Possibly with this fault in mind, the master was operating the radar on the 12-mile range. No 1 radar was on the 6-mile range.

From the evidence, it is clear that the radars were not ideal for use in conditions with rain and sea interference, and that their overall condition might have been below that required to enable a satisfactory radar watch to be maintained. It is also possible that *Hampoel* was not detected at all on either radar because of their condition and the effectiveness of the clutter controls.
