## SYNOPSIS

### 1.1 PARTICULARS OF *APACHE* AND *SERINAH* AND ACCIDENT

### Collision between the crude oil tanker *Apache* and the stern trawler *Serinah* (GH 116) in the Firth of Clyde, Scotland on 25 April 2024

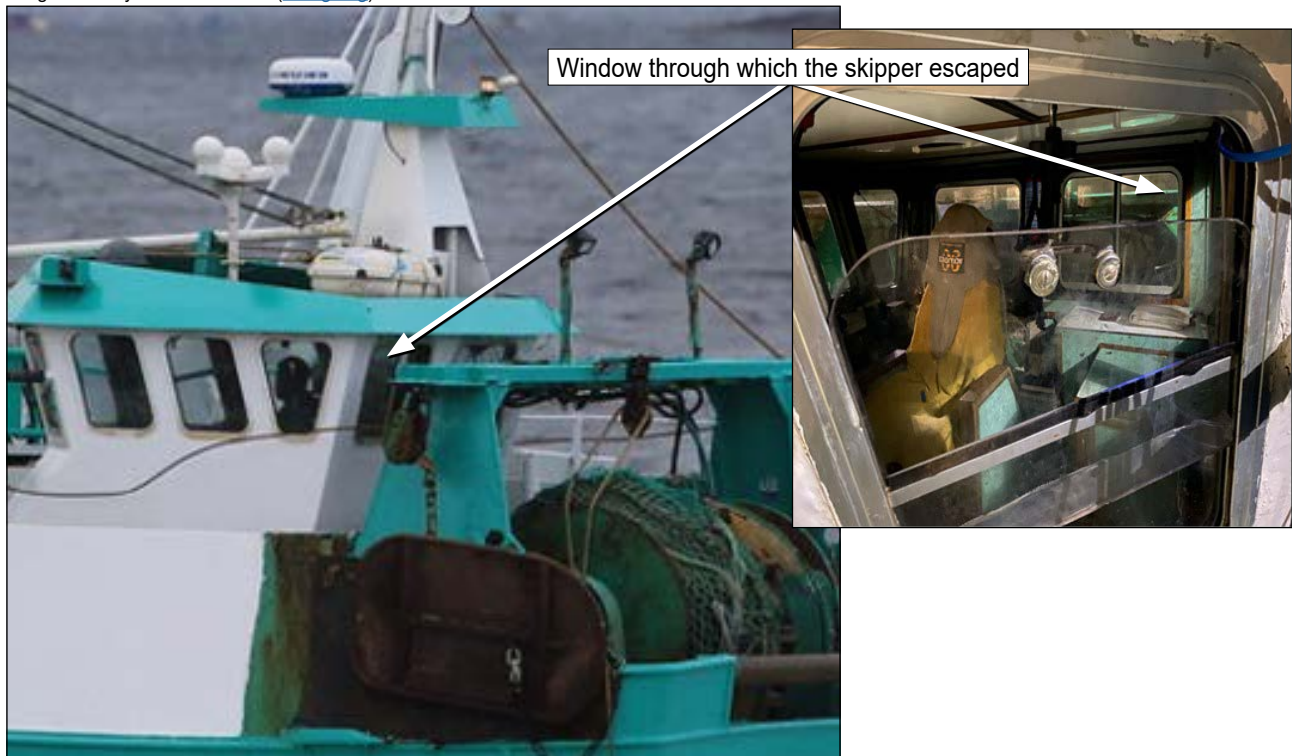
**Figure 4:** Aft windows in *Serinah*'s wheelhouse

*Serinah*'s hull penetration was pushed underwater and the vessel started to flood. *Serinah*'s skipper was still in the wheelhouse and, seeing that the egress route through the accommodation was flooded, grabbed a personal flotation device (PFD) and climbed out of the wheelhouse through an aft window (**Figure 4**).

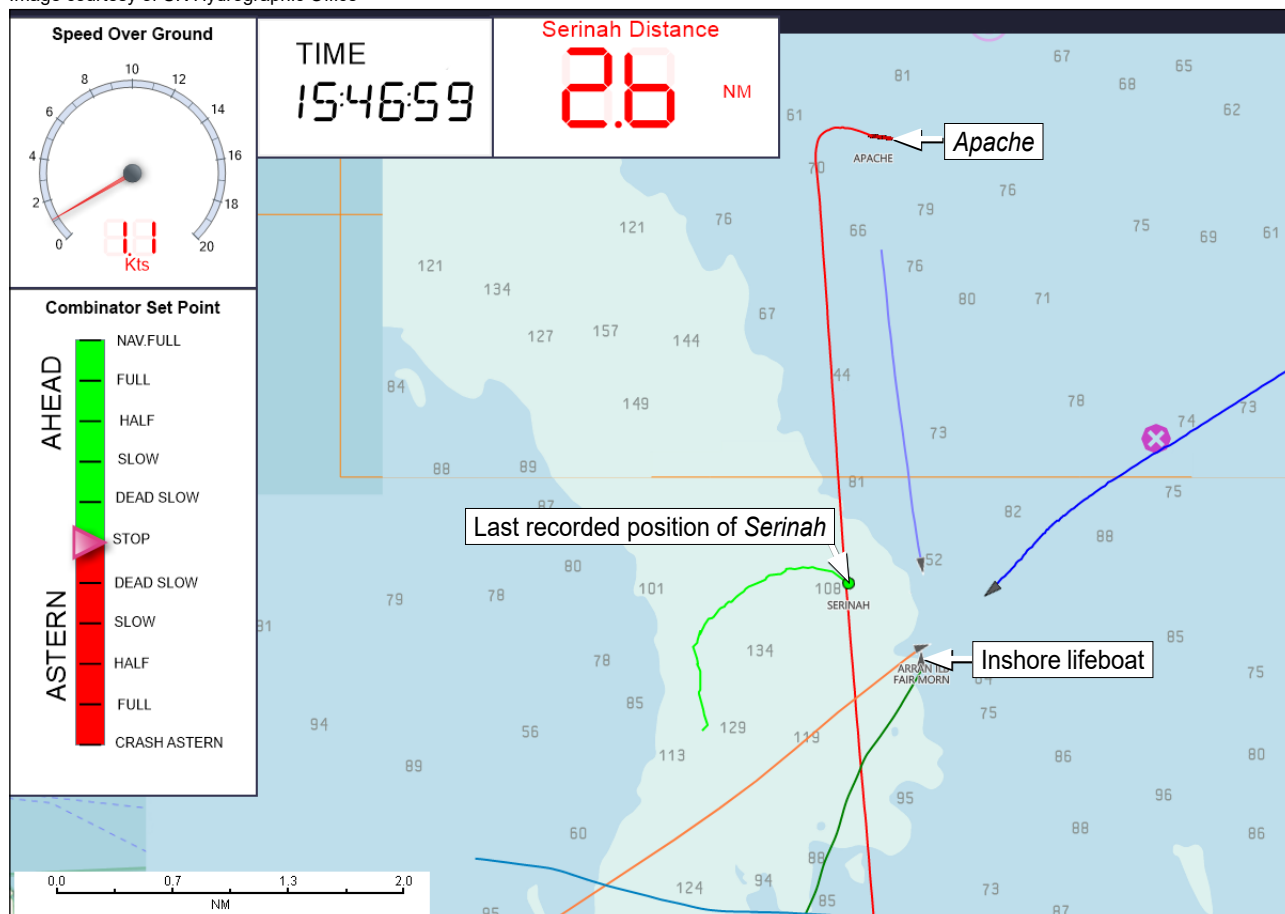
Figure 5: Positions of Apache and rescue vessels at 1546:59

At 1526, HMCG tasked the RNLI inshore lifeboat (ILB) based at Lamlash, Isle of Arran to assist. By 1530, *Apache* had launched its rescue boat and the craft headed south towards the liferaft, which had drifted about 0.8nm east from the collision site. At 1547, the ILB was the first vessel to reach the liferaft (**Figure 5**). All of *Serinah*'s crew boarded the Lamlash ILB, and were then transferred onto the Troon ALB to be taken to Troon harbour. After a medical assessment, and having tested negative for alcohol with Police Scotland, *Serinah*'s crew went home.
