## **Collision of the rigid inflatable boat *Tiger One* with a mooring buoy, River Thames, London, England 17 January 2019**

### **SUMMARY**

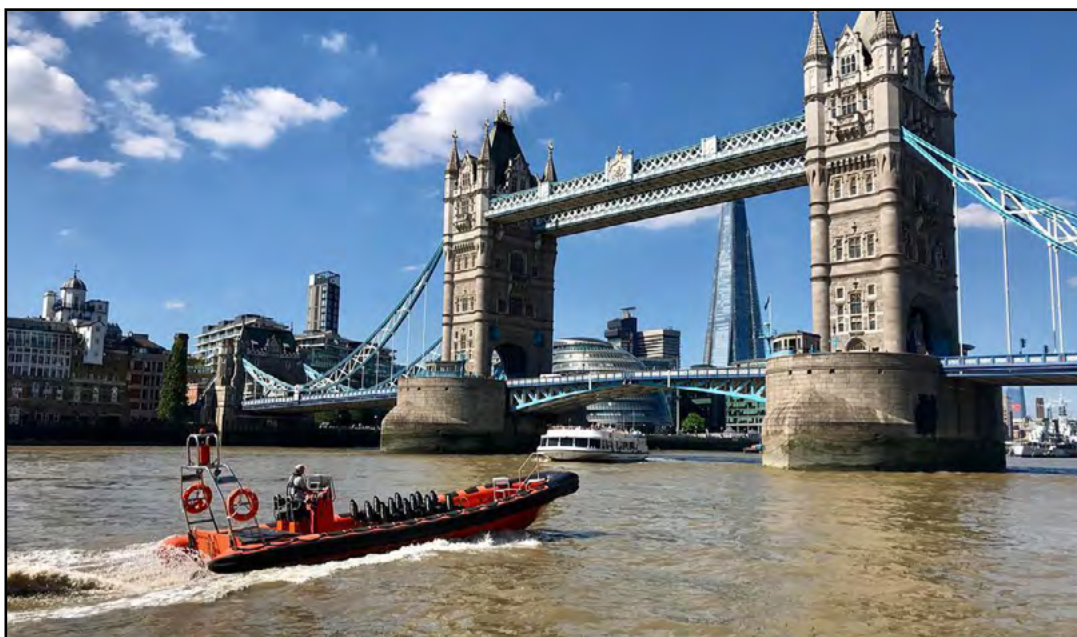
At 1738 on 17 January 2019, the commercially operated rigid inflatable boat *Tiger One* hit a mooring buoy on the River Thames in London, England, at a speed of about 26 knots in darkness. Two passengers and the boat's two crew were taken to hospital with minor injuries. *Tiger One* was severely damaged.

More serious consequences resulting from the collision were prevented by *Tiger One*'s robust construction, seating arrangements, and the skipper's use of a kill cord. However, the circumstances of the collision indicate that there is significant potential for more serious consequences to result from similar high-speed accidents in the future.

Following the accident, the Port of London Authority has, among other things, removed its authorisation for open deck high-speed craft to navigate above 12 knots during the hours of darkness, and taken steps to enable these craft to report passenger numbers via the automatic identification system. The Royal Yachting Association has included guidance on night operations and passenger number reporting in its recently revised guidance on passenger safety on board small commercial high-speed craft and experience rides. In view of the actions taken, no recommendations have been made.

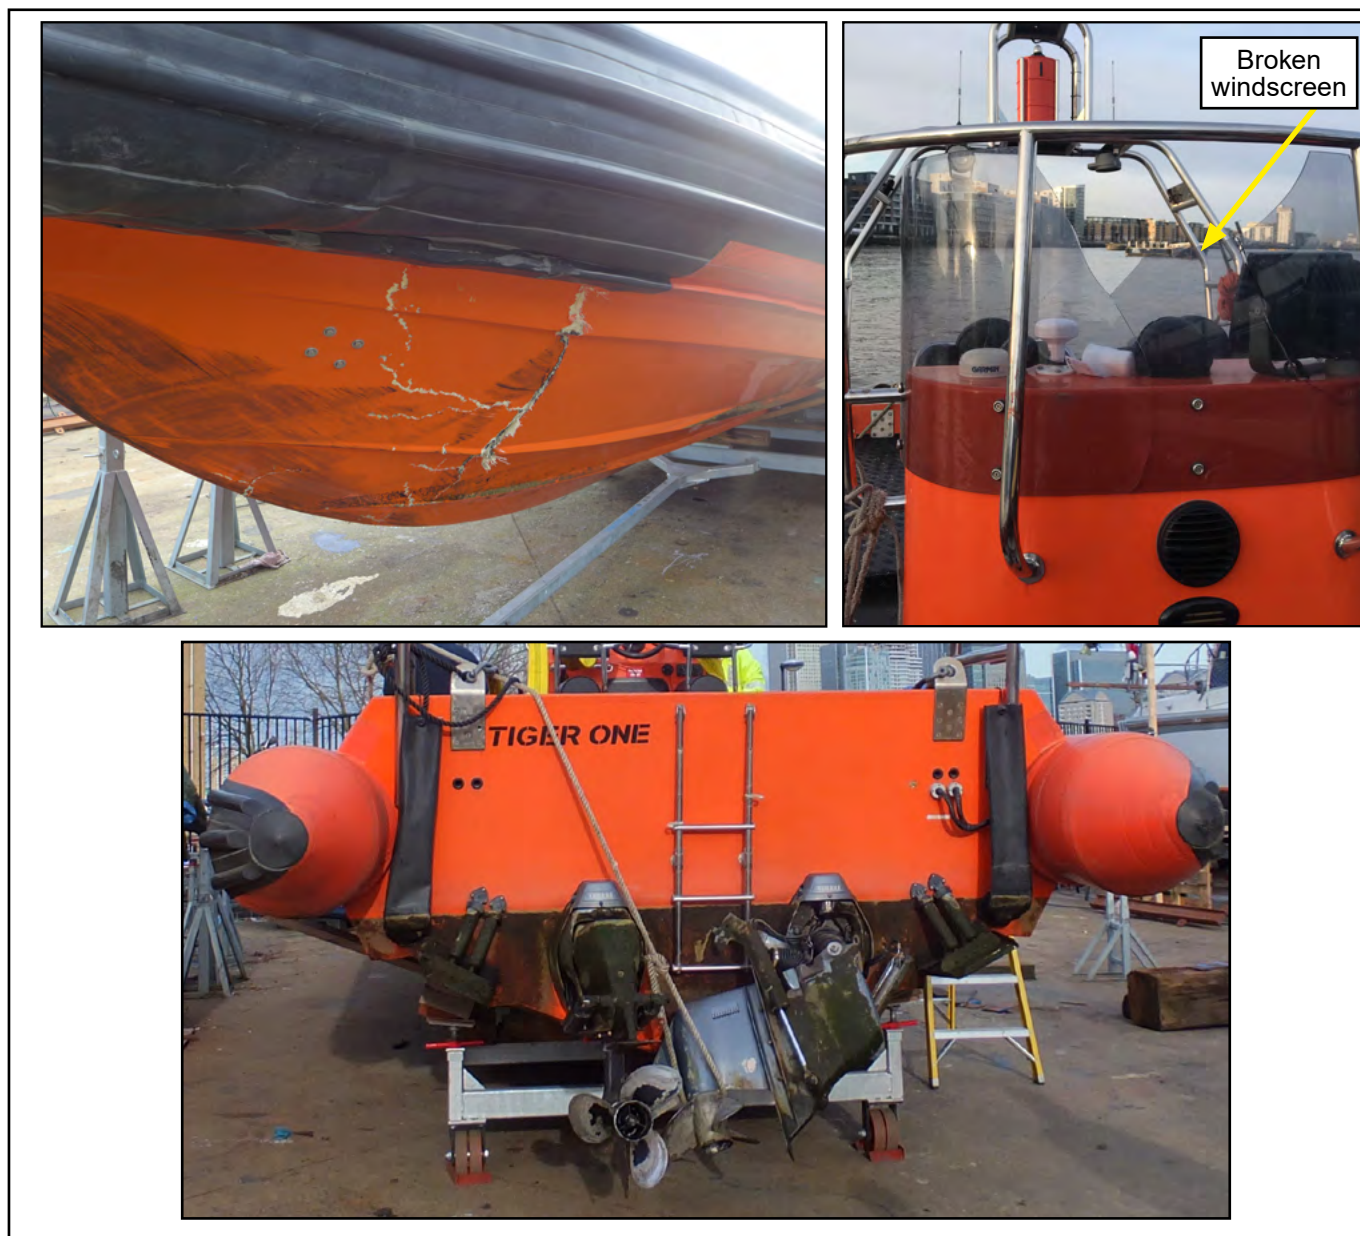
*Tiger One's* skipper checked the RIB and confirmed that it was not sinking. He then drove the RIB alongside Greenwich Pier, where the passengers and crew disembarked and were treated by the Tower lifeboat crew. Police breathalysed the skipper and deckhand; the results were negative. Both crew and two of the passengers were taken to hospital with facial injuries. Both crew also suffered bruising to the upper body. *Tiger One's* bow and starboard propulsion drive unit were badly damaged (**Figure 4**). There was no damage to the LST buoy.

**Figure 4:** Damage to bow, windscreen and stern drive

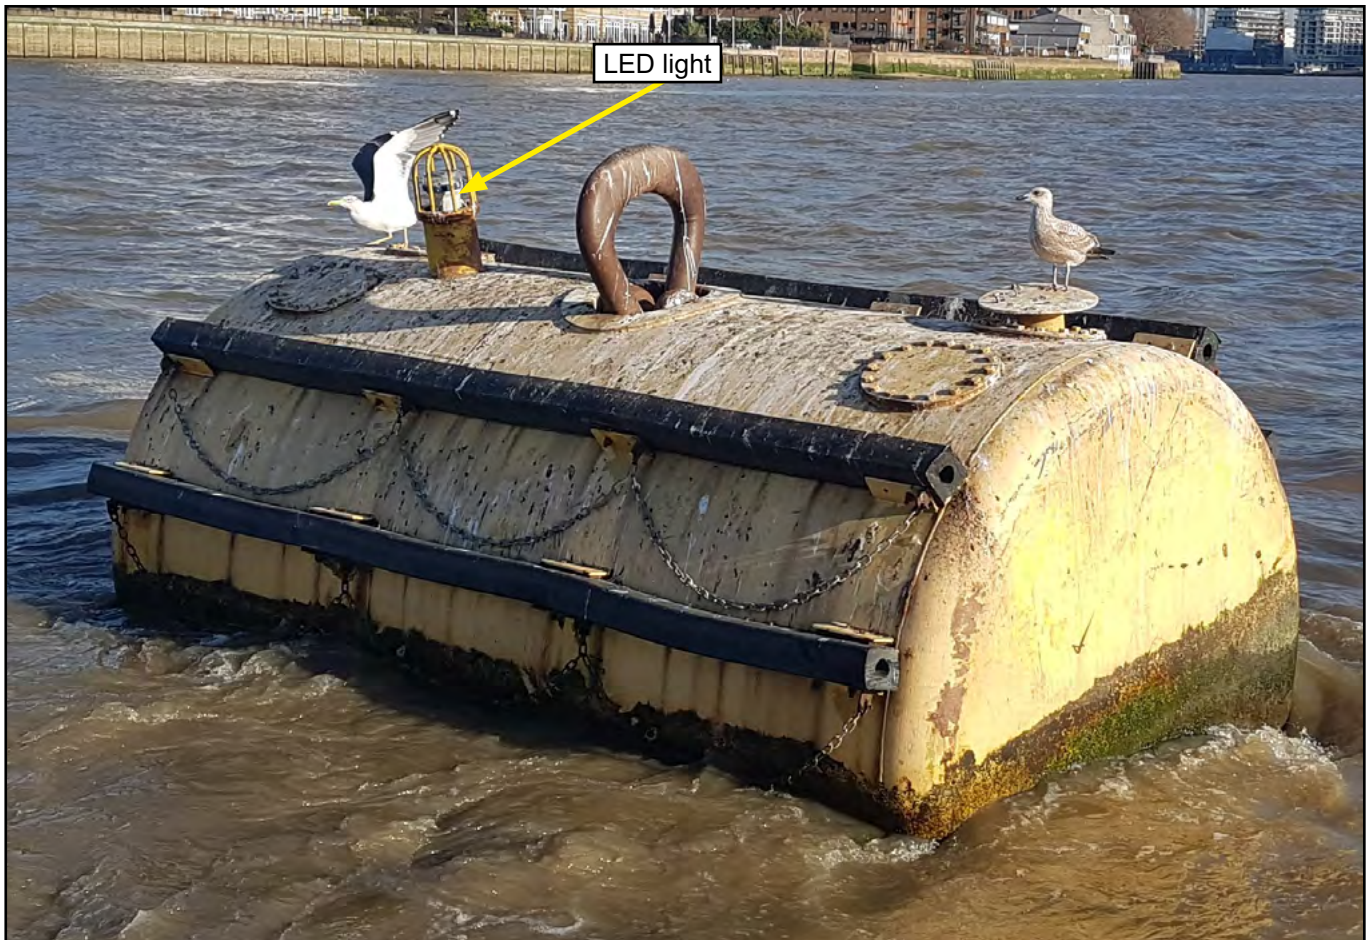
The Ship Tier buoys comprised six mooring buoys used by cruise ships visiting central London. The outer UST and LST buoys were anchored in the navigable channel (**Figure 3**) with a swing radius of about 5m depending on the height of tide. They were cylindrical (4m in length with a 2.4m diameter) and were painted yellow (**Figure 5**).

**Figure 5:** Outer lower Ship Tier buoy

It was evident from the amount of guano present on the surface of the outer LST buoy (**Figure 5**) that birds regularly perched on the river's mooring buoys. As birds were seen flying close to *Tiger One* immediately before impact, the likelihood that the buoy's LED light was obscured or partially obscured by birds cannot be discounted. Without a light, the silhouette of the outer LST buoy alone would have been very difficult to see.

- Trialled the use of isophase lights on the Greenwich Ship Tier buoys. The trial was unsuccessful due to a loss of light intensity, and research into the use of alternative lights and light characteristics is ongoing.
