## SYNOPSIS

At 1108 on 5 December 2016 the high-speed passenger catamaran *Typhoon Clipper* and the workboat *Alison* collided adjacent to Tower Millennium Pier, River Thames, London. *Alison* capsized and sank immediately; the two crewmen on board were subsequently rescued by *Typhoon Clipper*'s crew. *Alison*'s crewmen were treated at the scene for the symptoms of cold shock, then admitted to hospital for checks before being released later the same day. *Alison* was recovered off the riverbed the following day by the Port of London Authority; there was no pollution.

### 1.1 PARTICULARS OF *TYPHOON CLIPPER*, *ALISON* AND ACCIDENT

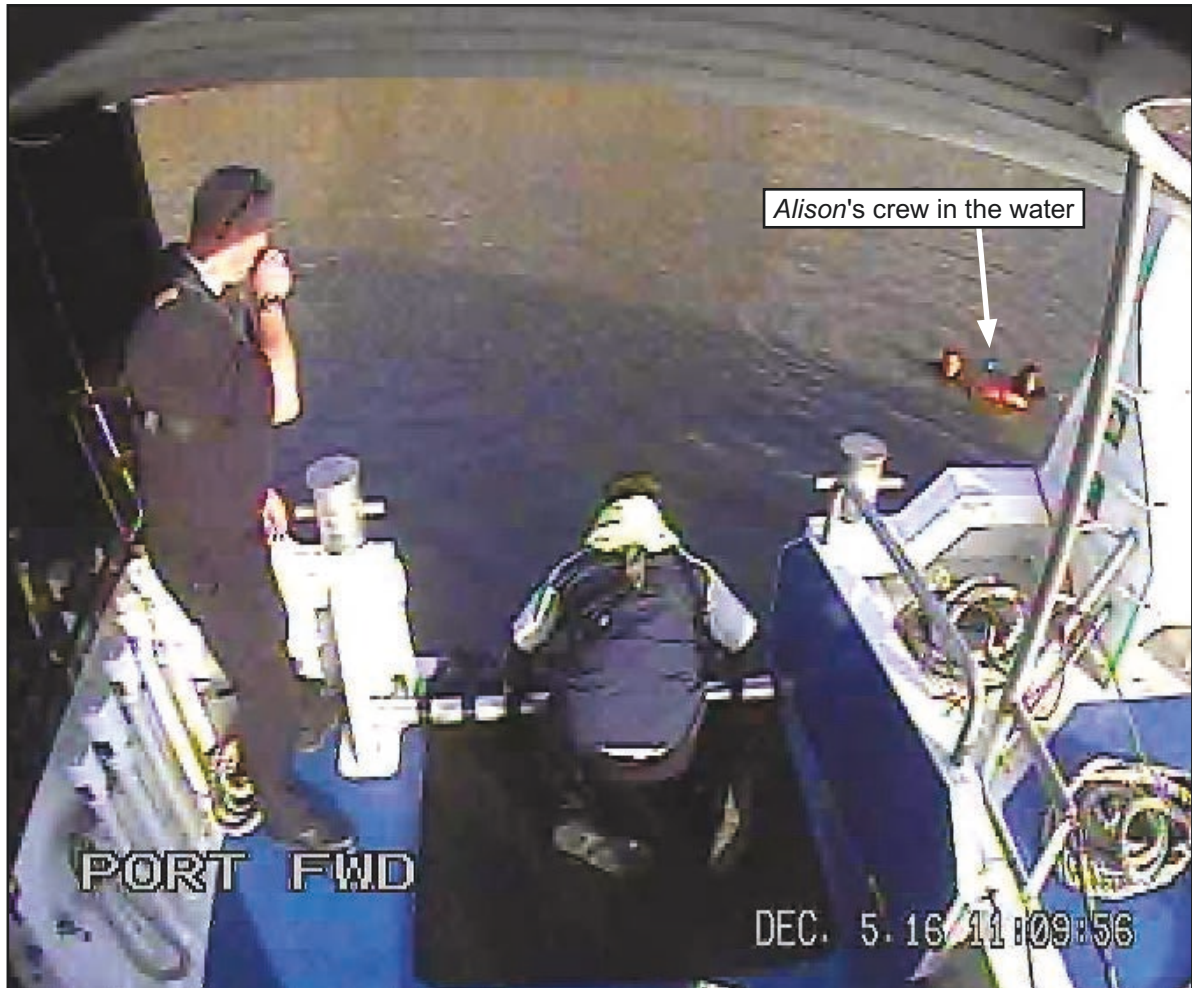
**Figure 8:** *Typhoon Clipper's* port forward embarkation area just prior to the rescue with *Alison's* crewmen in the water

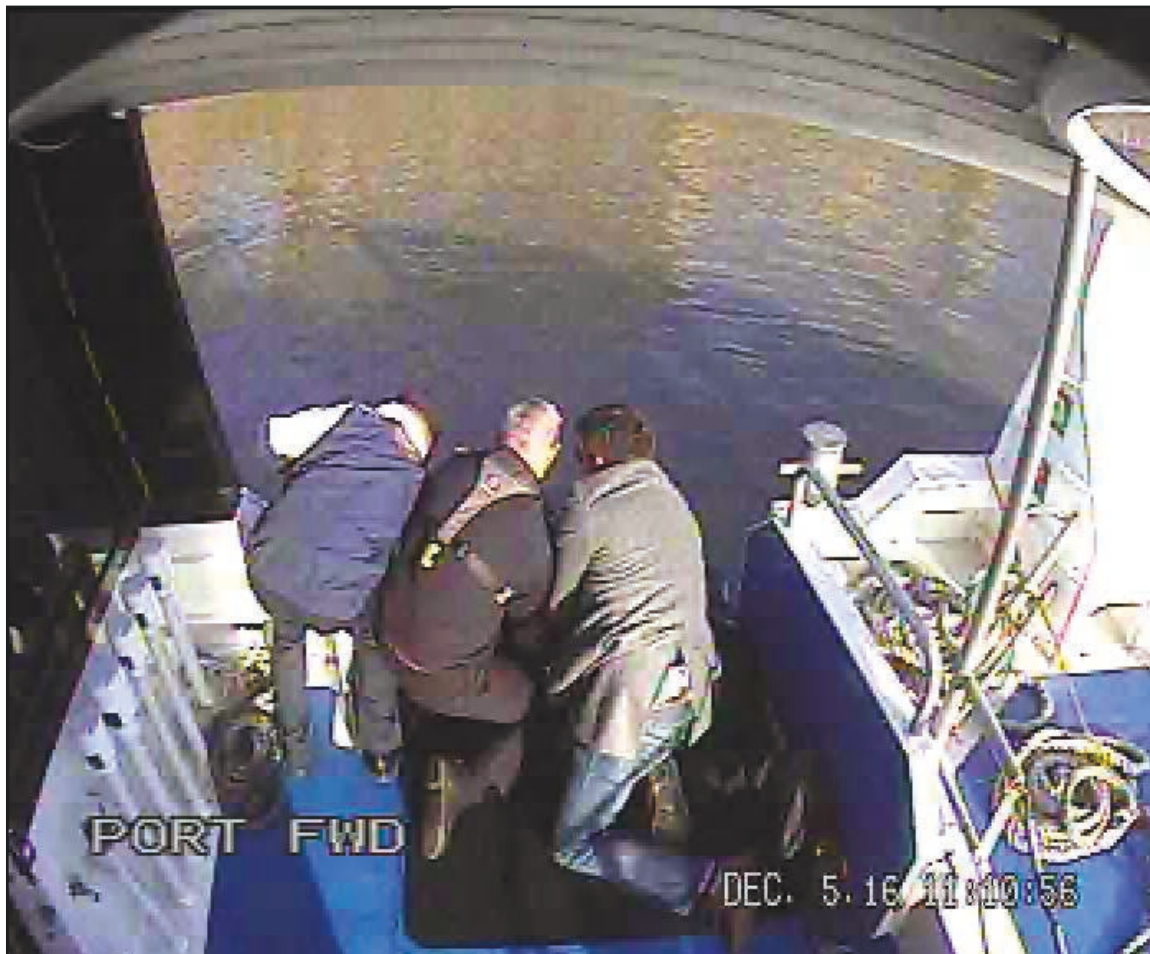
**Figure 9:** *Alison's* second crewman being rescued out of the water by *Typhoon Clipper's* mate, the DCSA, an off-duty DCSA and a passenger

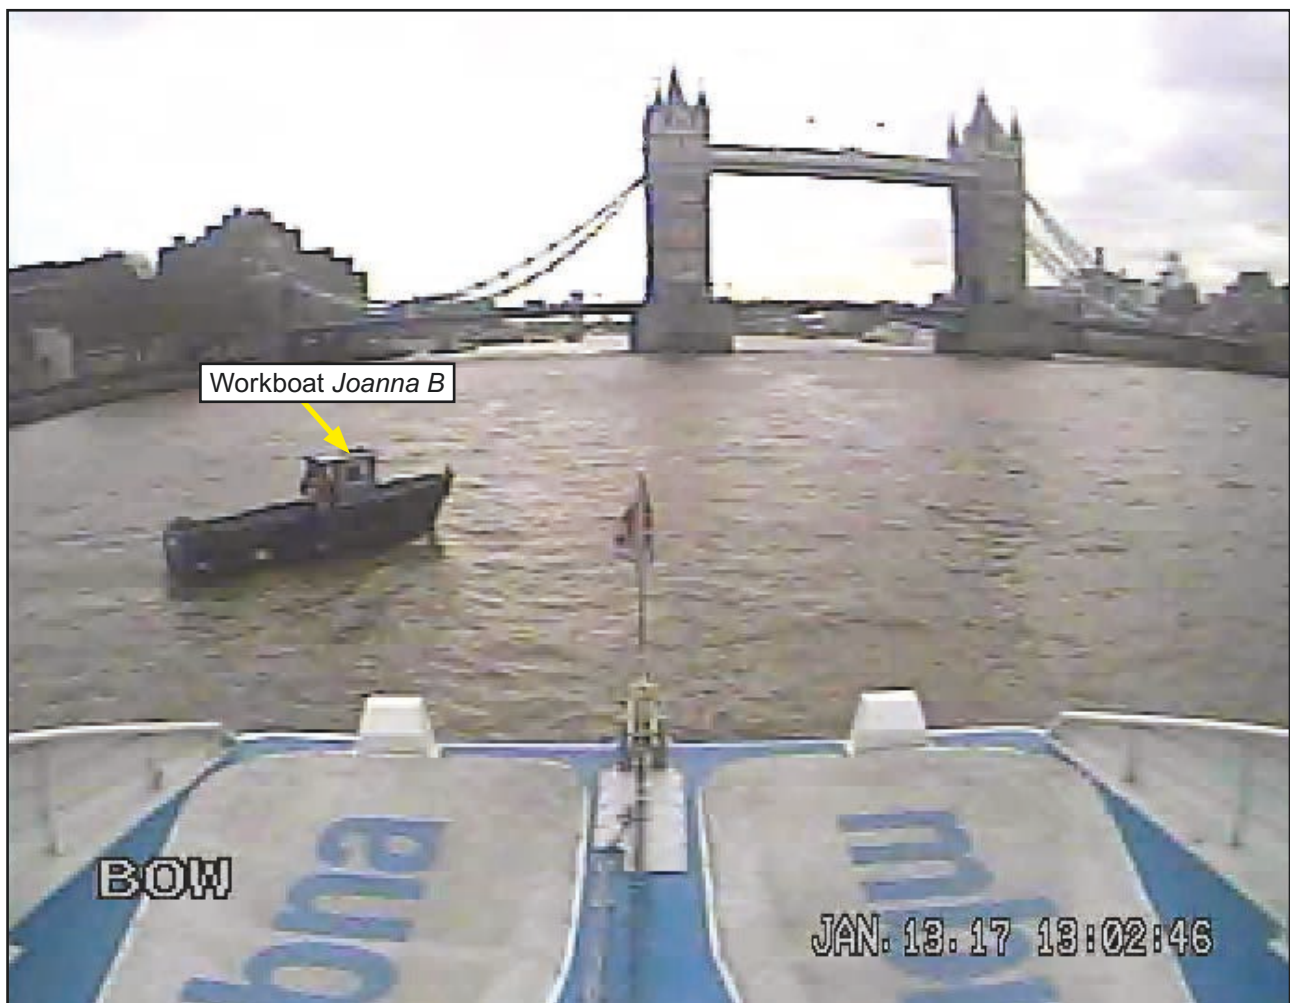
During the reconstruction, *Typhoon Clipper* was positioned adjacent to Tower Millennium Pier and *Joanna B* followed a similar track to *Alison*'s prior to the accident (**Figure 20**). Both *Joanna B*'s fixed horn and the hand-held device were sounded as the workboat departed the pier and again when ahead of *Typhoon Clipper*.

At each stage of the trial, both *Joanna B*'s fixed horn and the hand-held horn were clearly audible in *Typhoon Clipper*'s wheelhouse and, following the reconstruction, could also be heard on the playback of the recording of *Typhoon Clipper*'s wheelhouse audio.

The accident reconstruction demonstrated that, had *Alison*'s horn been sounded at any point between departure from the pier and the collision, it would have been audible on the recording of *Typhoon Clipper*'s wheelhouse audio.

**Figure 20:** Accident reconstruction - *Typhoon Clipper* bow camera view showing the workboat *Joanna B*

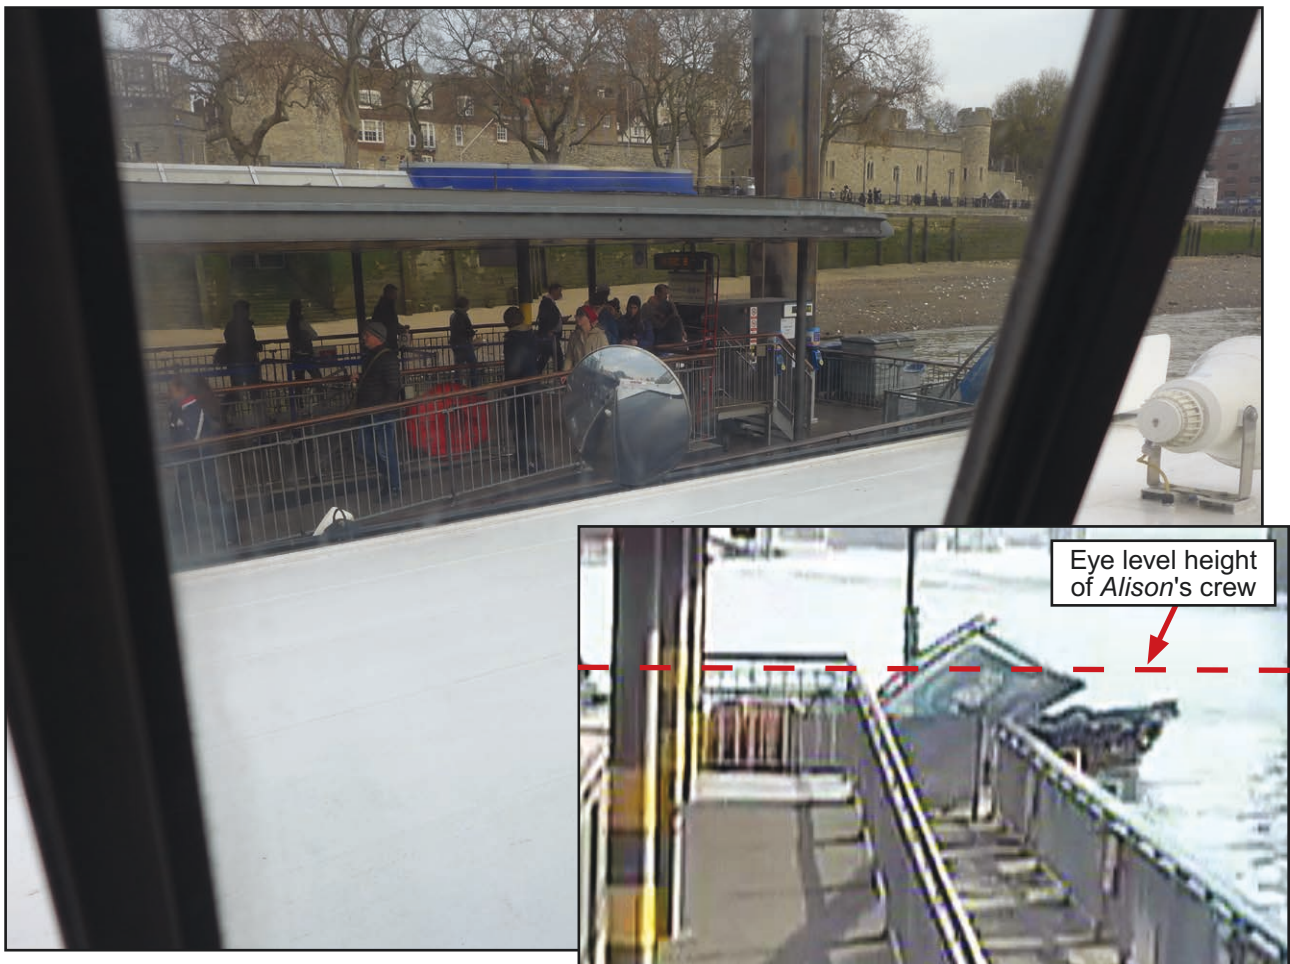
**Figure 21:** View of the pier from *Typhoon Clipper*'s wheelhouse (during reconstruction) and inset analysis of height of *Alison* when close by the pier

When *Typhoon Clipper* started accelerating, *Alison* is assessed to have been no more than 15m ahead. With an air draught of 1.7m, no part of *Alison* would have been visible when it was any closer than 21m ahead of *Typhoon Clipper*. To have had a realistic prospect of being seen from *Typhoon Clipper*'s wheelhouse, *Alison* would have needed to be about 50m ahead (**Figure 22**). Therefore, once *Alison* had passed the end of the pier, it entered *Typhoon Clipper*'s visual blind sector ahead and all possibility of a line of sight detection from *Typhoon Clipper*'s wheelhouse was lost.
