VERY SERIOUS MARINE CASUALTY

REPORT NO 4/2016

## Collision between the fishing vessels *Silver Dee* (B310) and *Good Intent* (SY79) resulting in the foundering of *Silver Dee* Irish Sea 29 July 2015

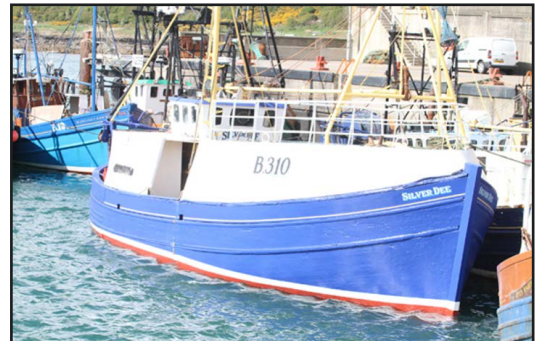
FV *Silver Dee*

*Silver Dee*'s rapid flooding was due to its lack of a collision bulkhead and other watertight subdivisions. Floodwater was able to rush through the damaged planking at the stem and then spread quickly through the vessel.

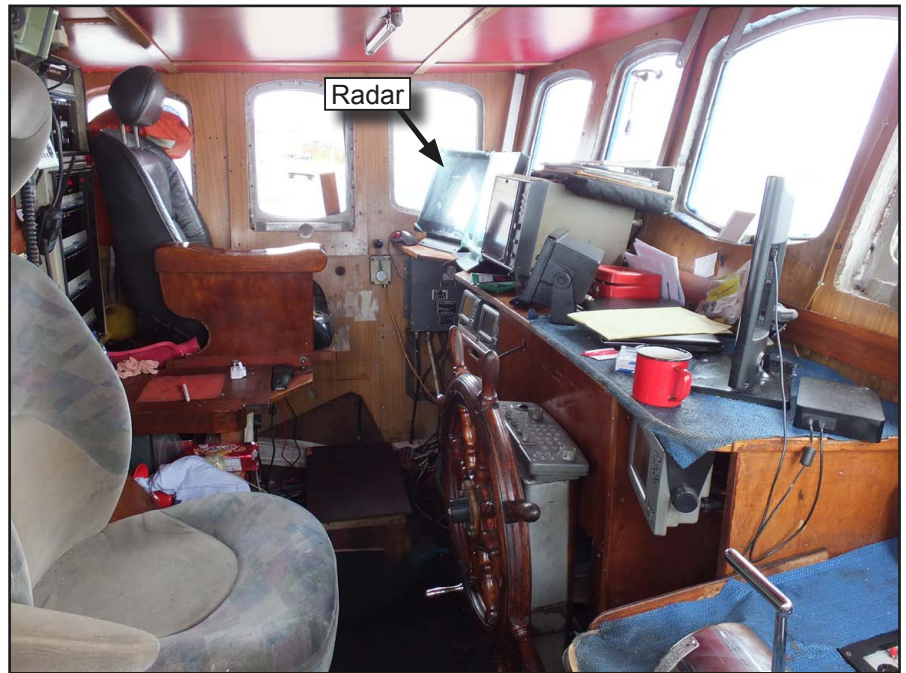
Figure 7: *Good Intent*'s wheelhouse

However, it would have been almost impossible for the bosun to enter the wheelhouse, look at the plotter and adjust the engine control lever without looking out of the windows with peripheral vision. Therefore, it is likely that the bosun did not notice *Silver Dee* because the vessel was obscured from his view by either the port side wheelhouse chair, the radar display or a window frame (**Figure 7**).
