## SYNOPSIS

At 1508 on 17 December 2004, the aggregates carrier *Brenda Prior*, and the DUKW *Beatrice*, collided adjacent to Lambeth Pier on the River Thames. *Brenda Prior* was sailing downriver in ballast having just completed a discharge of sand at Battersea, *Beatrice* was carrying 25 passengers on a circuit of the river between Vauxhall and Westminster Bridges. *Beatrice* sustained minor structural damage, but was able to return to shore, supervised by a Port of London Authority launch that was in the vicinity. *Brenda Prior* sustained no damage.

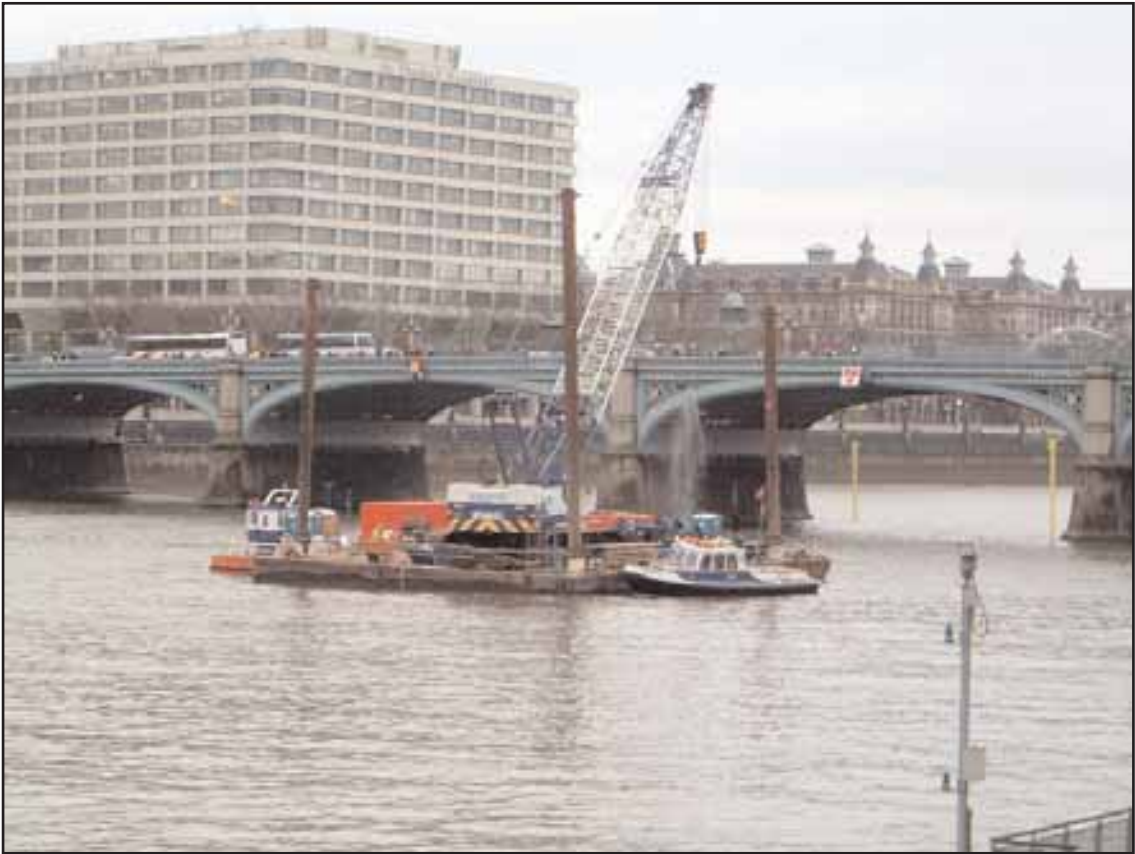
Construction work at Westminster Bridge

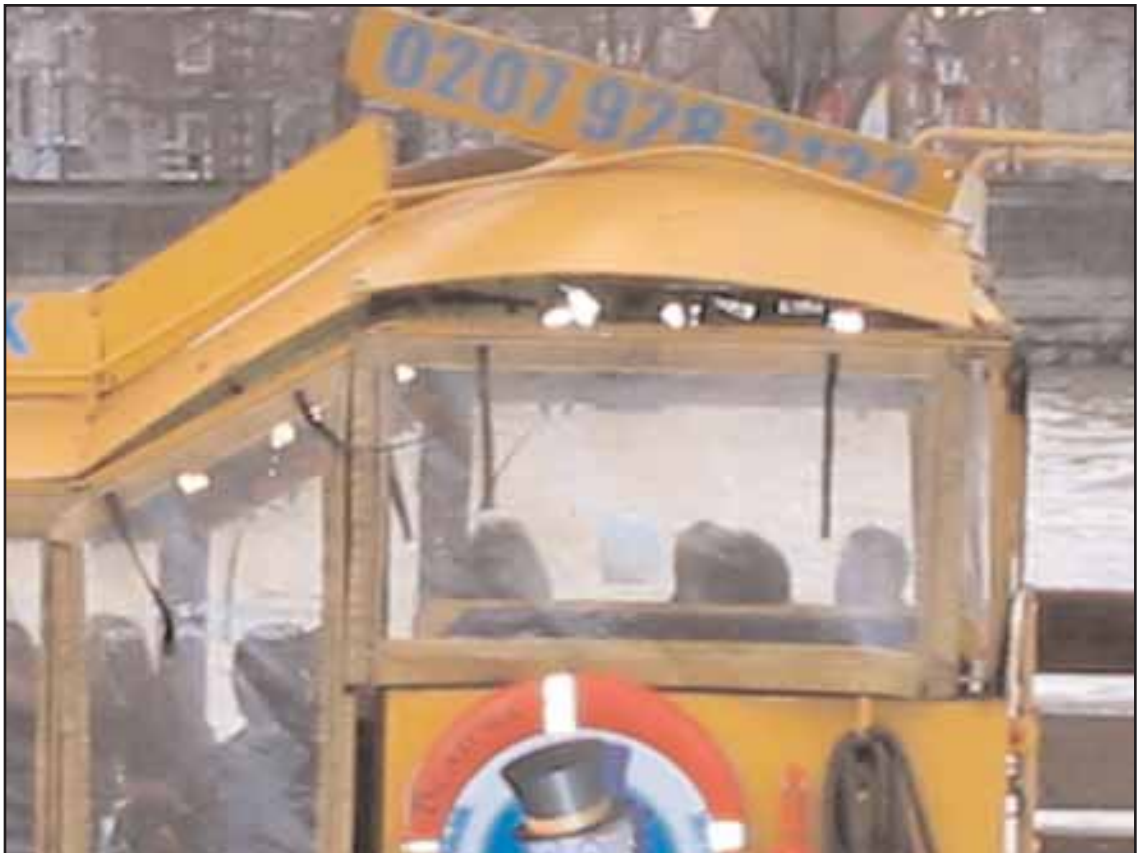
Figure 5

Damage sustained by the DUKW *Beatrice*

On return to Lacks Dock, the skipper of *Beatrice* reported the incident to Woolwich Radio VTS using his mobile telephone. In his report, he highlighted that he believed *Brenda Prior* had not seen him, because his vessel might have been situated in *Brenda Prior*'s "blind spot", and that as *Beatrice* was only 1.5 to 3 metres away from the craft moored alongside Lambeth Pier, he could not manoeuvre any further to starboard. The report confirmed that no injuries were sustained, however, *Beatrice* had received a glancing blow and had suffered damage to the rear access ladders and canopy top.
