## SYNOPSIS

At 1138 (UTC) on 3 February 2007, the high speed ferry *Sea Express 1* and the general cargo vessel *Alaska Rainbow* collided on the River Mersey in thick fog. The collision holed the starboard hull of the ferry, causing her to list and trim significantly within seconds. However, there were only minor injuries to passengers and the vessel remained afloat. There were no injuries on board *Alaska Rainbow*, and the damage to this vessel was minor.

### 1.1 PARTICULARS OF *SEA EXPRESS 1*, *ALASKA RAINBOW* AND ACCIDENT

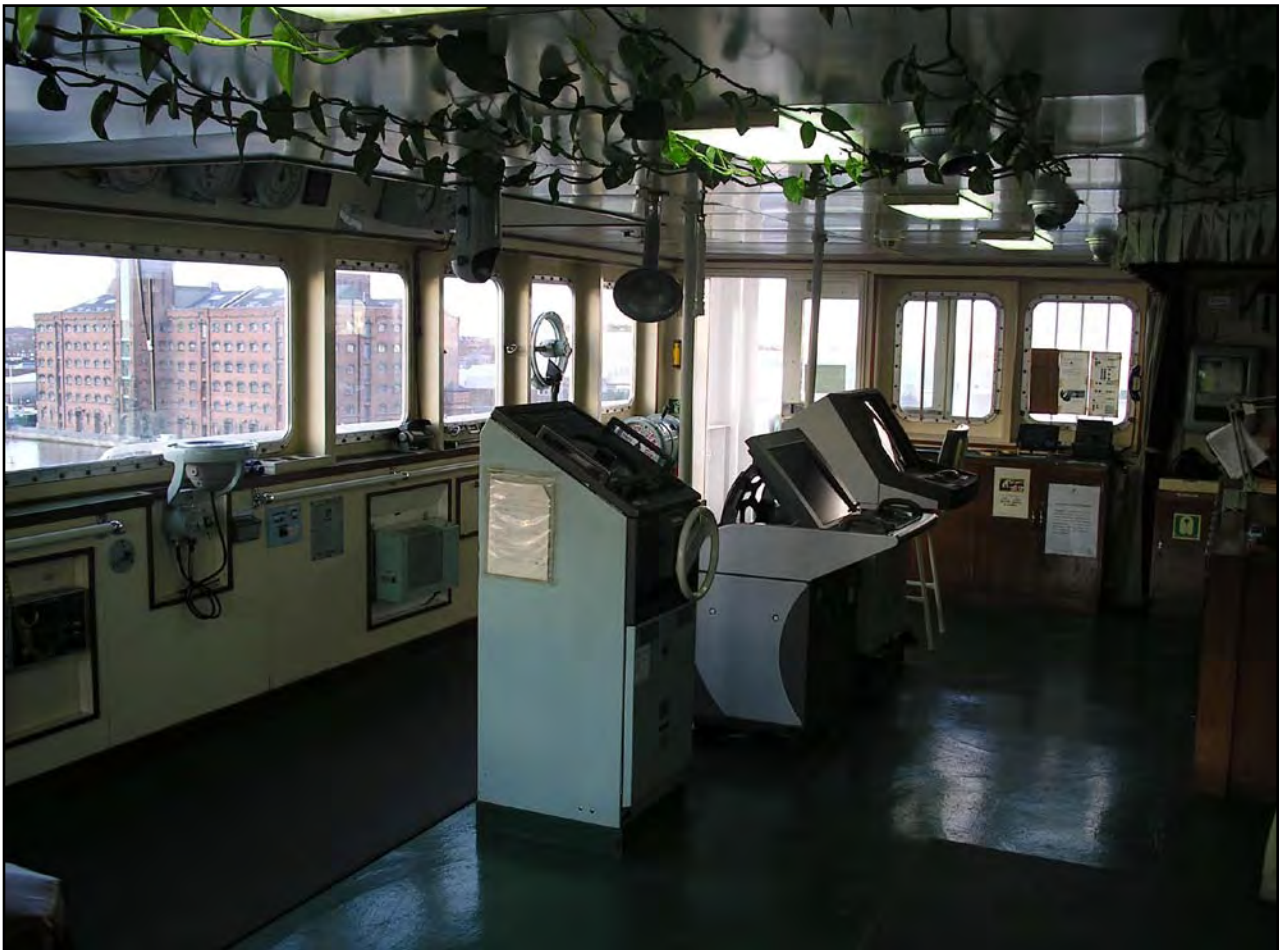
Figure 6

The bridge of *Alaska Rainbow* occupied approximately one third of the breadth of the ship, with large open bridge wings to either side. The wheel and telemotor unit were mounted on the centreline in the middle of the wheelhouse (**Figure 6**). To port of the telemotor unit was a fixed chair, and to starboard were the two radars, positioned next to each other. Forward of the radars was the engine telegraph, positioned close to the bridge front. To starboard, and aft of the wheelhouse was the chart room. The ship's two GPS receivers and the AIS receiver were all fitted in the chart room, in such a position that the data could also be read from the wheelhouse. The view directly ahead from a position on the centreline was restricted by the presence of the ship's cranes.

*Alaska Rainbow - bridge*

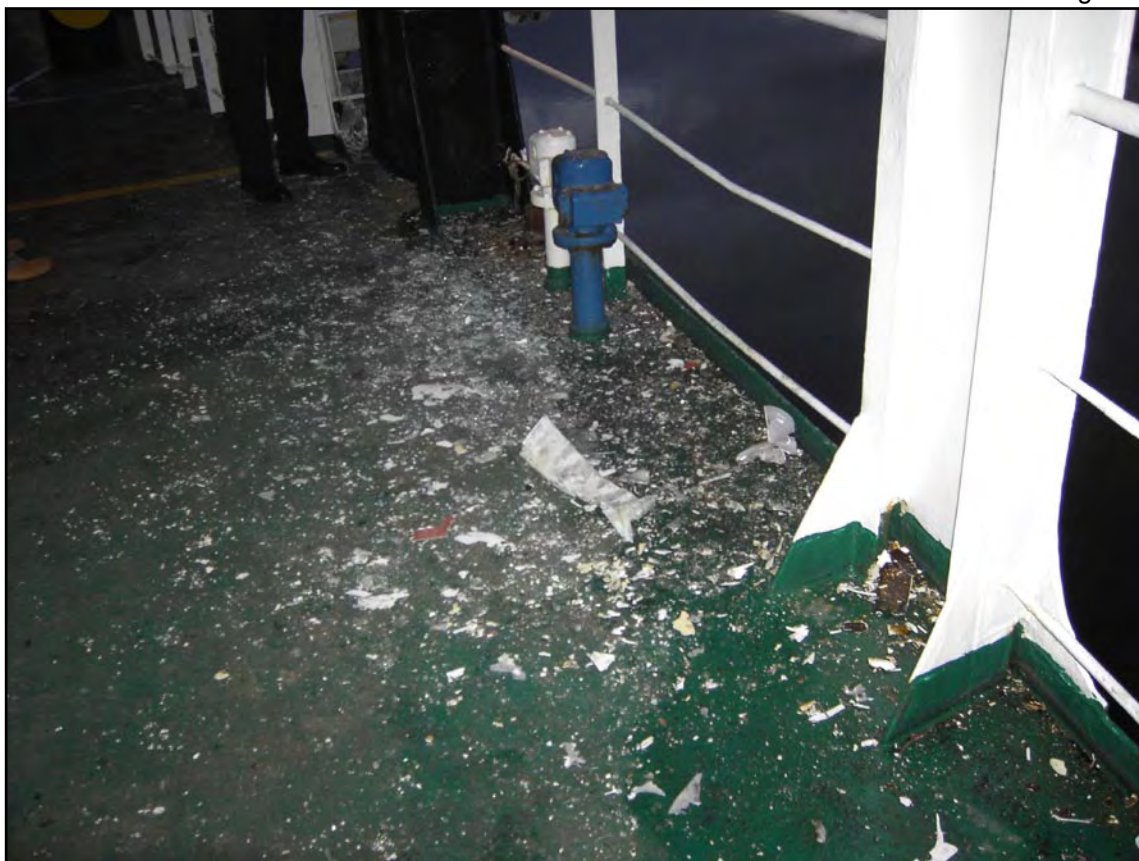
The aft part of the starboard hull of *Sea Express 1* and the bulbous bow of *Alaska Rainbow* collided, ripping a hole 2.5m by 6.5m in the engine room and jet pump room. This caused rapid flooding of the space, stopping the starboard engines and the two generators. The electrical load then transferred to the generator in the port engine room which overloaded and tripped out, leaving *Sea Express 1* temporarily on emergency electrical power only. The impact turned *Sea Express 1* to starboard, and a second impact was made with the hulls of the two ships parallel to each other (**Figures 7, 8 and 9**). *Sea Express 1* continued to slide down the starboard side of *Alaska Rainbow*, and the starboard bridge wing then made contact with *Alaska Rainbow*'s accommodation ladder stowed outboard of the ship's side railings near the accommodation. This impact ripped away *Sea Express 1*'s starboard bridge wing roof and windows, and damaged adjacent liferaft stowage arrangements.

Debris from *Sea Express 1* on the deck of *Alaska Rainbow*

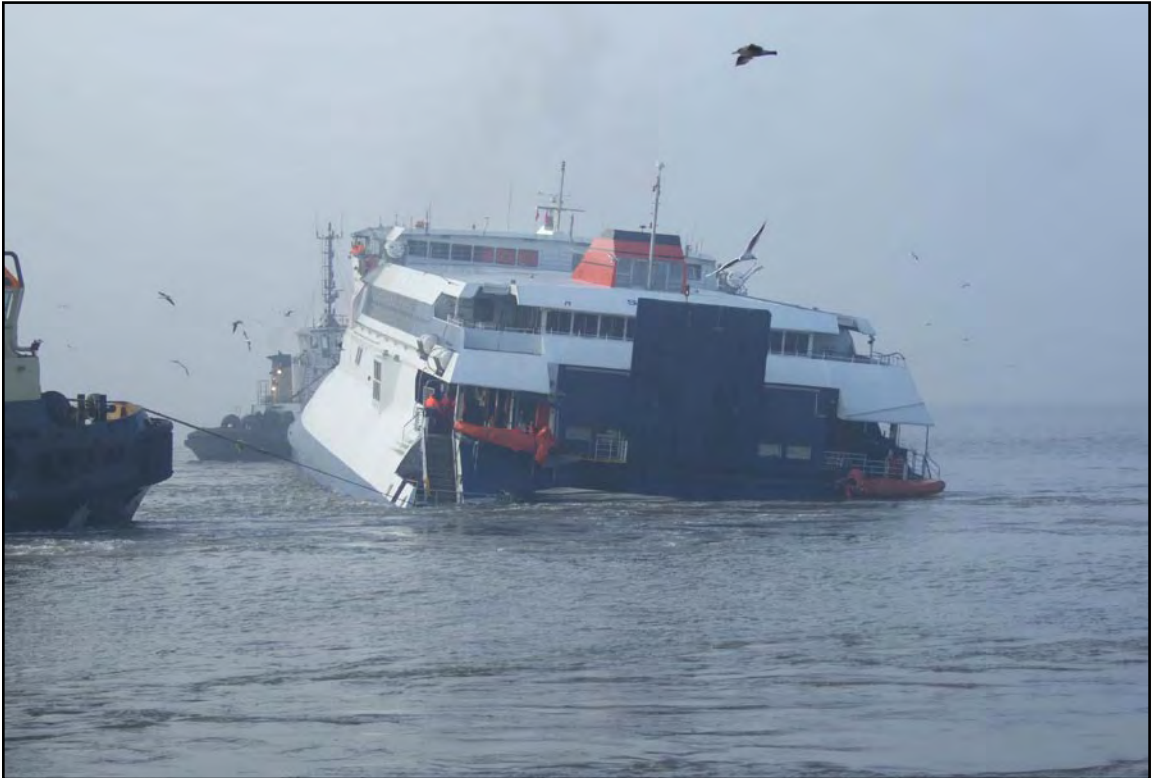
*Sea Express 1 under tow*
