## SYNOPSIS

At about 0210 on 13 April 2005, the UK registered tug *Thorngarth* was assisting the Liberian registered chemical tanker *Stolt Aspiration* and acting as bow tug. The two vessels collided when *Thorngarth* was attempting to recover her position ahead of *Stolt Aspiration*.

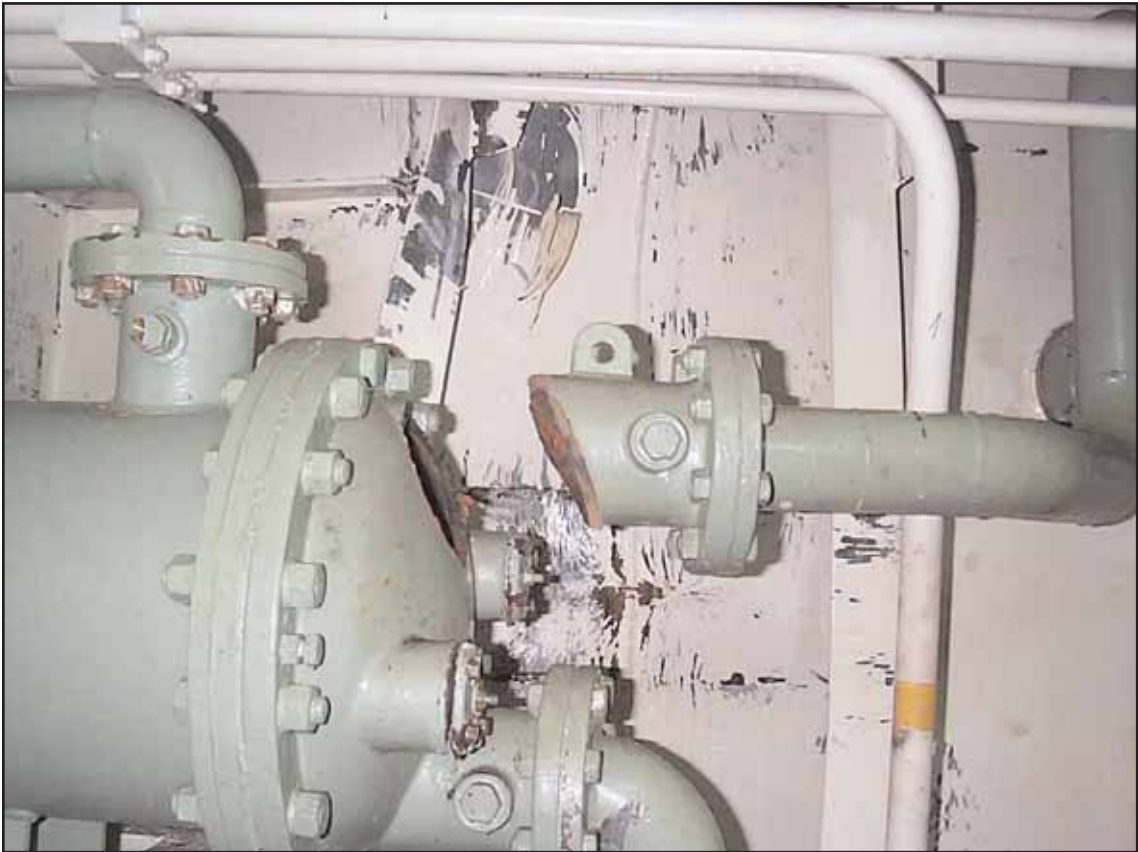
Figure 4

| Damage | : | Holes in starboard side above and below waterline, extensive buckling and displacement of shell plating and internal support structure, and damage to internal fittings. |

When *Thorngarth* came back upright, her mate left the bridge to check on the other crew members. Passing through the cross-alleyway, he came across the engineer, lying on the deck with his arm at an unusual angle. The engineer appeared to be in no imminent danger, so the mate went out on deck to confirm that the deckhand was unhurt. He then shouted to the master that the engineer had been injured. The deckhand and the mate then went to the engine room to assess the damage. They could see water coming in through a crack in the ship's side and from damage to the starboard main engine jacket water cooler (**Figure 4**).

Damage to the starboard main engine jacket water cooling heat exchanger and ships side
