## SYNOPSIS

At 0218 on 6 March 2011, the UK registered container ship *Cosco Hong Kong* collided with the China registered fish transportation vessel *Zhe Ling Yu Yun 135*. The accident occurred in international waters off the coast of Zhejiang Province, China. *Zhe Ling Yu Yun 135* sank almost immediately, with the loss of 11 lives. *Cosco Hong Kong* was not damaged.

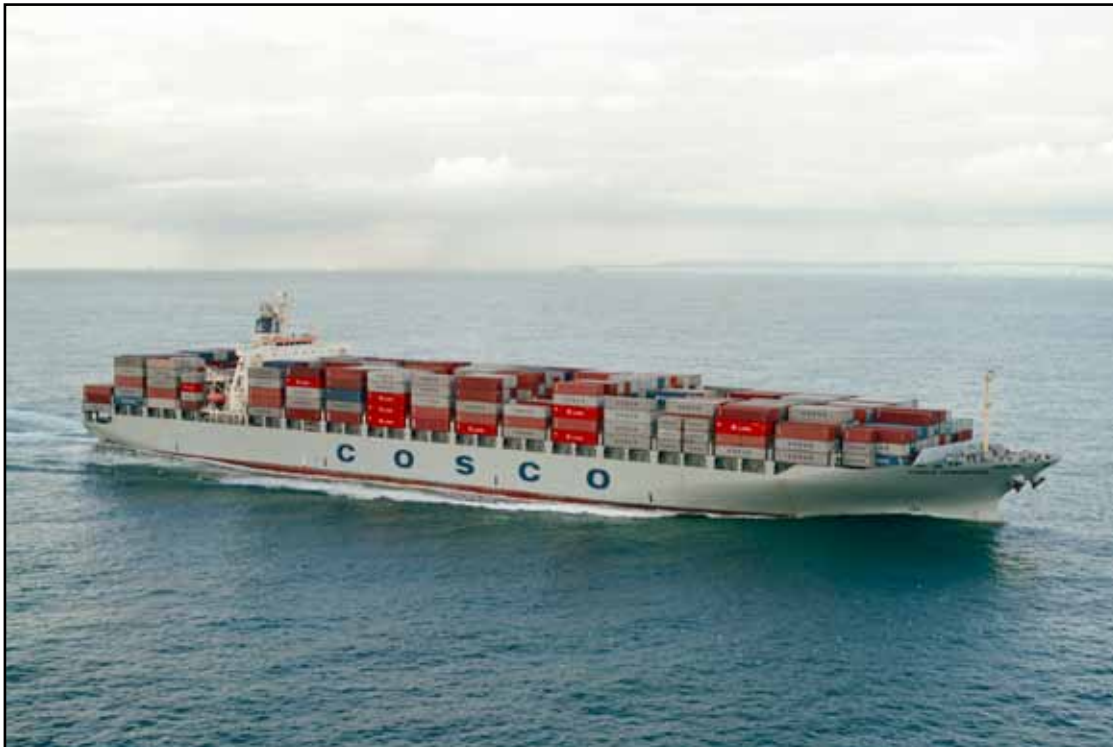
*Cosco Hong Kong*

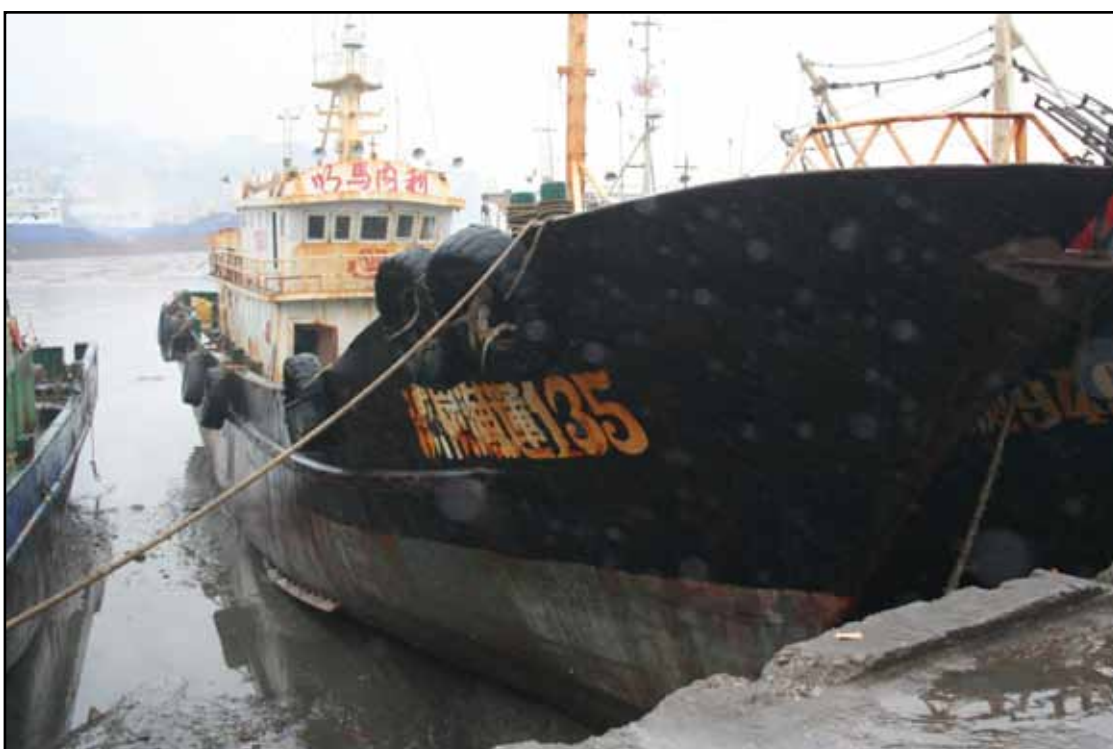
*Zhe Ling Yu Yun 135*
