## Collision between fishing vessel *Achieve* (HL257) and general cargo ship *Talis*, resulting in the sinking of *Achieve* off Tynemouth, England on 8 November 2020

### SUMMARY

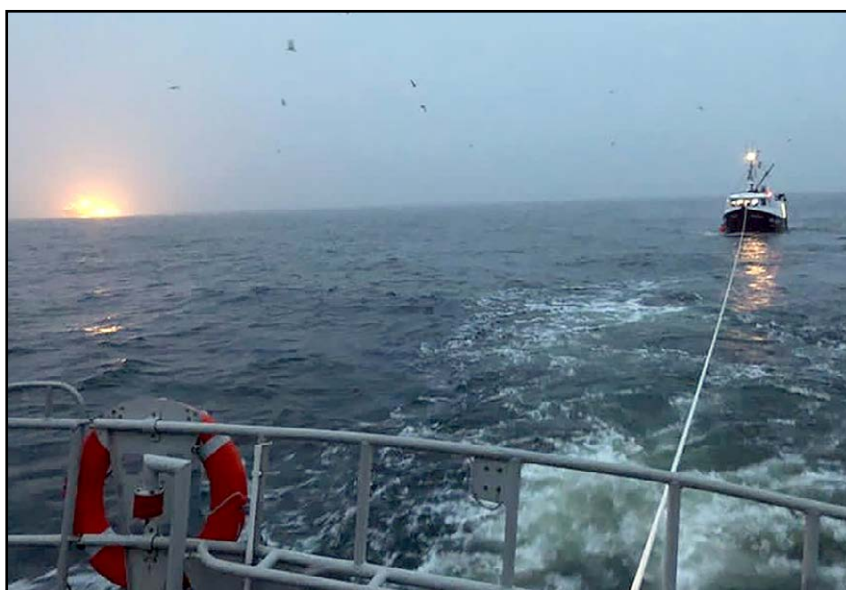
**Figure 5:** *Achieve* being towed by RNLI all-weather lifeboat

*Achieve*'s skipper and the ALB coxswain's decision to tow the vessel was understandable given the port's proximity, and towing from the bow was the quickest method. However, this may have increased the water inflow, which resulted in the vessel sinking.
