## SYNOPSIS

At about 0005 on 5 February 2013, a crewman from the motor tug *Endurance* fell overboard in rough seas about 2.3 miles west-south-west of Beachy Head on the south coast of England. The crewman fell while attempting to cross to the unmanned motor cruiser *Sirius M* with a replacement towline after the original towline connecting the two vessels had parted. The motor tug's skipper's efforts to recover the crewman back on board in rough seas were unsuccessful; the crewman soon lost consciousness and disappeared from view.

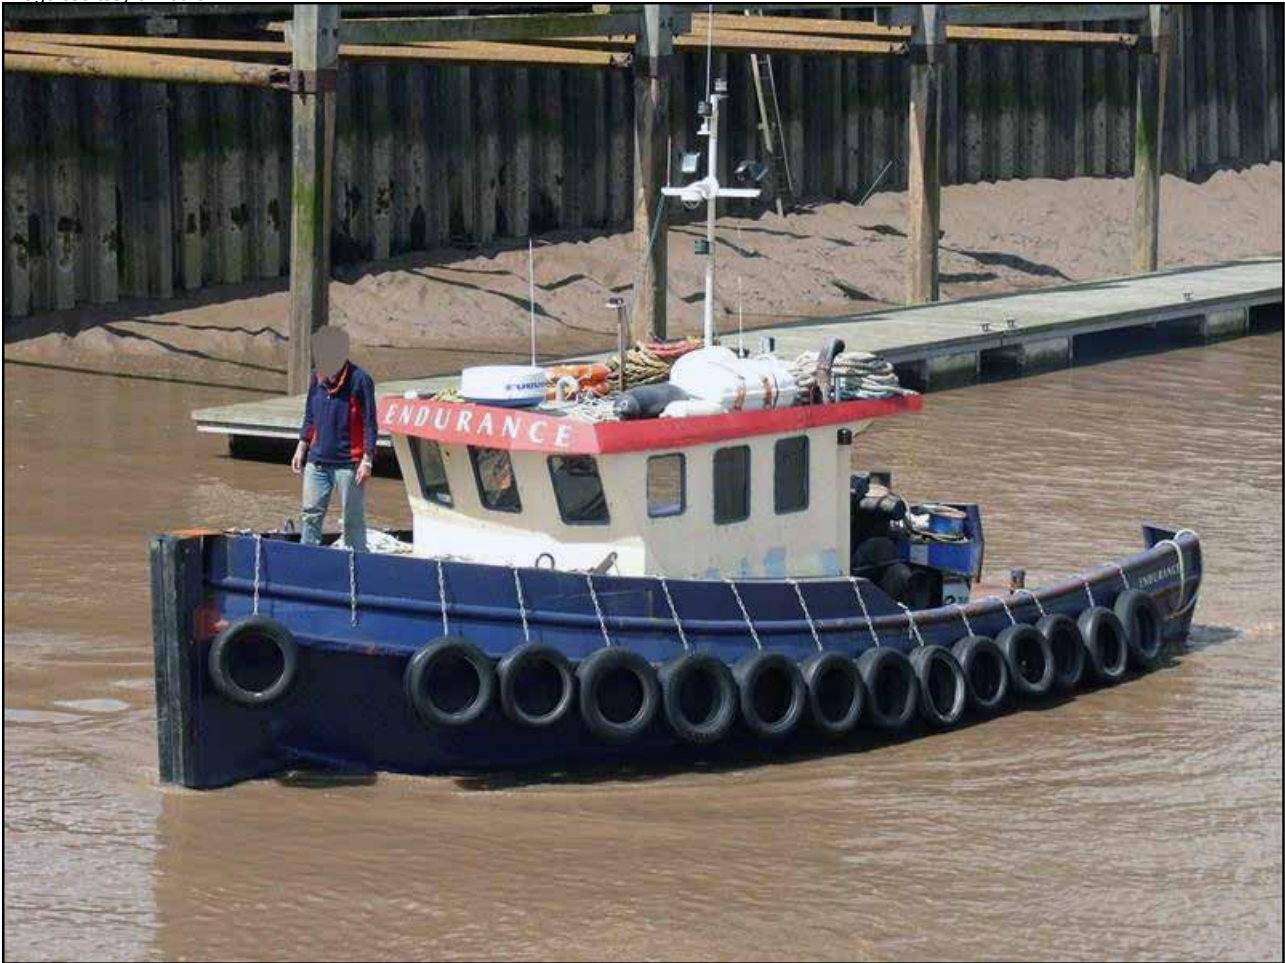
At about 0400 on 3 February 2013, the skipper of the motor tug<sup>1</sup> *Endurance* (**Figure 1**) and his crewman, Steven Trice met at Cuxton Marina near Rochester, England. They boarded a small boat and made their way to *Endurance's* River Medway mooring. *Endurance* was then manoeuvred across the river to Medway Bridge marina (**Figure 2**), where the skipper and Steven connected a towline from *Endurance* to the bow of the motor cruiser *Sirius M* (**Figure 3**). *Sirius M* was then towed by *Endurance* downriver. The vessels' destination was Brighton on the south coast of England. *Endurance's* skipper had checked the weather forecast using the *windfinder.com* website<sup>2</sup> and had assessed the predicted conditions to be suitable for the 2 day passage. He intended to berth the vessels overnight in Dover.

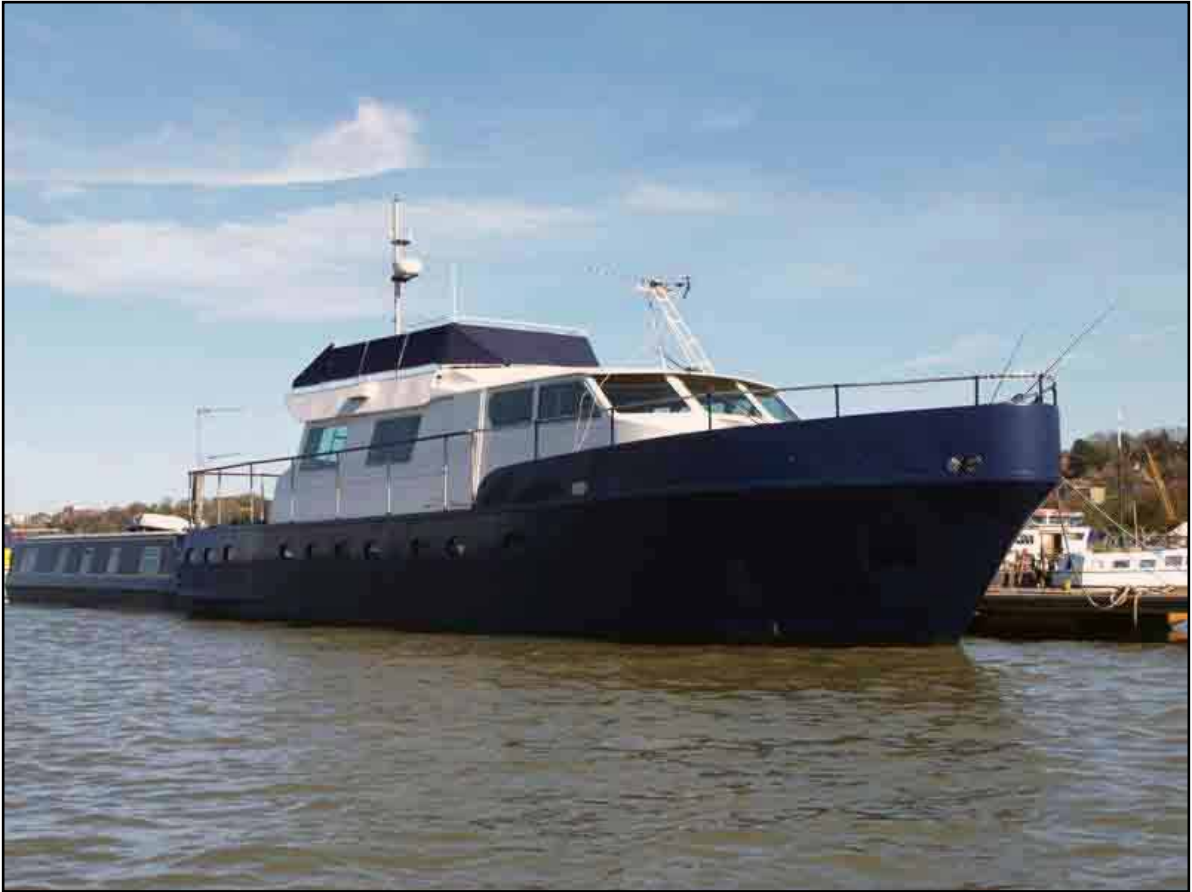
**Figure 3:** *Sirius M* berthed at Medway Bridge marina

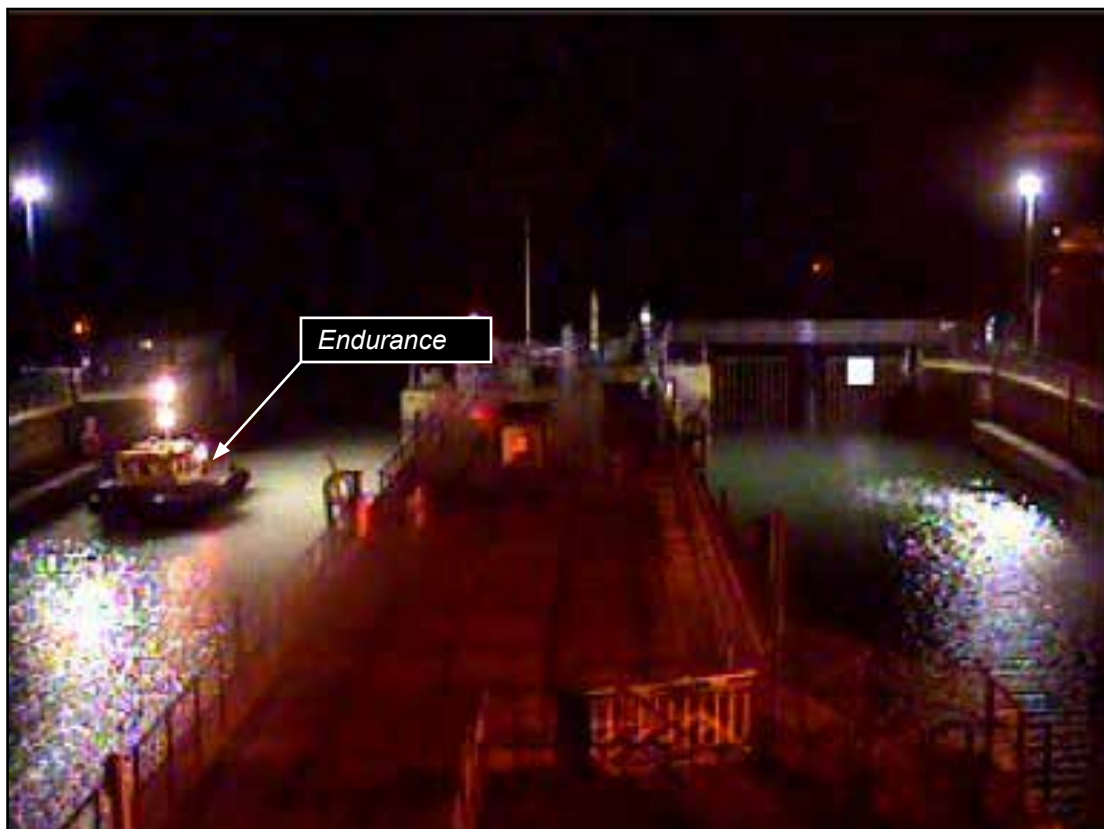
At 0215, *Endurance*'s skipper requested the coastguard's permission to head into Eastbourne. By this time, the extent of the rolling and pitching of the tug was so severe that the skipper was concerned that it might lead to problems with the engine fuel supply. The coastguard approved the request and, at 0305, *Endurance* entered Eastbourne's Sovereign Harbour (**Figure 12**). *Sirius M* was later recovered by the Newhaven ALB and towed into Eastbourne (**Figure 13**).

**Figure 12:** *Endurance* entering Eastbourne's Sovereign Harbour

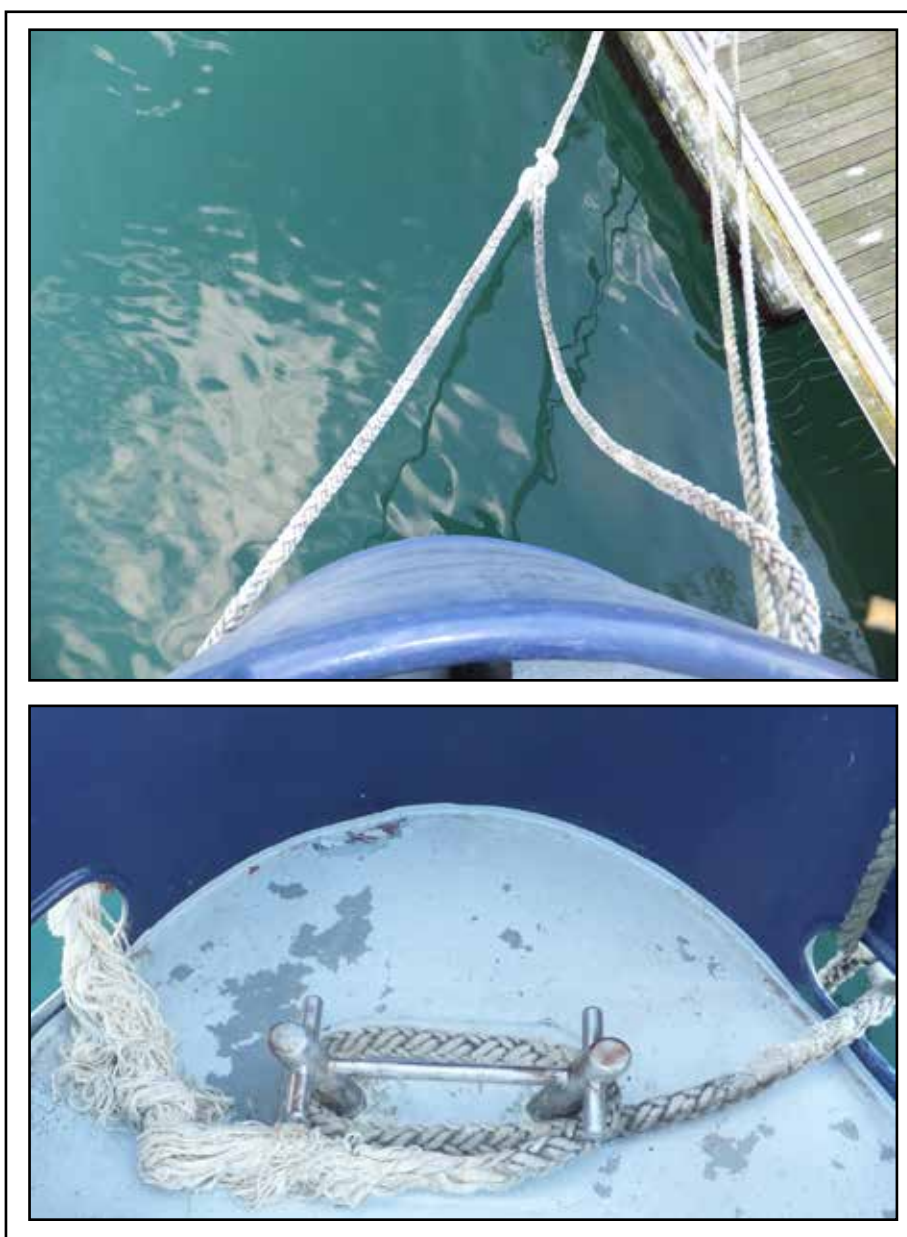
Examination of the parted towline indicated that the rope was old and in poor condition. MAIB inspectors reconstructed the towing eye in situ (**Figure 24**), and it was evident that the rope had parted at a point where it had been in contact with the steel rim of one of the motor cruiser's fairleads. The rope was also damaged where it had been in contact with the other fairlead (**Figure 25**). Paint on the forward edge of both fairleads had been removed and the base steel had a freshly polished

**Figure 24:** Tow rope securing arrangement reconstructed on *Sirius M*'s foredeck

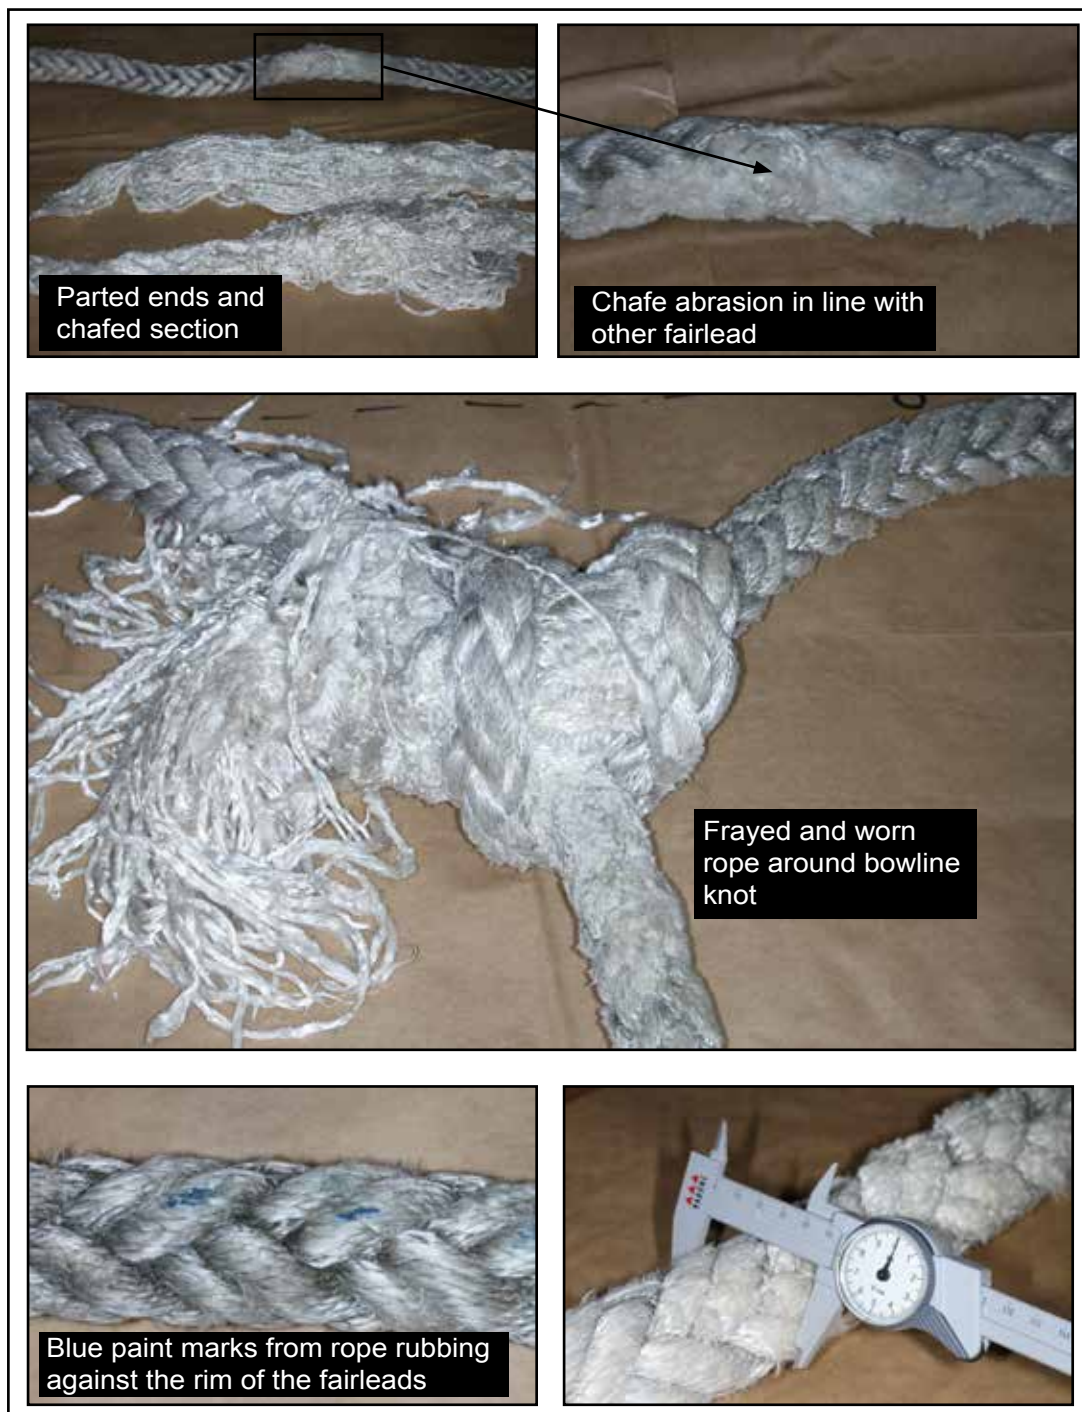
**Figure 25:** Tow rope chafe marks and frayed ends, and fraying at the bowline knot used to form the towing eye

appearance. Blue paint could be seen on the rope in the areas where it had rubbed against the steel rim of the fairleads. It was also noted that the length of rope within and around the bowline had started to fray and wear.

7. The tow rope parted due to chafe abrasion caused by the rubbing action of the rope against the steel rims of *Sirius M*'s bulwark fairleads. This undoubtedly occurred because the arrangements did not follow good practice in safety-critical areas. [2.6]
