# MARITIME FEEDBACK

Issue 60  
August 2020

An independent and confidential reporting system for the maritime industry

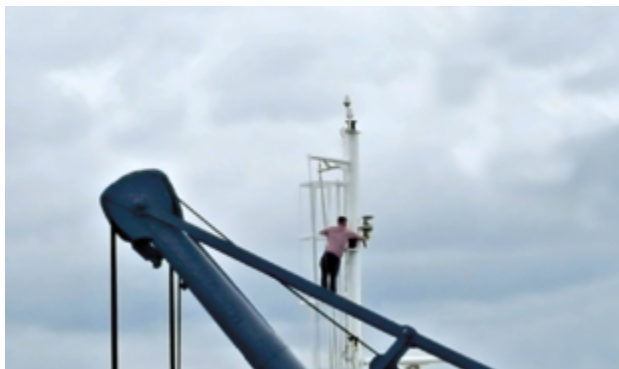
Whilst our vessel was alongside, I observed the following on an adjacent vessel. A crew member (or possibly a contractor) was standing on the outside of the back scratcher (ladder cage) of the mainmast ladder. He stretched from this position to change a lamp on the forward end of the mast. He descended the ladder and then returned, on both occasions climbing through the back scratcher. Upon inserting the lamp the light immediately illuminated, suggesting that the power was not switched off. On the first occasion, another crew member was standing at the starboard bridge wing door watching. He did nothing to stop the job and seemed to be taking an observing / standby role.

Working aloft with no safety harness or PPE

In this case, a proper risk assessment, toolbox talk, and an electrical lockout work permit all appear to have been missed. A perfectly reasonable question to ask is "Why was this, and could it happen on your ship?"

*CHIRP* has long been a champion of engineering solutions to remove hazards. Whilst a mast-head navigation light will still be at the top of the mast, fitting a platform with guard rails or installing horizontal foot and hand rails around the mast at an appropriate level with securing points for safety harness lanyards, would have made access for a routine task easier and safer.

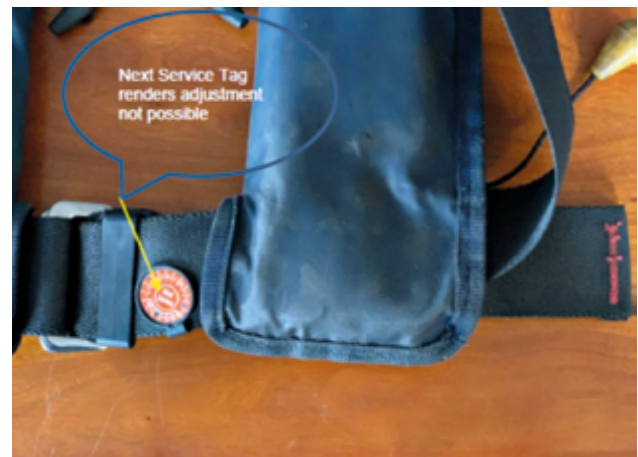
I want to share the following with you as I feel it would make a worthwhile safety flash to share across the industry. One of our vessels has reported that on two of its inflatable lifejackets, the servicing tags had been fitted in such a manner that they made it impossible to adjust the waist strap. Please see the attached photographs which illustrate the issue.

Highlighting that the positioning of the service tag renders waist strap adjustment impossible

However, *CHIRP* would suggest that upon return from third-party servicing, LSA and FFA equipment needs to be checked by ship's staff and, if possible, tested before being put into service. *CHIRP* is aware of liferafts being returned with time-expired equipment and survival rations out of date – only discovered on a subsequent service in a different country. BA sets have been returned in an inoperative condition and fire extinguishers returned with either time-expired CO<sub>2</sub> cartridges or unpressurised stored pressure units. It is possible that the renewed certificate is considered more important than a proficient health check on equipment.

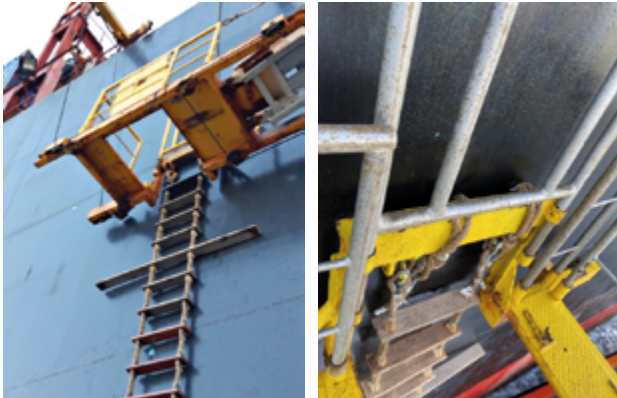
A vessel was identified by the port authority as having a non-compliant pilot ladder arrangement on 17.03.2020. The vessel has a trap-door platform, but the pilot ladder does not extend 1.5 m above the platform. A report was submitted to the national regulator who visited the vessel and confirmed that the arrangement is non-compliant. Pilots are told not to use non-compliant arrangements and can be penalised should they do so or report such ladders and then use them despite the known defects. However, this ship, and others are still making calls to the port. If inspected, non-compliant ships are simply issued with a letter from the regulator, but this does not stop them sailing and pilots are put in an impossible position because management and port authorities tacitly condone these arrangements and simply tell pilots not to board if it is unsafe.

2 examples of non-compliant 'trapdoor' pilot boarding arrangements

Members of the MAB noted that quite a lot of improvement on trap door pilot boarding arrangements has been seen in Europe. Some companies have carried out modifications with class approval. *CHIRP* is also aware of at least one flag state administration that is in consultation with class to resolve the issue. This is encouraging, although more needs to be done.
