## Collision between **MV PHILIPP AND FV LYNN MARIE** 6nm south of the Isle of Man 9 April 2011

### SUMMARY

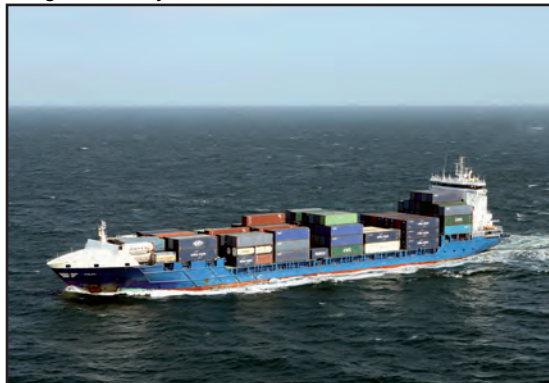
MV Philipp

The distance between *Philipp* and *Lynn Marie* continued to reduce, so the chief officer sounded five short blasts on the ship's whistle and the lookout shone a searchlight towards the fishing vessel. The chief officer also moved from the centreline to the starboard side of the bridge to get a clearer view of the rapidly closing fishing vessel. At 0453, the starboard side of the container ship hit *Lynn Marie*'s port outrigger; the container ship was still under helm to port and her heading was passing through 250°. *Philipp* suffered cosmetic damage to her starboard side in way of bay 28.

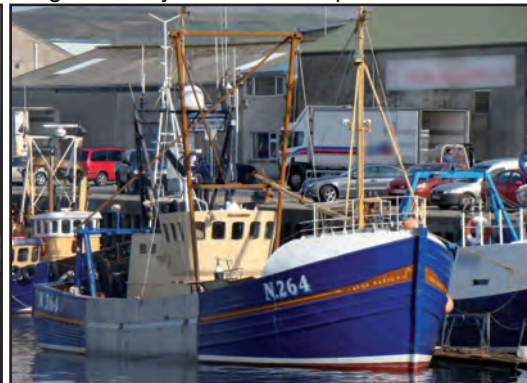
FV Lynn Marie

*Lynn Marie* suffered major damage to planking and frames on the port and starboard bow, stem post, whaleback and port outrigger (**Figure 6**).

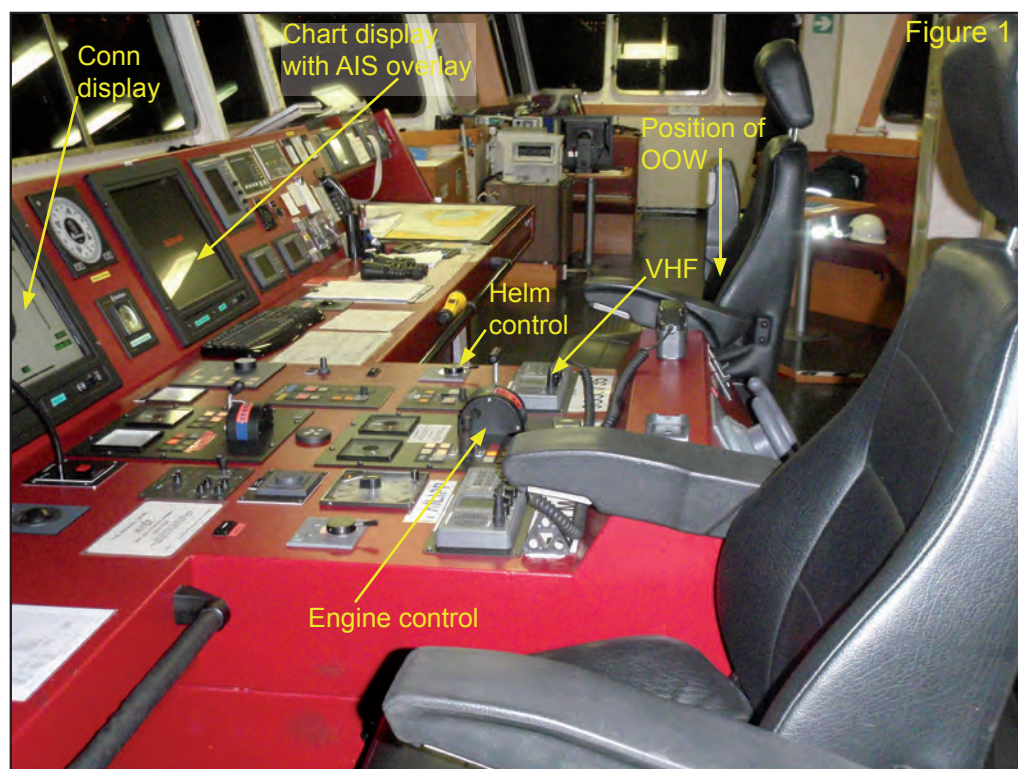
Figure 1

Between 0350 and 0400, the chief officer relieved the second officer as the OOW. The vessel was on an autopilot controlled heading of 298° at a speed of 16.5 knots. After taking over the watch, the chief officer sat in the forward-facing chair sited on the starboard side of the centreline control console (**Figure 1**) from where he could see electronic chart system (ECS) with overlaid automatic identification system (AIS) information on the display directly in front of him.

Centreline control console
