## SYNOPSIS

At 2321 on 1 June 2011, the privately owned rigid-hulled inflatable boat *Morfil* collided with the passenger ferry *Sun Clipper* by Blackfriars Road Bridge on the River Thames, London. The vessels were travelling in opposite directions. On impact, *Morfil*'s two crew were pitched into the water but were quickly rescued by the local inshore lifeboat; both were shocked but uninjured. *Morfil* eventually grounded under the road bridge and was a constructive total loss. Damage to *Sun Clipper* was only superficial and there was no pollution.

### 1.1 PARTICULARS OF *MORFIL* AND *SUN CLIPPER* AND ACCIDENT

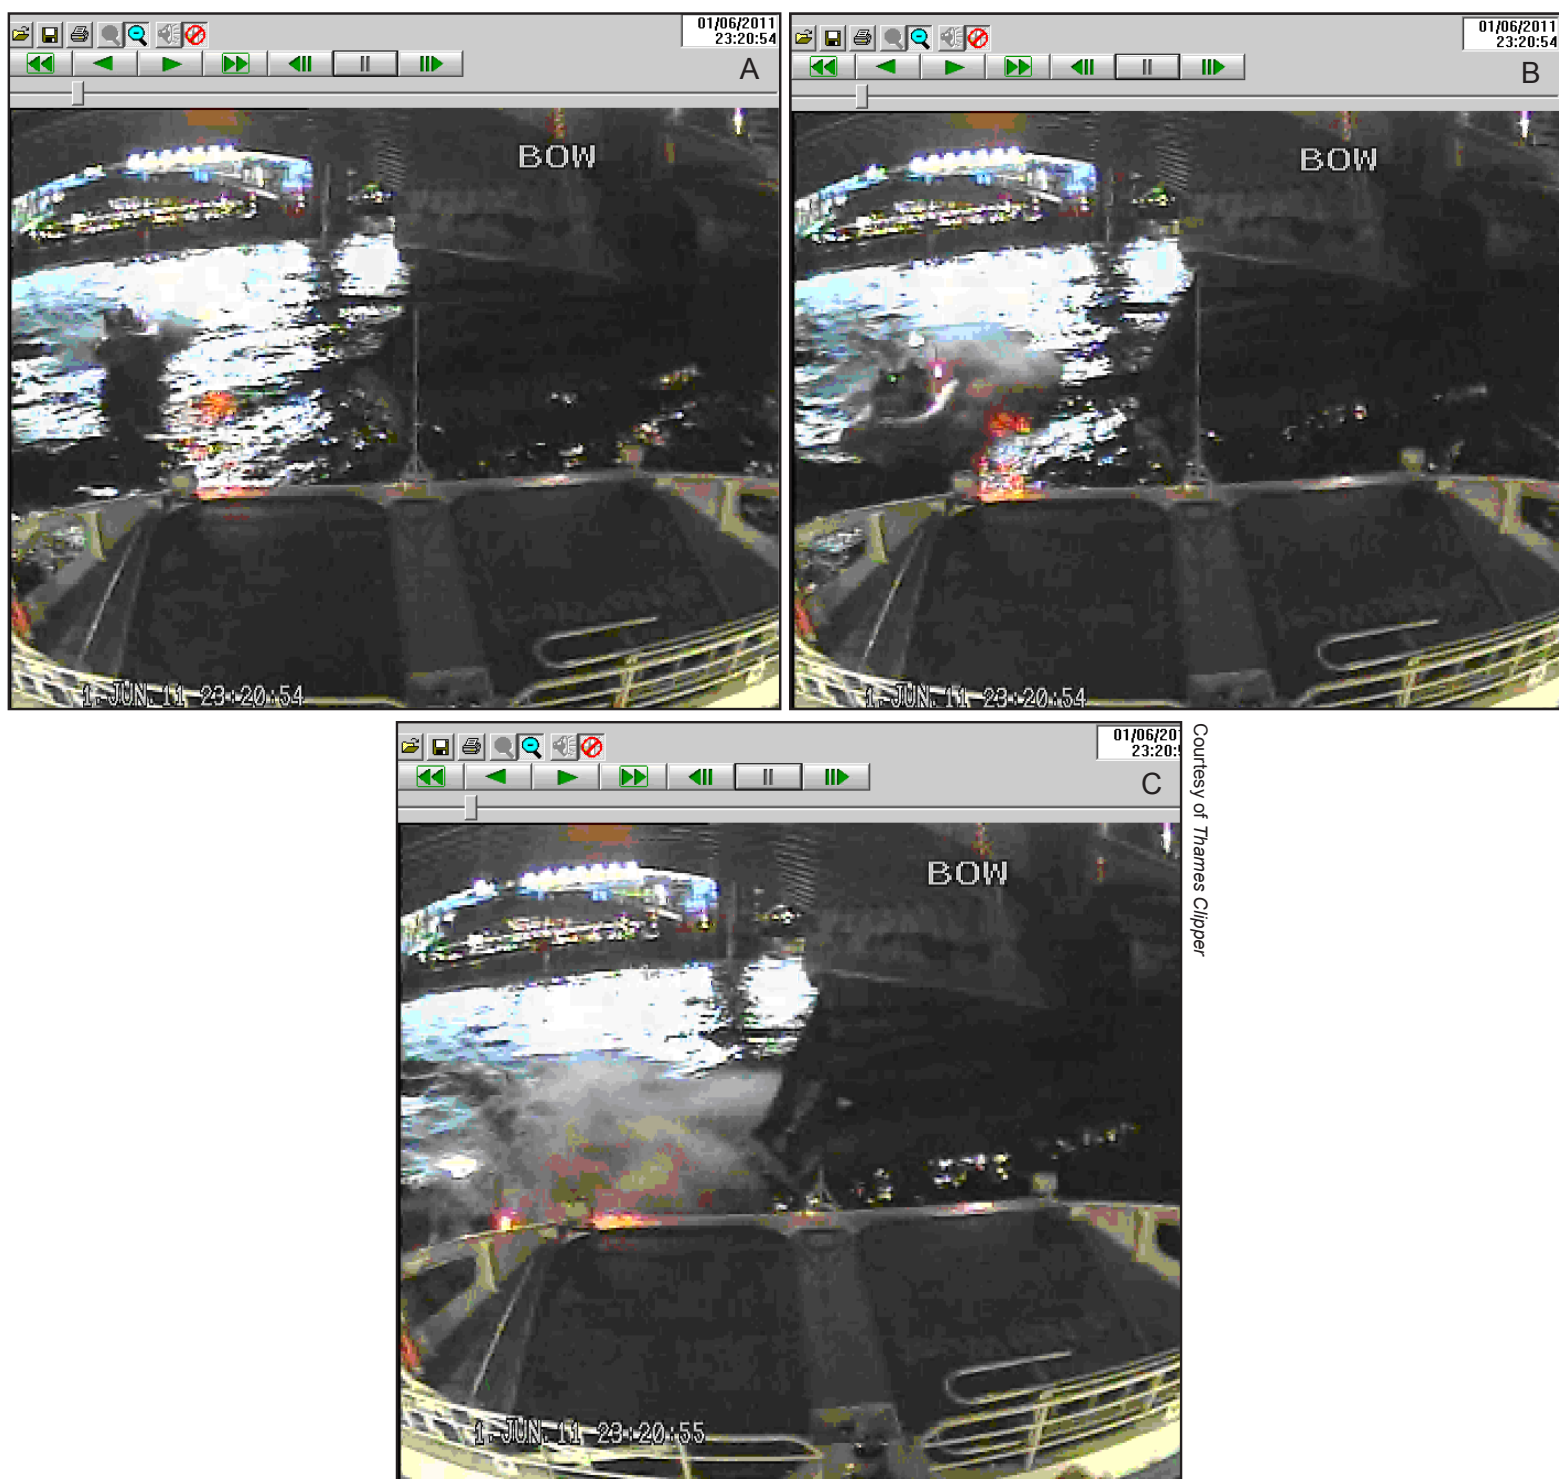
**Figures 6a to c: CCTV still - *Morfil*'s swerve to starboard**

Moments later, *Morfil*'s coxswain saw *Sun Clipper* directly ahead, and turned the steering wheel to port and then to starboard (**Figures 6a to 6c**). This action caused the RIB to swerve violently. Seconds later, at 2321, *Morfil* collided with *Sun Clipper*'s port bow and both the RIB's occupants were thrown overboard.

It is evident from **Figures 5 and 6a, 6b and 6c** that *Sun Clipper* and *Morfil* were potentially in sight of each other for approximately 10 seconds prior to the collision. However, the lack of reaction by *Morfil*'s coxswain indicates that he did not see the oncoming ferry until he took action to try and avoid a collision between 1 and 2 seconds before the impact. By then, the two vessels were too close and closing too quickly for his instinctive attempt to manoeuvre clear to be effective. Although *Sun Clipper*'s master immediately reduced speed when he saw *Morfil* approaching, he was prevented from taking any further avoiding action by the close proximity of the temporary mooring buoys and the No.3 arch buttresses (**Figure 3**).

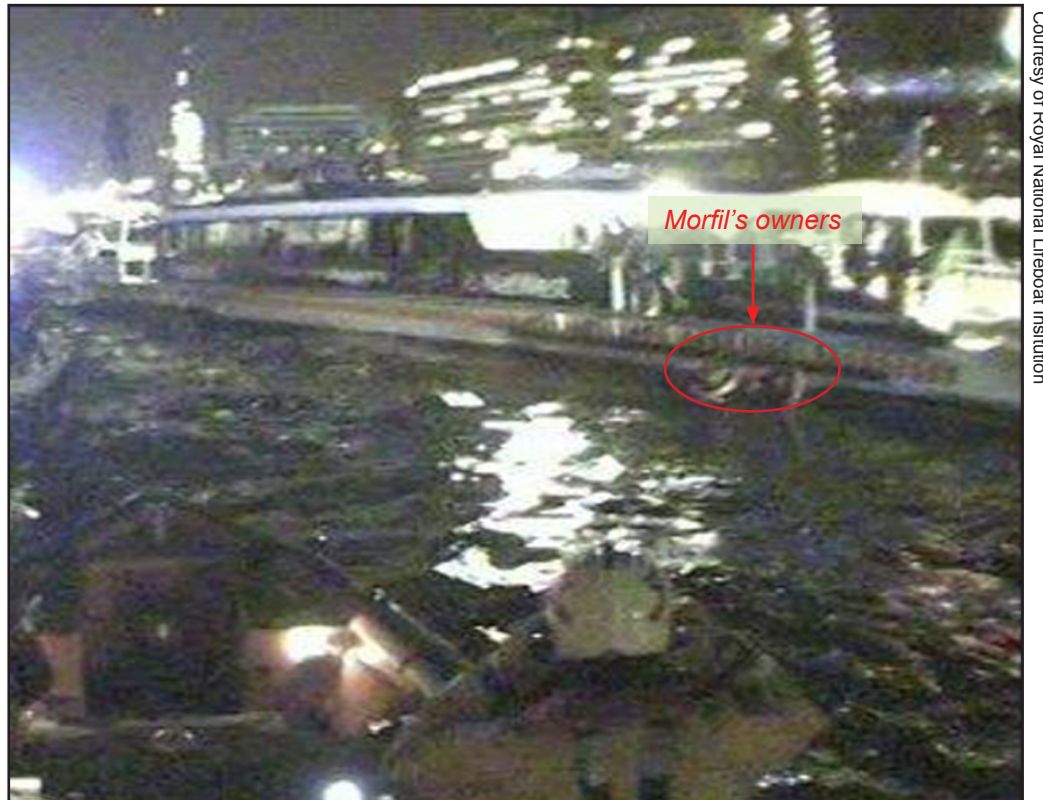
**Figure 7:** CCTV still - *Morfil*'s owners at stern of *Sun Clipper*

Meanwhile, some of *Sun Clipper*'s passengers gathered on the vessel's open aft deck and threw two lifebuoys to the men in the water. The passengers then used the lifebuoy's lines to pull the men to the vessel's side (**Figure 7**).

After the collision, *Morfil*'s owners were extremely fortunate that the RIB, the engine of which continued to run because the coxswain had not fitted a kill cord, did not strike them and cause serious injury – or worse – as it passed close by. They were also fortunate that their rescuers were close at hand, otherwise their chances of survival in the strong flowing river, without lifejackets and while under the influence of alcohol, would have been reduced significantly.

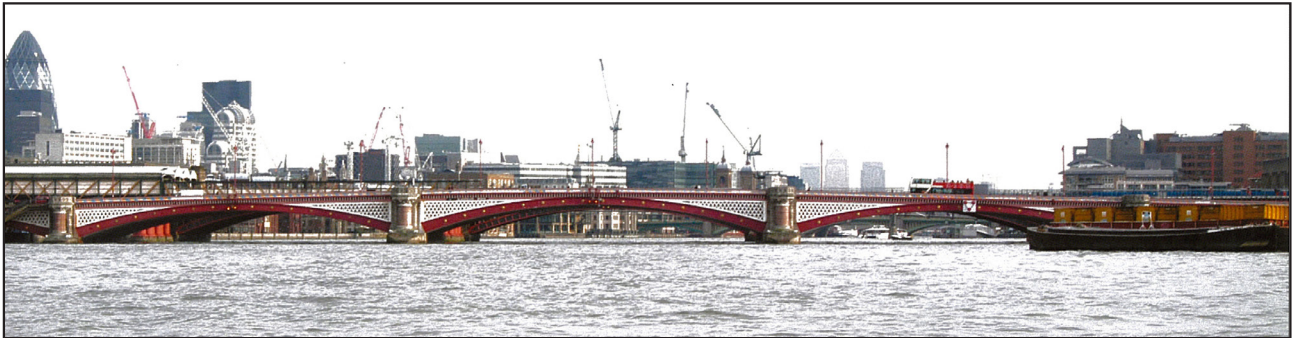
**Figure 9:** Blackfriars Road Bridge

The River Thames is the longest river in England. It is tidal from its estuary to Teddington Lock and is crossed by 29 bridges along this stretch. Blackfriars Road Bridge spans the River Thames from Blackfriars on the north bank to Southwark on the south bank (**Figure 3**). The road bridge was built in 1869 and has five steel frame arches that are supported by stone faced buttresses (**Figure 9**). Blackfriars Rail Bridge is 48m downriver from the road bridge and also has five arches. The bridges' No.3 arches are normally used by larger vessels; smaller vessels generally use No.2 and No.4 arches.

On the evening of 1 June 2011, the No.2 arches on both Blackfriars Road and Rail bridges were closed to navigation. The work barge, *Haven Seafield*, and tug *Horton* were positioned under the No.2 arch of Blackfriars Road Bridge. The closure of the No.2 arches on the Blackfriars Road and Rail bridges was indicated by a triangle (apex down) of three red lights in accordance with PLA River Byelaw 29.
