At about 1912 (UTC) on 19 March 2000, the United Kingdom registered 4,015gt cargo ship *Celtic King* was in collision with the Belgian registered 38m fishing vessel *De Bounty*. The MAIB was informed of the accident at 2243 that day. Captain D Wheal and Captain P Kavanagh carried out the investigation.

## PARTICULARS OF VESSELS AND ACCIDENT

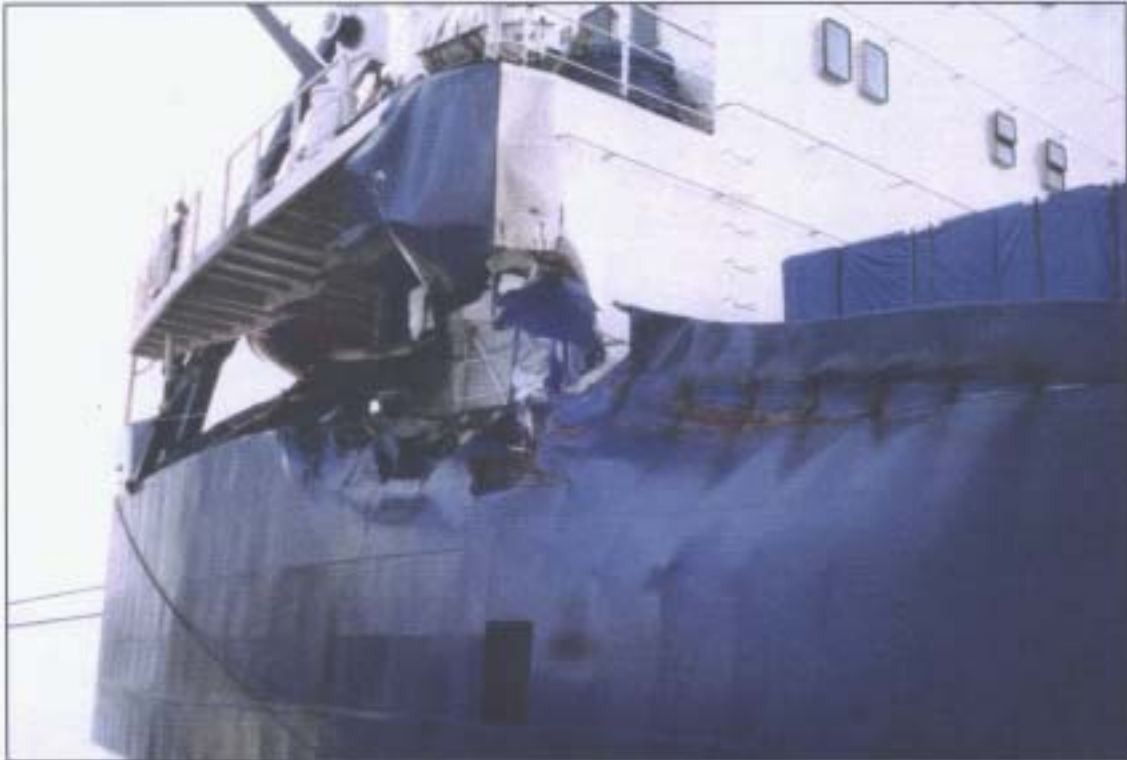
Photograph 3

| Damage | : | Severely distorted<br>bulwarks, gangway<br>and hull | Slight damage to stem |

The bulwark from the main deck to the forward starboard side of the accommodation superstructure was severely indented and scraped. The gangway stored aft of this was distorted. The fairing between the poop deck and the boat deck was distorted and ripped. The compartment below the poop deck was severely indented at the forward corner.

Damage to *Celtic King*
