## SYNOPSIS

### 1.1 PARTICULARS OF CARDIFF BAY YACHT CLUB RIBS AND ACCIDENT

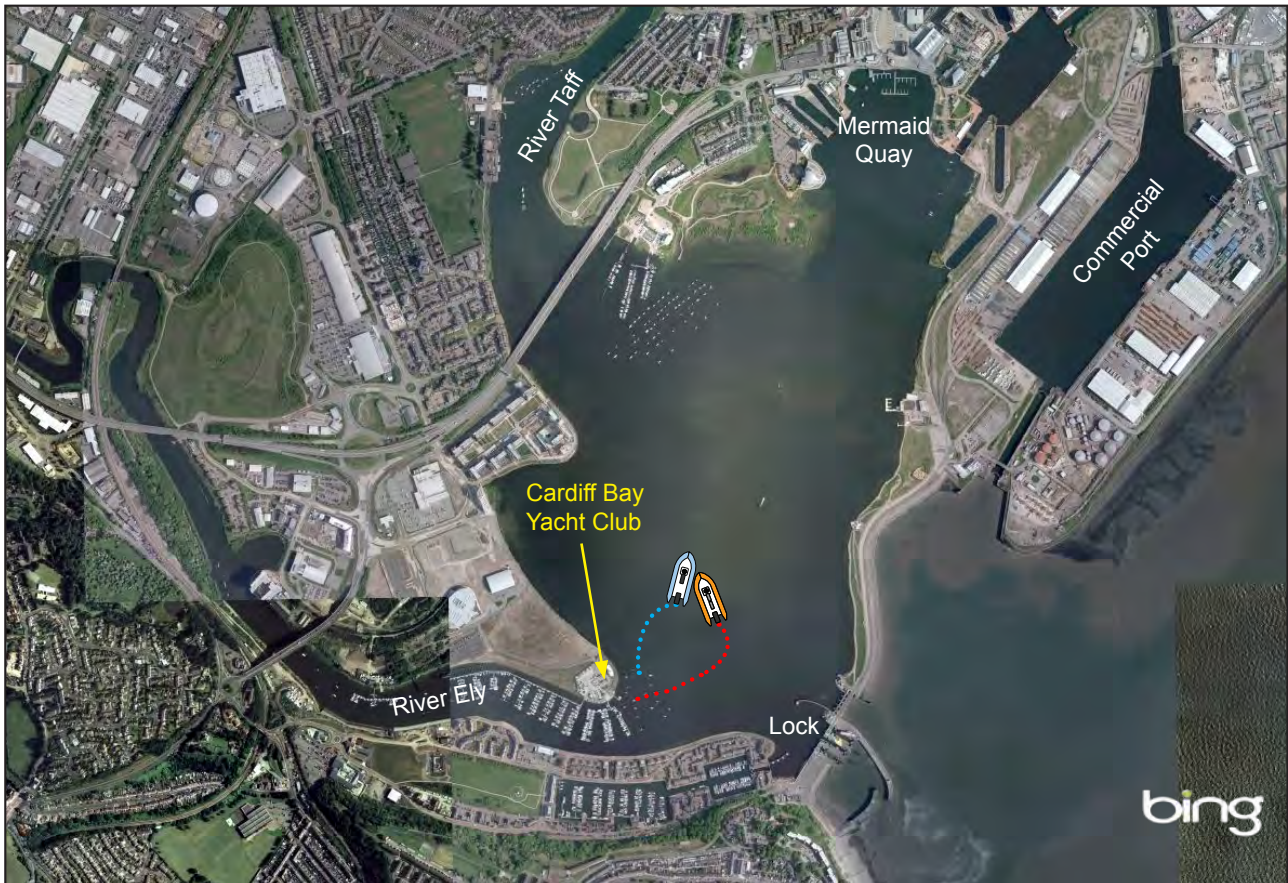
Figure 2

The RIBs driven by the two 17 year olds were behind the leading boats when they cleared the mooring area. As they entered clear water, the last two boats increased speed to about 20 knots and started to separate. One, a dark blue tubed Ribcraft

RIB, with its driver and six girls on board, set off to the left of the track taken by the first two RIBs. The other, an orange tubed Tornado RIB, with its driver, a house mother and four girls on board, set off to the right, passing close to moored craft on the outer edge of the moorings (**Figure 2**). The driver of this RIB soon became concerned about approaching too close to the locks, and swung the boat back to port towards the centre of the bay.

Track of the RIBs prior to the collision
