## SYNOPSIS

At 1955 on 5 December 2005, the UK registered 6326gt container feeder vessel, *Arctic Ocean*, was leaving Brunsbüttel Lock basin to turn east across the westbound fairway of the Elbe River to head for Hamburg. At the same time, the Gibraltar registered 1857gt general cargo vessel *Maritime Lady* was in the westbound fairway approaching the exit from the lock basin and heading for the North Sea.

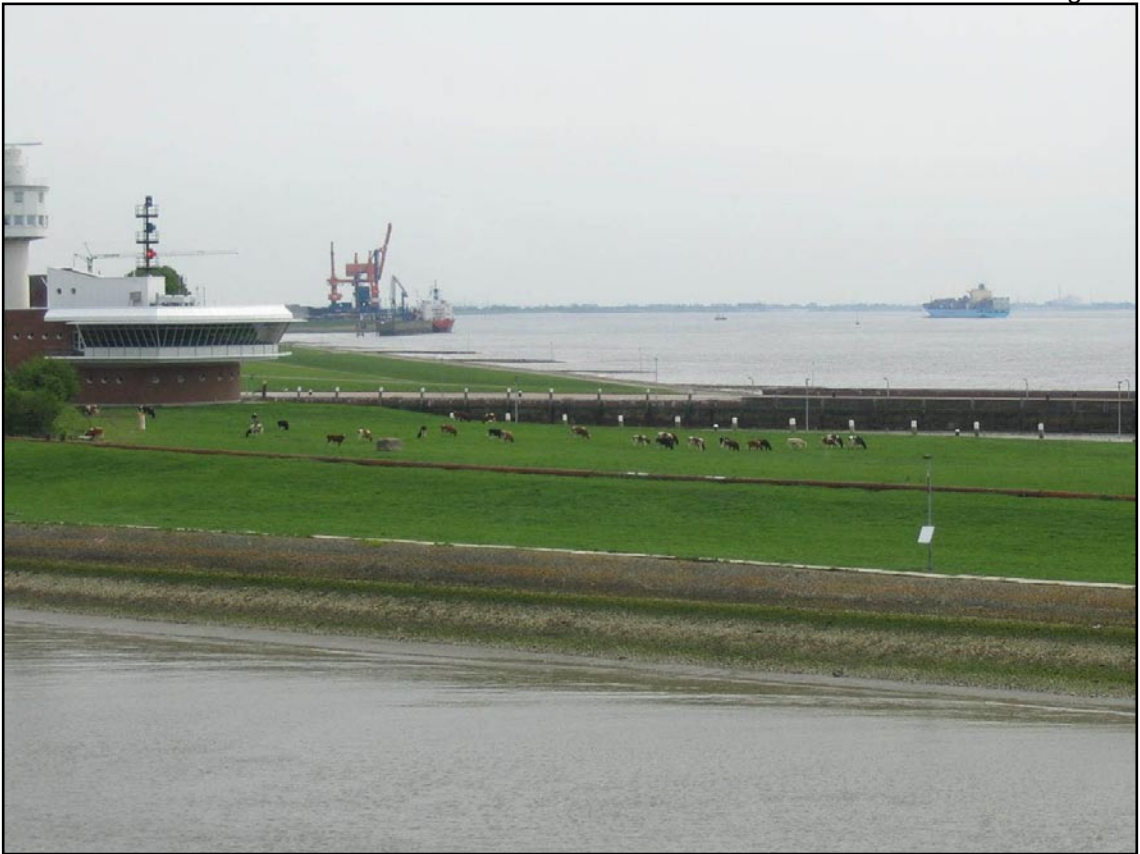
View east by day from bridge of *Arctic Ocean* in exit basin from Brunsbüttel Lock

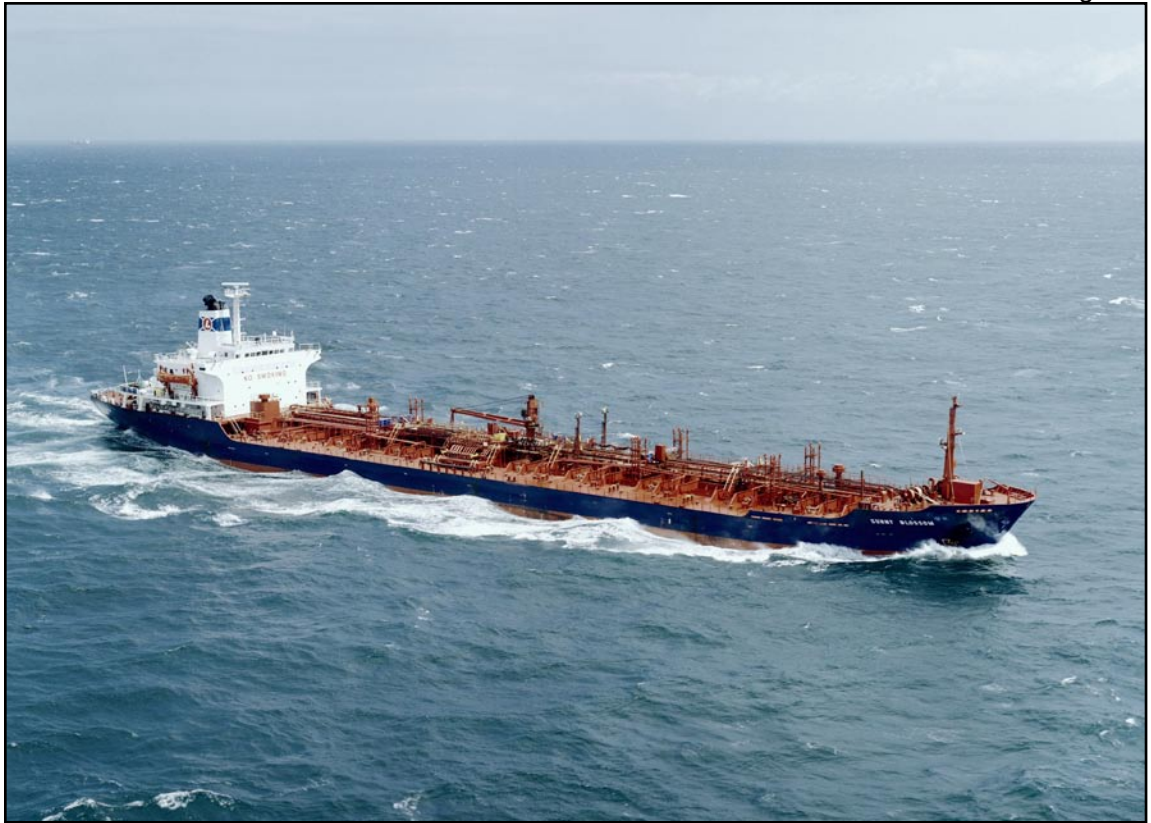
*Sunny Blossom*
