## Collision between the ro-ro passenger ferry *Red Falcon* and the motor cruiser *Phoenix* Thorn Channel, Southampton, England 29 September 2018

### SUMMARY

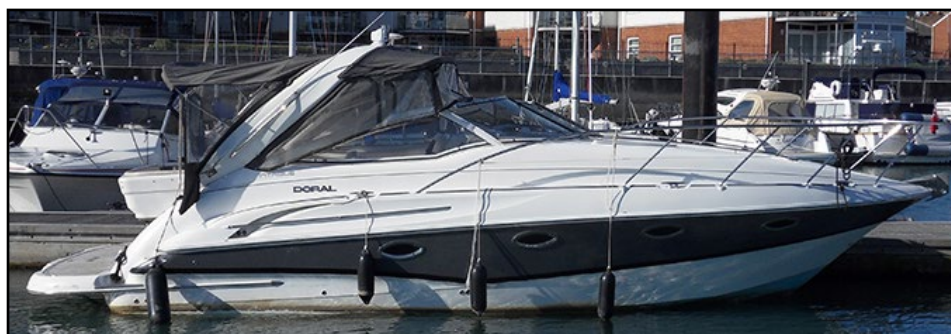
On 29 September 2018, the UK registered roll-on roll-off passenger ferry *Red Falcon* and the privately-owned motor cruiser *Phoenix* collided in the Thorn Channel, Southampton, England. Both vessels were heading for Cowes on the Isle of Wight. The ferry was carrying 20 crew and 182 passengers, and the motor cruiser had four persons on board. *Phoenix* was pinned against the ferry's bow for 18 seconds and was seriously damaged. *Red Falcon* was not damaged. There were no injuries and no pollution.

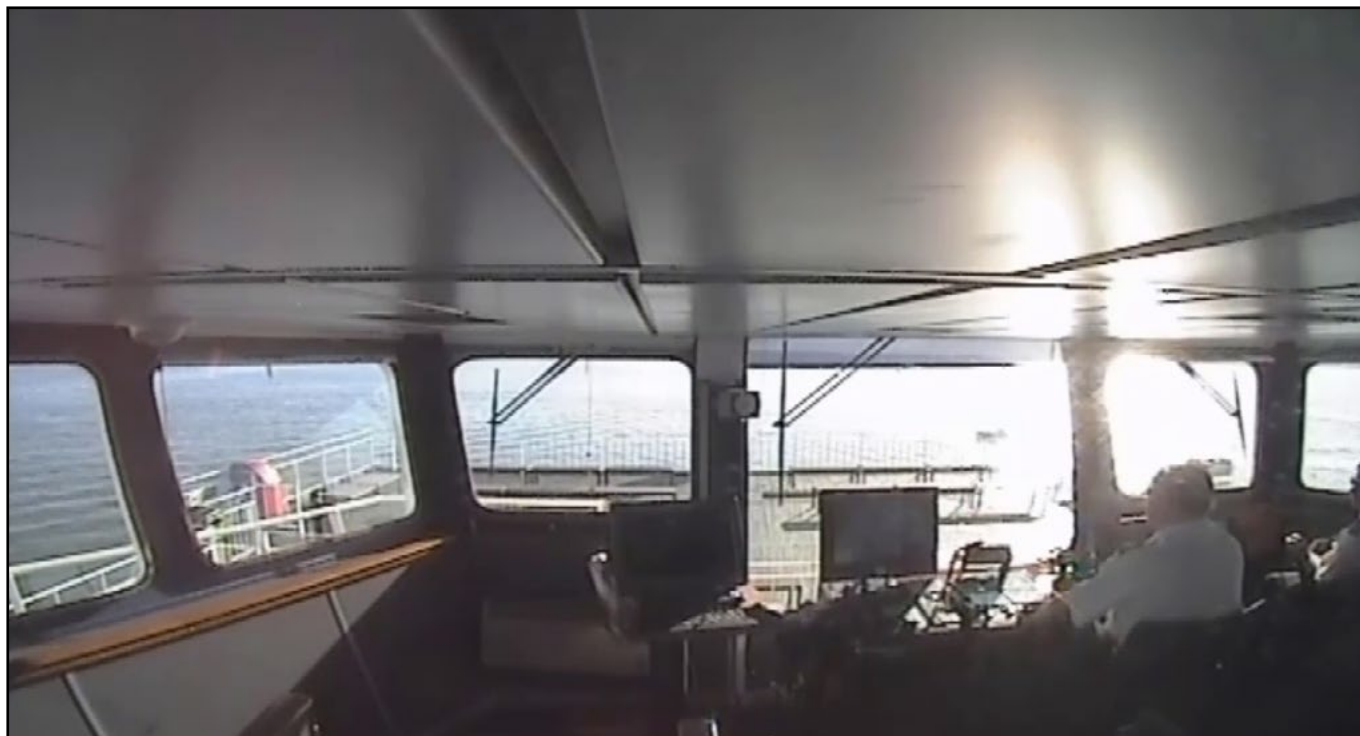
**Figure 9:** *Red Falcon's* bridge at 1635.07 (CCTV image)

Between 1634 and the collision just before 1636, not only was *Red Falcon*'s bridge team's focus largely to port, but also their view of *Phoenix* during this period was obscured by the sun's glare. The low sun (19°) was bearing 240° and therefore coincident with the bearing of *Phoenix* from *Red Falcon*. Although

the master wore sun shades over prescription spectacles, without the sun blinds, which were not used because of the imminent alteration of course to port, *Phoenix* would have been very difficult to see. Replay of the CCTV recordings indicated that *Phoenix* emerged from the sun's glare (Figure 9) only 14 seconds before it was lost from view as it entered the shadow zone ahead.

- Completed its own investigation report, which made recommendations connected with bridge manning, bridge watchkeeping procedures, the use of window blinds and the positioning of radar displays, which are intended to improve navigational watchkeeping practices.
- Issued a circular to all staff warning of the dangers of repetitive tasks and a fleet-wide letter regarding the conduct of navigation.
