## Dragging anchor by the general cargo vessel *Celtic Spirit* and subsequent collisions with *Atlantic Explorer* and *Celtic Warrior* River Humber, England on 1 March 2018

### SUMMARY

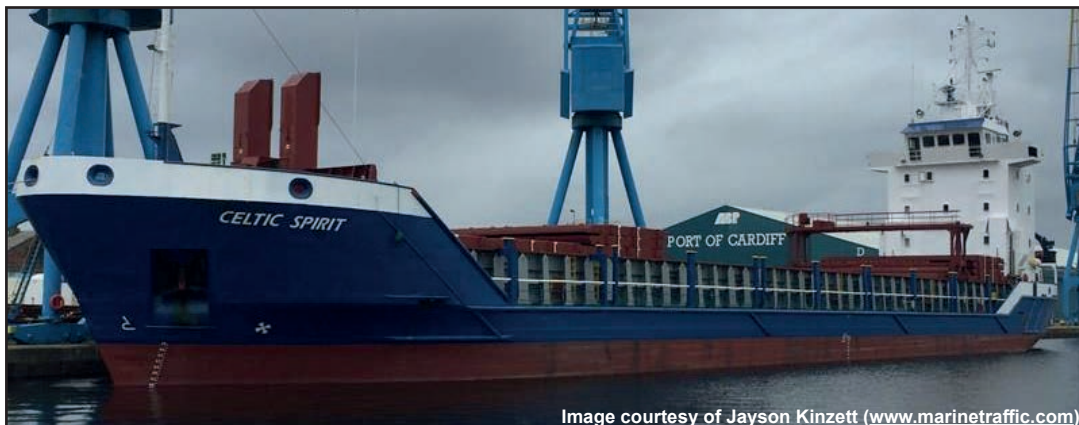
At 0246<sup>1</sup> on 1 March 2018, the UK registered general cargo vessel *Celtic Spirit* dragged its anchor in heavy weather on the River Humber, England. The vessel subsequently collided with the research and survey vessel *Atlantic Explorer* and the general cargo vessel *Celtic Warrior*, which were also at anchor. All three vessels sustained shell plate damage, but there were no injuries and no pollution.
