## Collision between two Formula 4 powerboats resulting in serious injury to one driver at Stewartby Lake on 2 July 2017

### SUMMARY

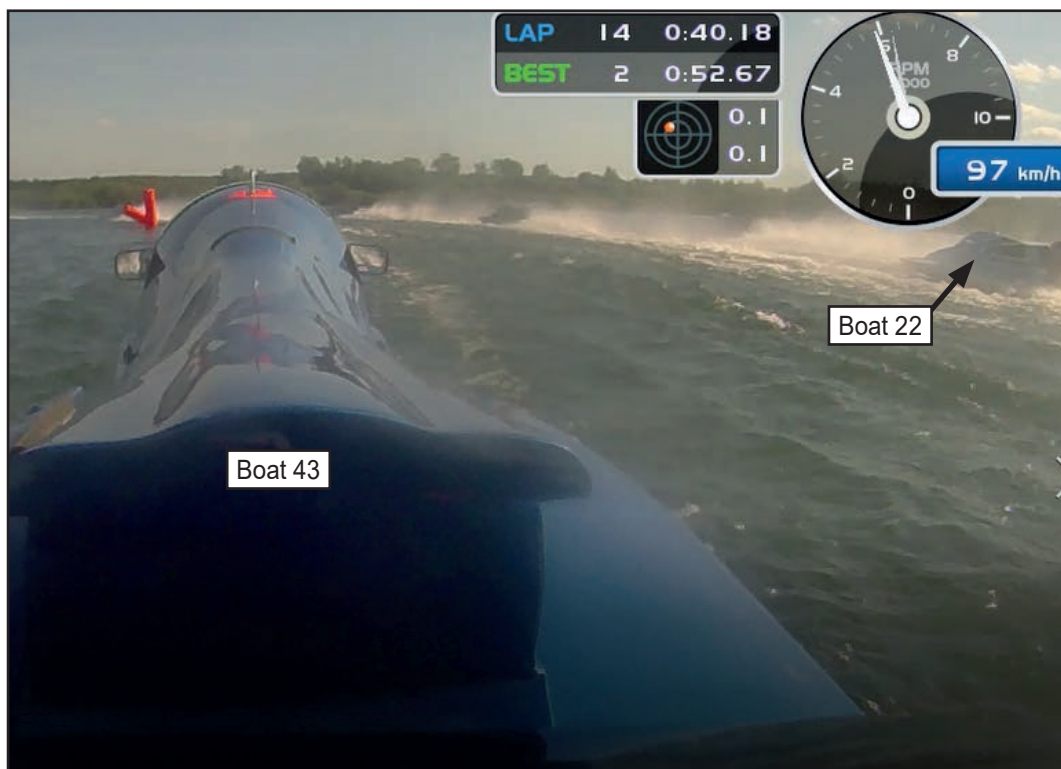
Shortly after the restart, at about 1709, *Boat 22* rounded Turn-1 on the outside and just ahead of *Boat 43* (**Figure 3**). As *Boat 22* began to straighten and head toward Turn-2 it suddenly veered violently to port and into the path of *Boat 43*. Travelling at a speed of 100km/h (62mph), *Boat 43* collided head-on with *Boat 22*'s port hull (**Figure 4**). The force of the impact caused *Boat 43* to flip into the air, roll to starboard and capsize. *Boat 22* remained upright but its port hull was holed and it began to sink. The OOD saw that an incident had occurred, raised a yellow flag and despatched the safety boats to the scene.

**Figure 3:** Picture from *Boat 43* onboard camera having just rounded Turn-5 with Turn-1 buoys visible

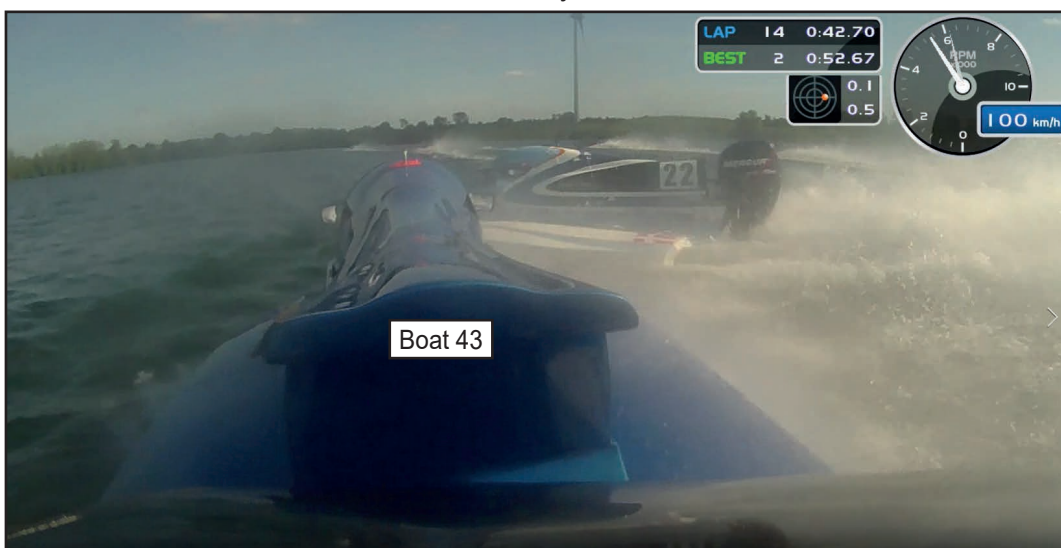
**Figure 4:** Picture of *Boat 43* and *Boat 22* immediately prior to collision

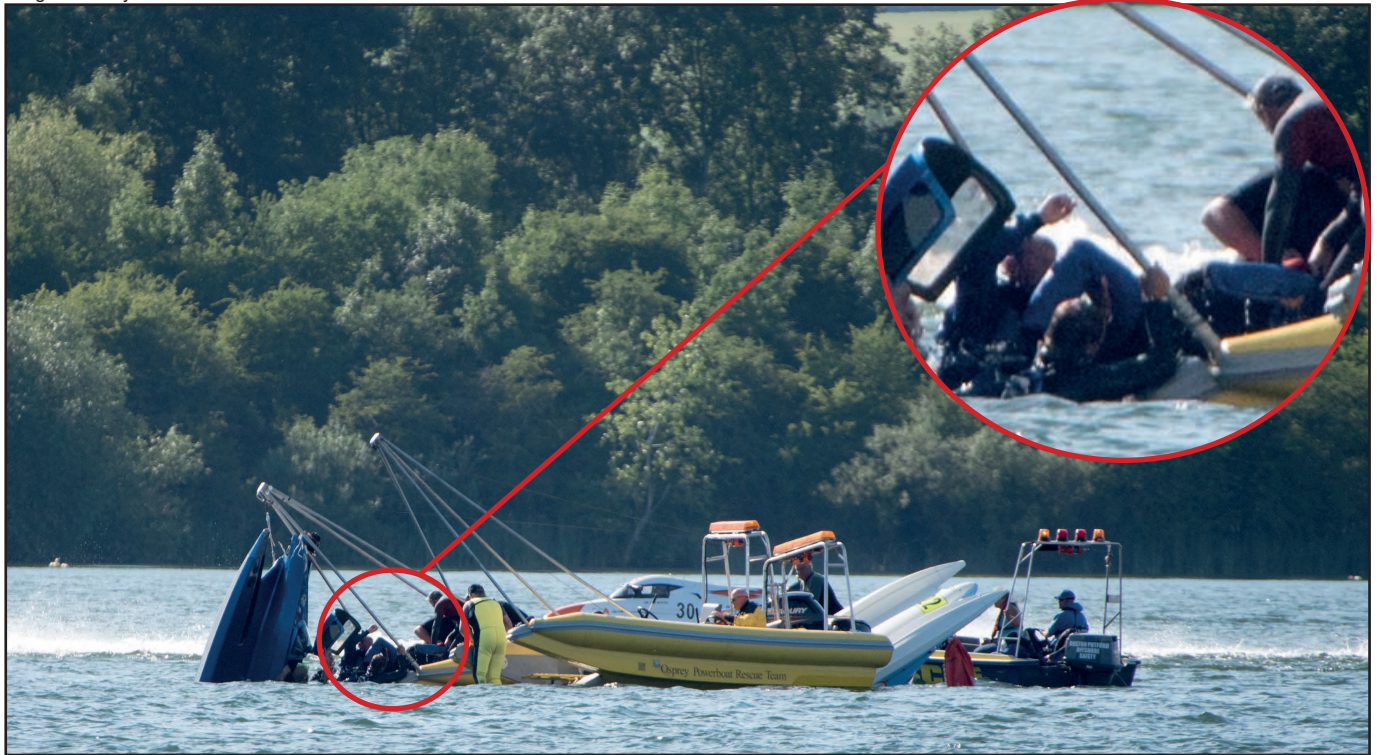
Once *Boat 43* was vertical, with its cockpit clear of the water, the rescue divers located and released the driver's seat harness buckle. About 5 minutes after the collision, the rescue boat crew pulled the unconscious driver into their boat (**Figure 6**); he was not breathing and his airway was full of water.

**Figure 6:** *Boat 43's* driver being pulled into a rescue boat

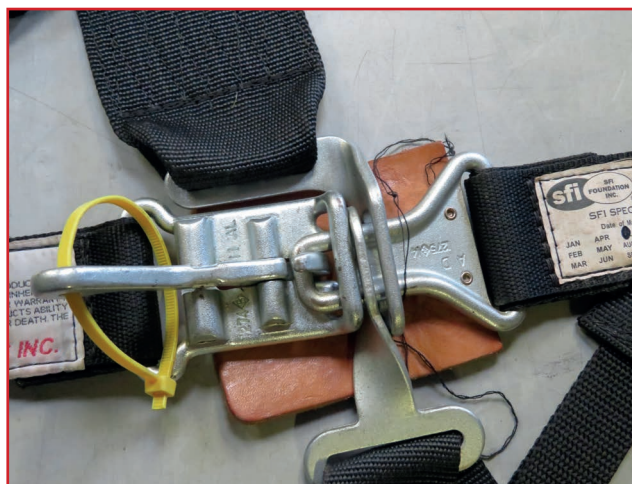
- The canopy could be opened from both inside and outside the cockpit using the main handle.
- The canopy emergency release pin was a tight fit within the hinge and it required force to pull it out.
- The rim of the steering wheel was deformed, but it could still be removed as intended.
- The driver's carbon fibre seat was cracked; but,
- The cockpit safety cell remained intact.

It was noted that a cable tie had been fitted to the harness buckle's release lever (**Figure 10 inset**). This was a modification made by many drivers to make it easier to locate and pull the lever with a gloved hand.

Further investigation into the cause of the tight-fitting canopy hinge pin revealed that the driver had previously replaced the boat builder's metric-sized hinge with an imperial-sized spare but had retained the original release pin.
