## Collision between *Petunia Seaways* and *Peggotty* on the River Humber 19 May 2016

### SUMMARY

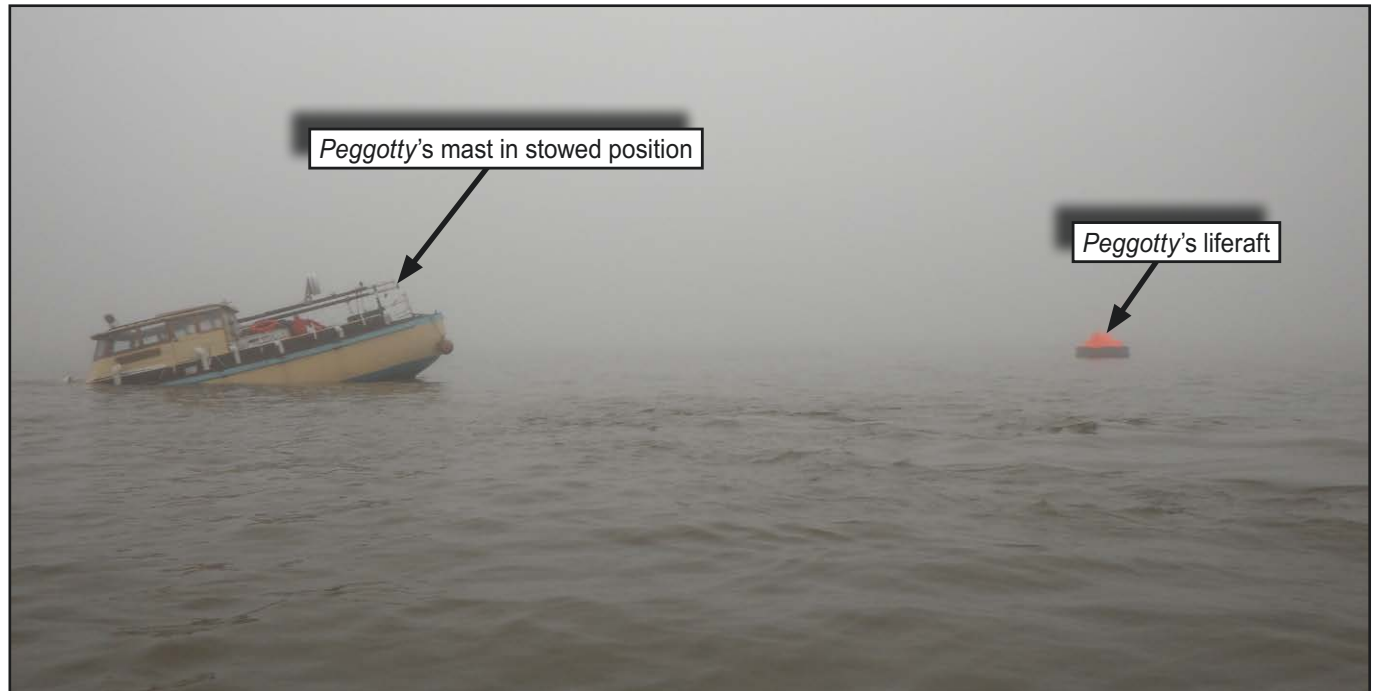
**Figure 1:** *Peggotty* following the collision (note: stowed mast and deployed liferaft)

As *Petunia Seaways* continued on its voyage, *Peggotty*'s crew were shocked but uninjured. *Peggotty*'s upper structure had been seriously damaged, and as the skipper began to gather his belongings together he saw that the forward cabin space had water seeping up through the deck. At 0454 *Peggotty*'s skipper called VTS and advised that the launch had been 'brushed by a ferry' and that *Peggotty* was taking on water and required assistance. During the resultant VHF conversation, the VTSO established that *Peggotty*'s own bilge pumps were working but not able to cope with the volume of water ingress, and that its position was just north of the Middle Burcom buoy. At 0457:38, encouraged by the buyer's representative, the skipper called a "Mayday" on his VHF as *Peggotty* began to sink by the bow.

*Peggotty* was a historic launch and of sound construction when built. However, at the time of the accident the launch was over 70 years old and it had not been subjected to a structural survey for at least 20 years. It is without doubt that *Peggotty*'s wooden hull failed in the collision with *Petunia Seaways*. As no direct source of water ingress was visible, it is likely that the launch's planking failed along the upper limit of the lower hull's fibreglass coating, leading to catastrophic damage and making the loss of the launch inevitable.
