## SYNOPSIS

On 11 February 2015, the United Kingdom registered container ship *Ever Smart* collided with the Marshall Islands registered oil tanker *Alexandra 1* near the entrance to the buoyed approach channel in Jebel Ali, United Arab Emirates. The container ship was outbound at a speed of 12 knots and had disembarked its pilot. The tanker was inbound and was moving very slowly ahead while waiting for the pilot from the container ship to board. Both vessels suffered major structural damage to their bows but there were no injuries or pollution.

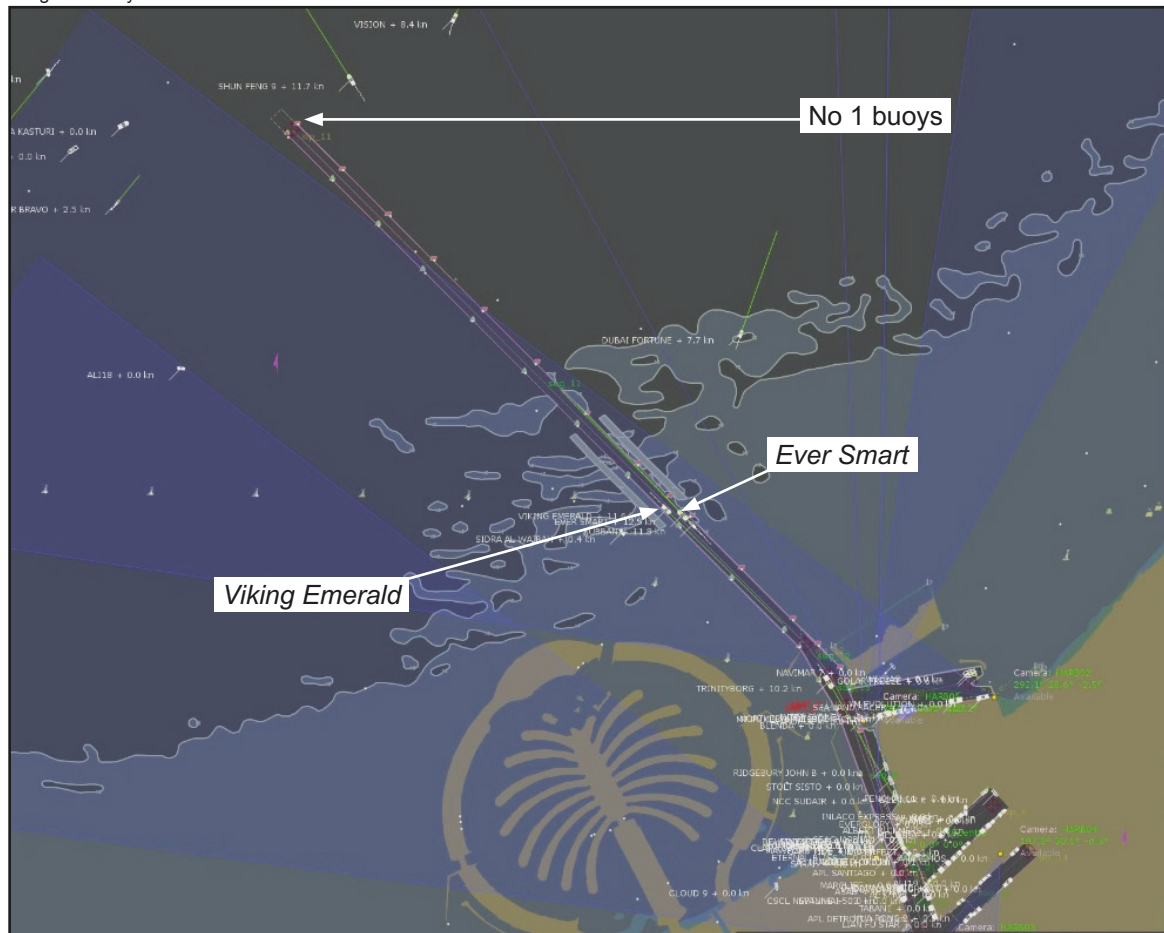
At 2302 *Ever Smart* passed the inbound cargo vessel *Trinityborg*. Seven minutes later, the container ship passed the inbound car carrier *Viking Emerald* (**Figure 2**). *Ever Smart* was making good a speed over the ground (SOG)<sup>3</sup> of 12 knots (kts).

**Figure 2:** VTS radar showing *Ever Smart*'s position at 2309

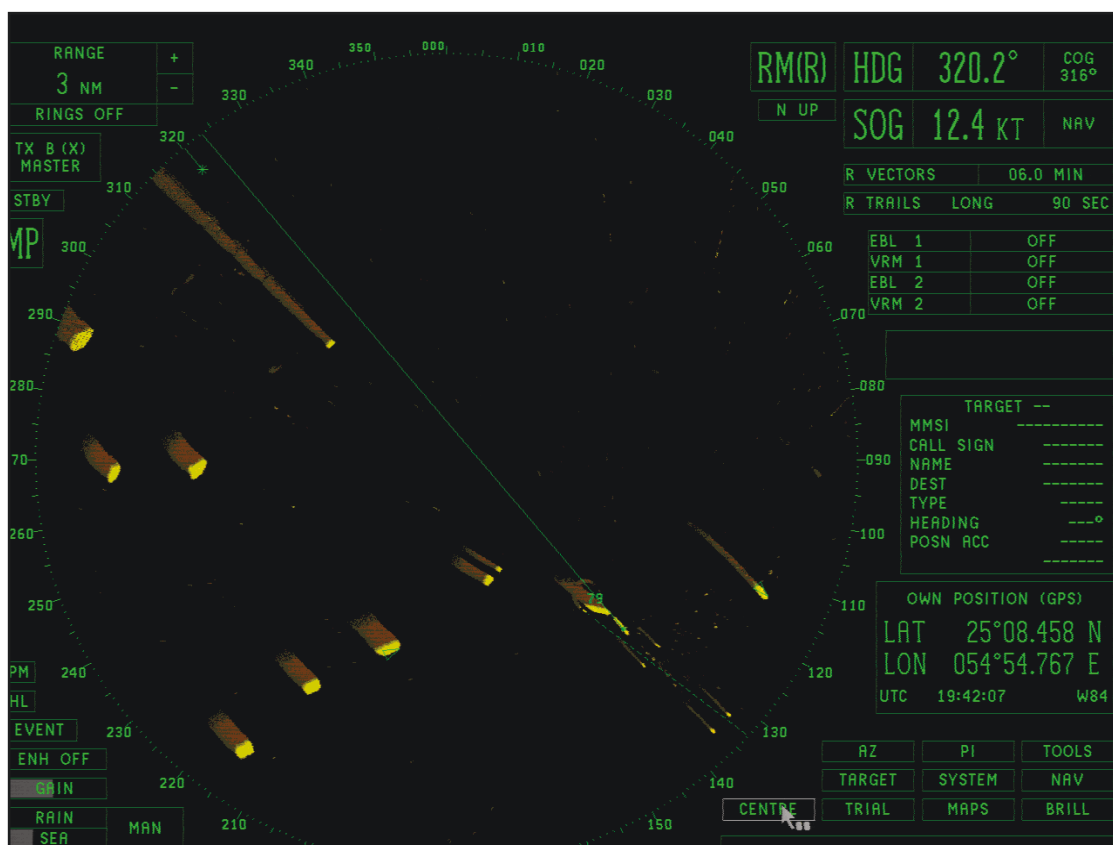
**Figure 9:** *Ever Smart* – port radar display at 2342:07

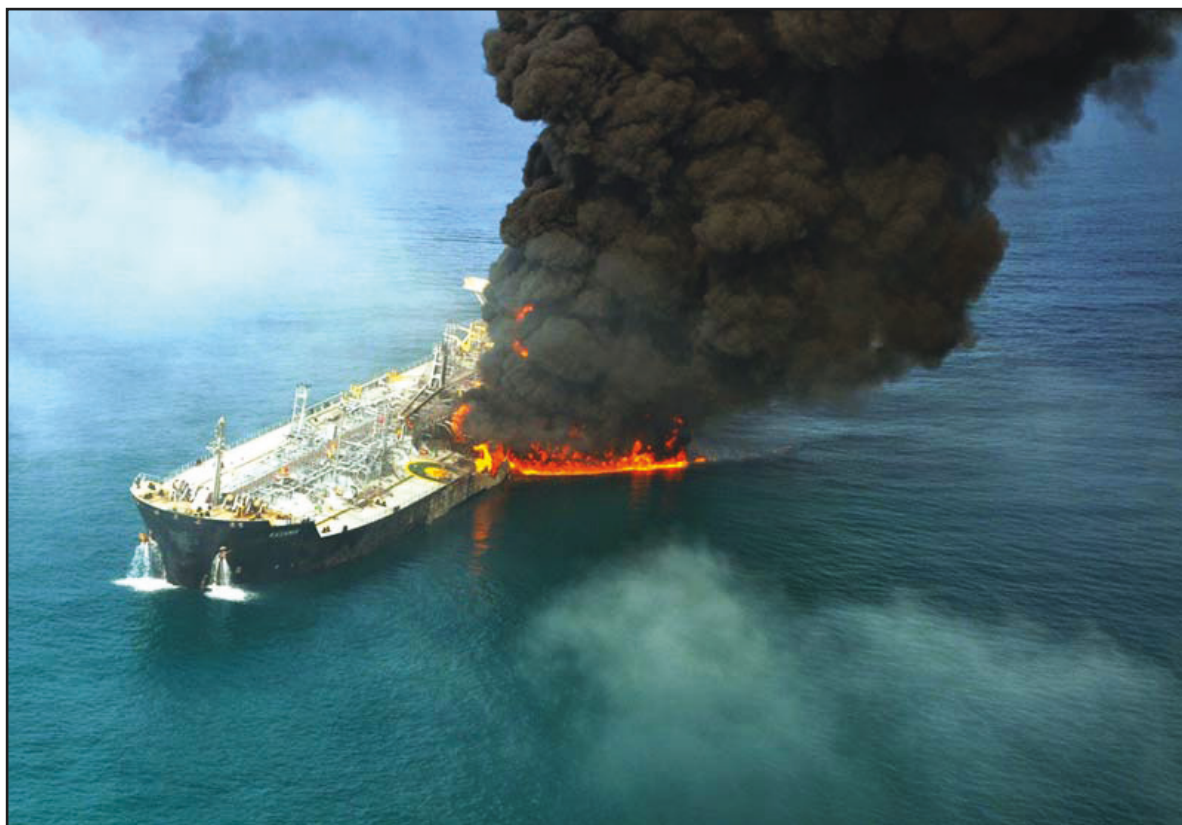
A port to port passing had been agreed but *Kashmir* was turned across the channel in order to avoid the green (western) No6 buoy. Once the vessel was clear of the buoy, starboard helm was used to manoeuvre the vessel back towards the western side of the channel. However, collision with *Sima Saman*, which was in the centre of the channel, could not be avoided. *Sima Saman*'s bow penetrated *Kashmir*'s hull in the vicinity of the tanker's port manifold. The subsequent fire and explosion (**Figure 14**) caused severe damage to both vessels. Two of the tanker's crew were injured. There was no pollution.

**Figure 14:** *Kashmir* on fire in the Jebel Ali approach channel

Following the accident, among other things, DP World UAE introduced measures to restrict the passing of certain types and sizes of vessel in the channel (see paragraph 1.6.5).
