## SYNOPSIS

At 0449 on 29 October 2008, the UK registered general cargo vessel *Scot Isles* was in collision with the Egyptian bulk carrier *Wadi Halfa* in the Dover Strait.

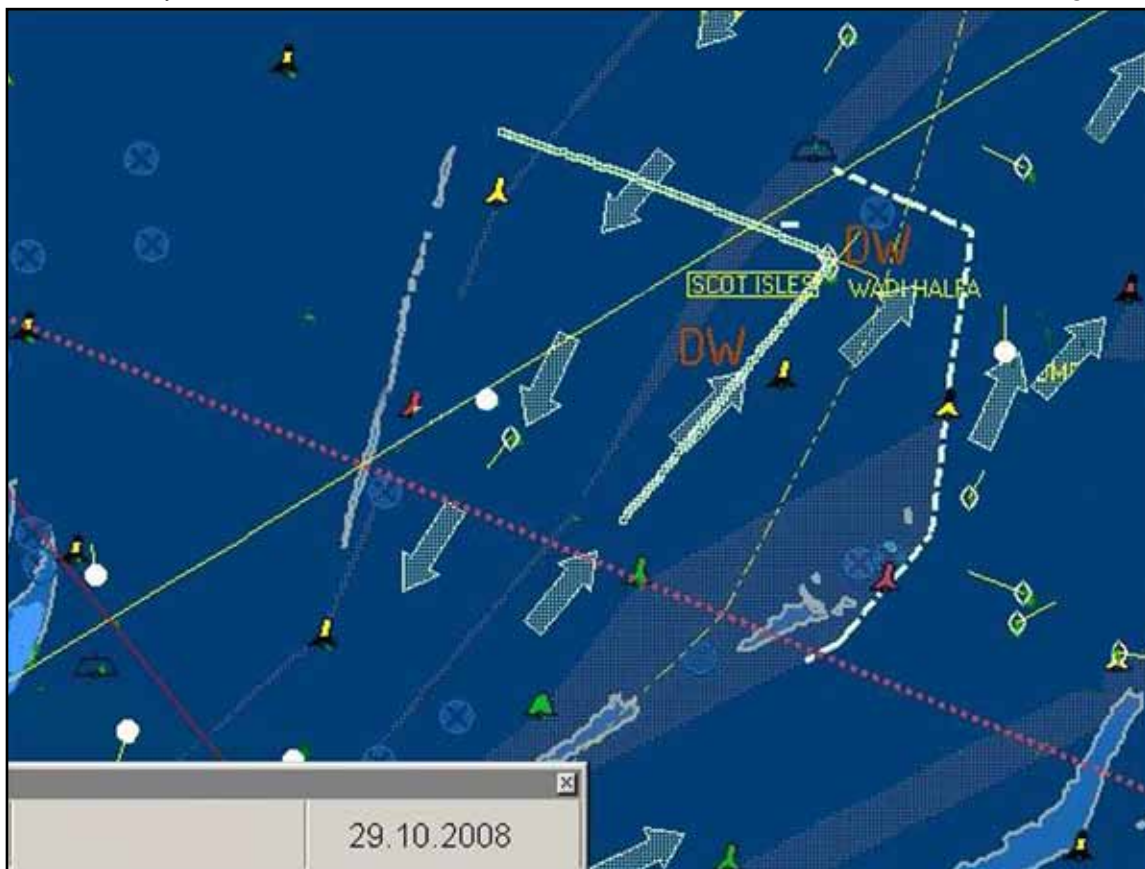
Figure 2

At 0410, *Scot Isles* altered course to 109°(T), and at 0421 she began to cross the SW traffic lane of the TSS. The vessel's position was not plotted on the chart after 0400, so this reconstruction is based on radar replay information obtained from the Channel Navigation Information Service (CNIS) at Dover following the accident (**Figure 2**).

Radar replay screen shot from CNIS, 0449 29 October 2008
