## SYNOPSIS

At 1840 on 12 January 2011, the 16.84m prawn trawler *Silver Chord* (**Figure 1**) collided with the 14.99m prawn trawler *Sapphire II* (**Figure 2**). At the time of the collision, *Sapphire II* was stopped in the water while her skipper, who was operating single-handed, recovered the vessel's fishing gear. *Silver Chord* was making 5.5 knots (kts) as she proceeded towards Stornoway after a day's fishing.

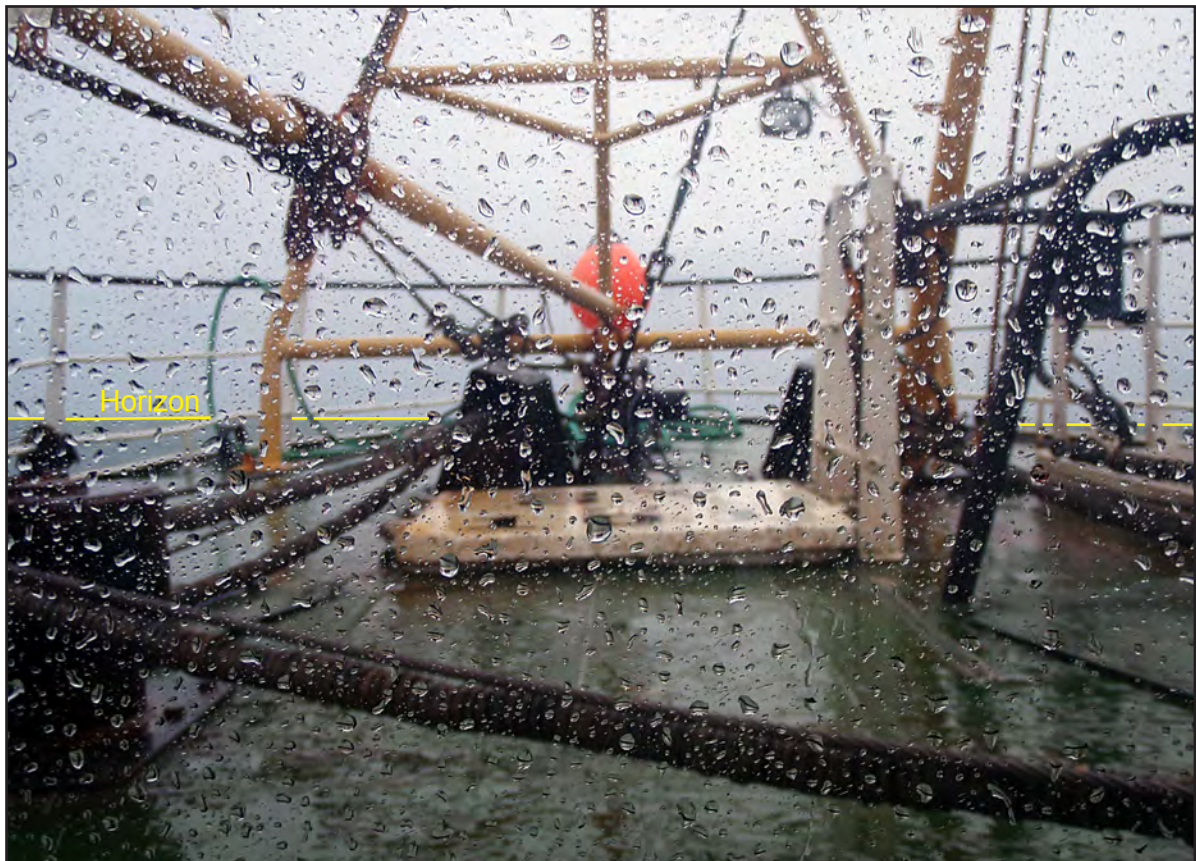
Figure 8

However, because of the restricted view ahead from the wheelhouse (**Figure 8**), the skipper's view of *Sapphire II* could have been obscured by the shelter or the deck fittings, particularly during the early stages of the passage. Nevertheless, as the distance between the vessels reduced, *Sapphire II*'s lights would inevitably have become brighter and more apparent. Therefore, notwithstanding the partially obstructed view ahead, the skipper's visual lookout during his periodic visits to the wheelhouse in the 52 minutes from leaving the fishing grounds, was not effective.

*Silver Chord* - view ahead from the steering position

1. The shelter added to *Silver Chord* in the 1980s and the fitting of deck equipment onto the shelter in the 1980s, adversely affected the visibility ahead from the wheelhouse, but no mitigating measures had been adopted. [2.6]

Has significantly improved the forward facing visibility from the wheelhouse steering position by fitting a raised observation compartment on the centreline of the wheelhouse deck head.
