## SYNOPSIS

At 0540 on 10 March 2012, the bulk carrier *Seagate* and the refrigerated-cargo ship *Timor Stream* collided while transiting open waters, in good conditions of visibility, 24 nm north of the Dominican Republic. There were no injuries, but both ships were badly damaged and there was some minor pollution.

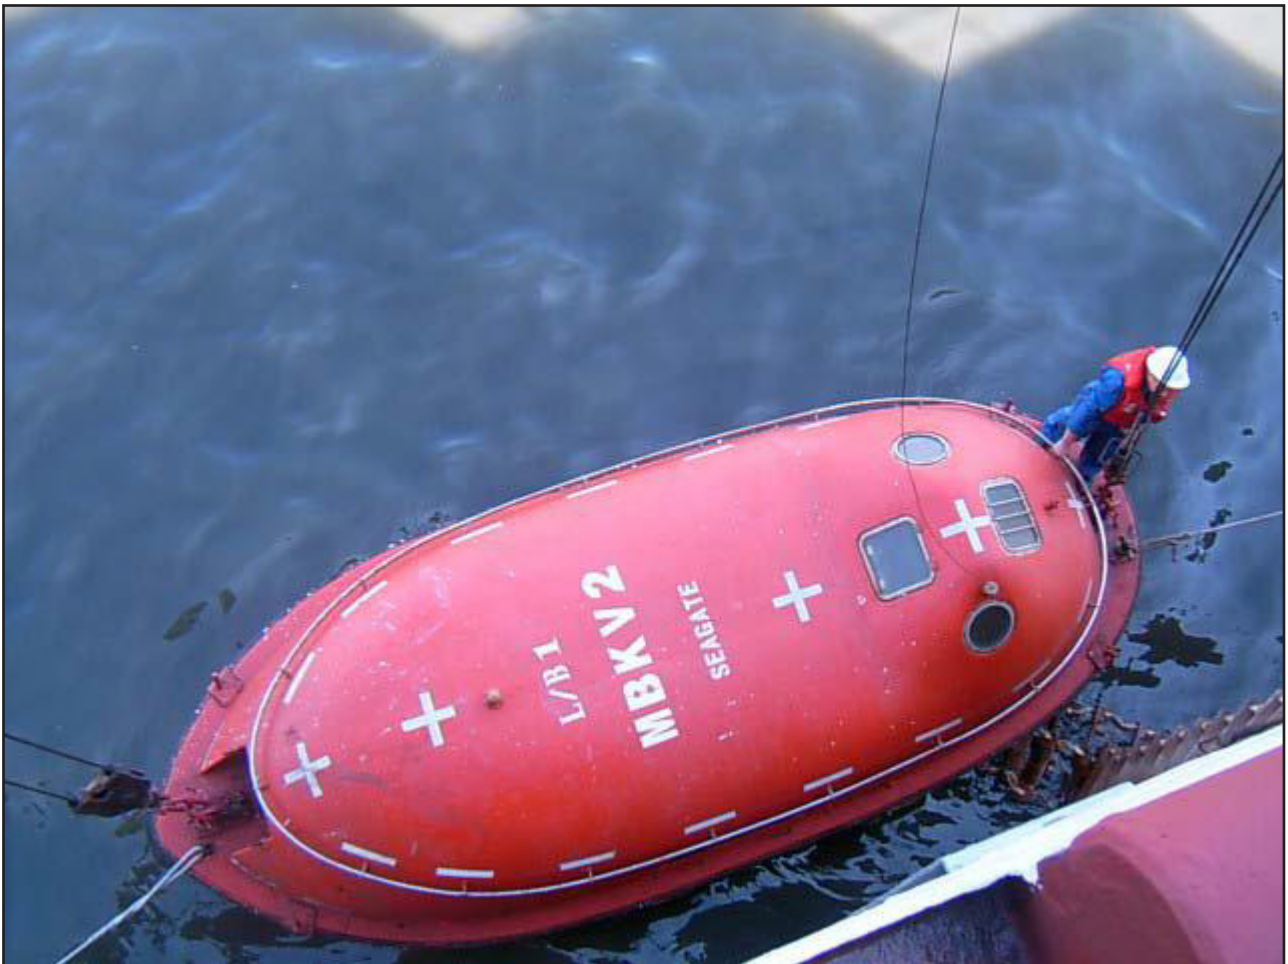
Also at around 0600, *Seagate's* master instructed the chief officer to prepare the port side lifeboat and liferaft for launching. The chief officer took a motorman, and told him to lower the lifeboat into the water. The chief officer, who was not wearing a lifejacket, then climbed onto the top of the lifeboat (**Figure 9**), went inside it and attempted to disengage the lifeboat's fall blocks from their release hooks. The chief officer was not familiar with the release mechanism and was unable to release the hooks.

**Figure 9:** Pre-accident photograph showing *Seagate's* starboard lifeboat for illustration purposes

At about 0630, *Seagate's* chief officer climbed onto the bow of the port lifeboat and attempted to disengage the lifeboat's release hooks manually. Shortly afterwards, at around 0635, he fell overboard from the lifeboat, landing in the sea between the lifeboat and the ship's side. *Seagate's* master used the VHF radio to broadcast that a man was overboard, and the chief engineer threw a lifebuoy into the sea close to the chief officer. The chief officer held onto the lifebuoy and the liferaft boarding ladder. *Battered Bull's* master manoeuvred his yacht (**Figure 10**) close to the chief officer and a manoverboard recovery net was rigged over the yacht's side (**Figure 11**). The chief officer swam, with the lifebuoy, to *Battered Bull* and their crewmen pulled him on board. The chief officer was covered in oil, exhausted and disorientated, but was uninjured.
