Report on the investigation of  
the collision between the passenger vessel  
***Millennium Time***  
and the motor tug  
***Redoubt***  
with 3 barges in tow  
on the Kings Reach, River Thames, London  
17 July 2014

At 1414 on 17 July 2014, the passenger vessel *Millennium Time* collided with the motor tug *Redoubt* and its towed barges between Blackfriars Road Bridge and Waterloo Bridge on the River Thames, London. Both vessels were damaged and nine passengers sustained minor injuries. There was no pollution.

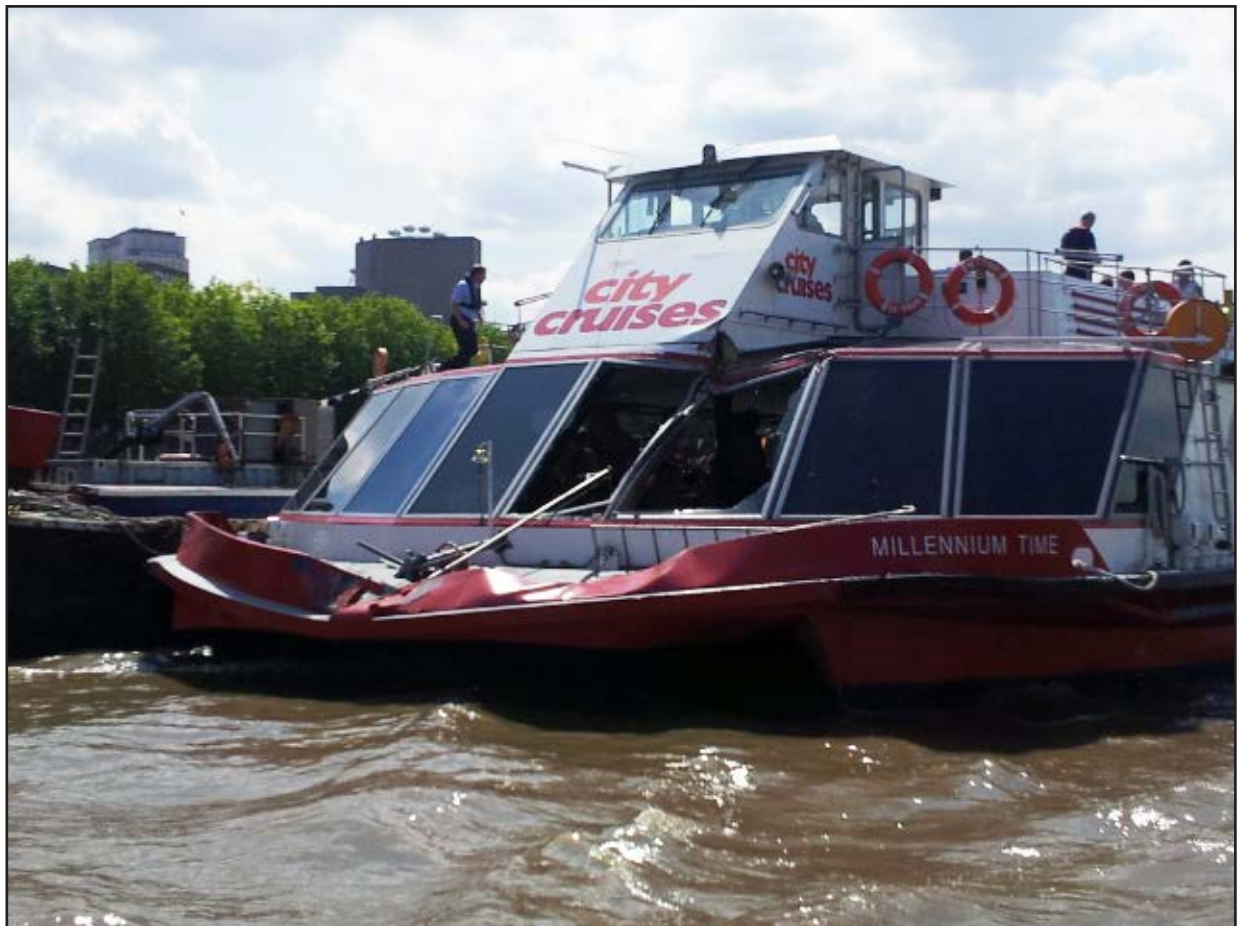
**Figure 8:** Damage to *Millennium Time*

*Millennium Time* sustained structural damage to its bow, and windows at the forward end of the passenger saloon were broken (**Figure 8**). The vessel was taken out of the water and took 32 days to repair.

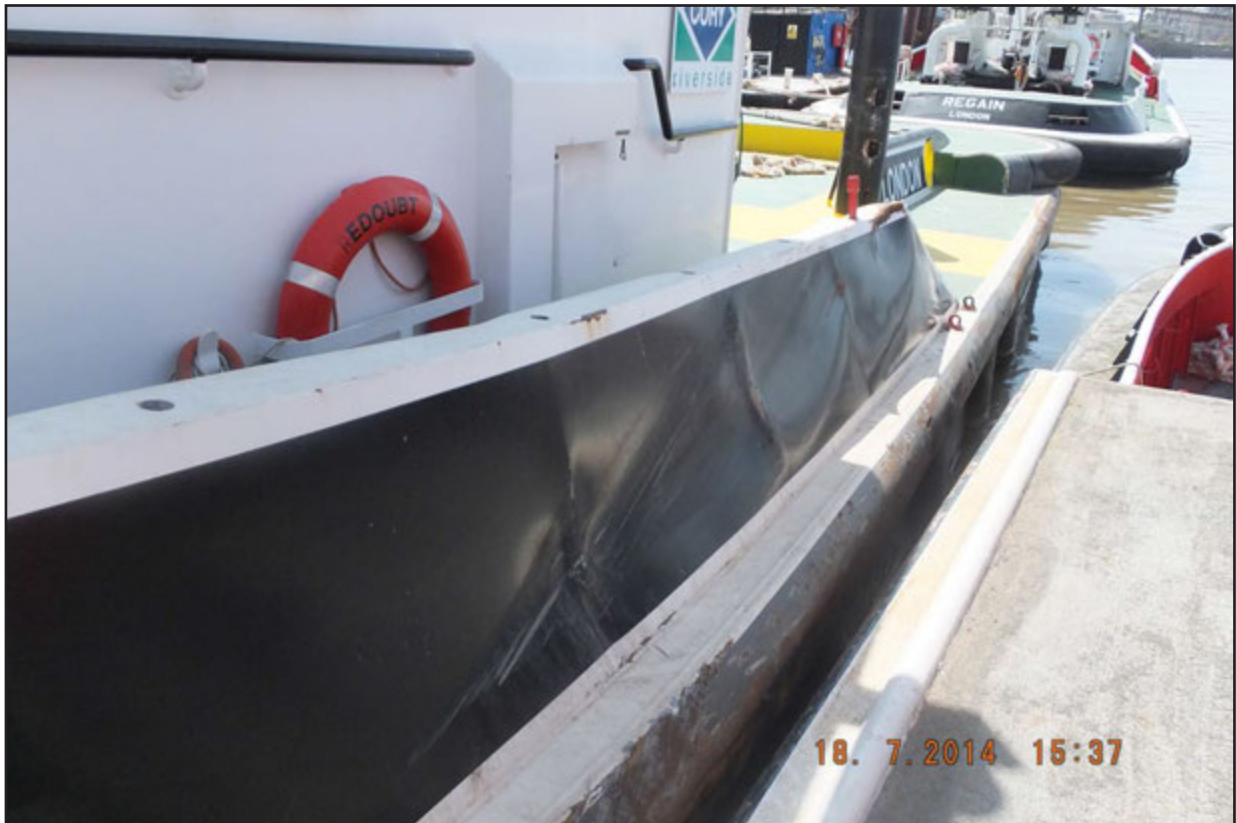
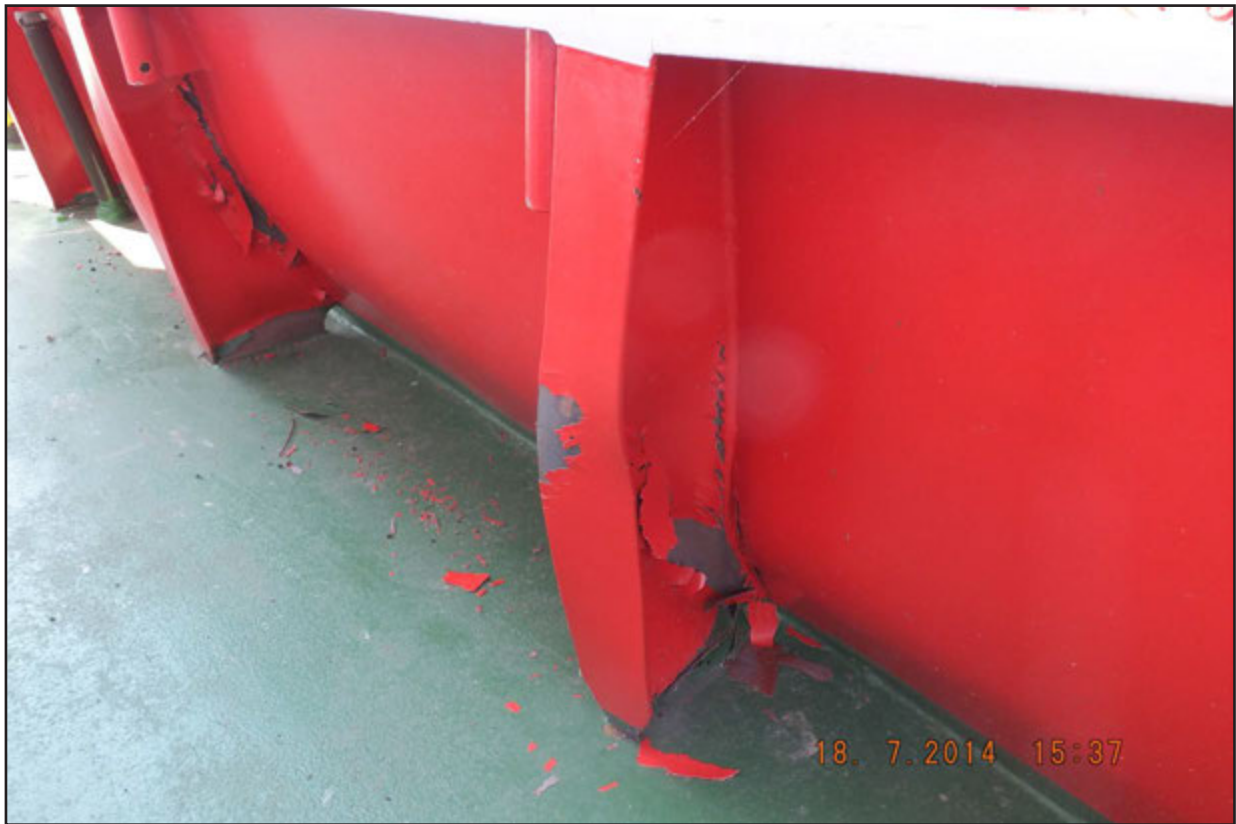
**Figure 9:** Damage to *Redoubt*

The bulwarks on *Redoubt*'s port shoulder were pushed inboard (**Figure 9**), which resulted in four penetrations through the main deck. The repair included the removal and replacement of 5m of bulwark plating and capping. *Redoubt* was out of service for 10 days.

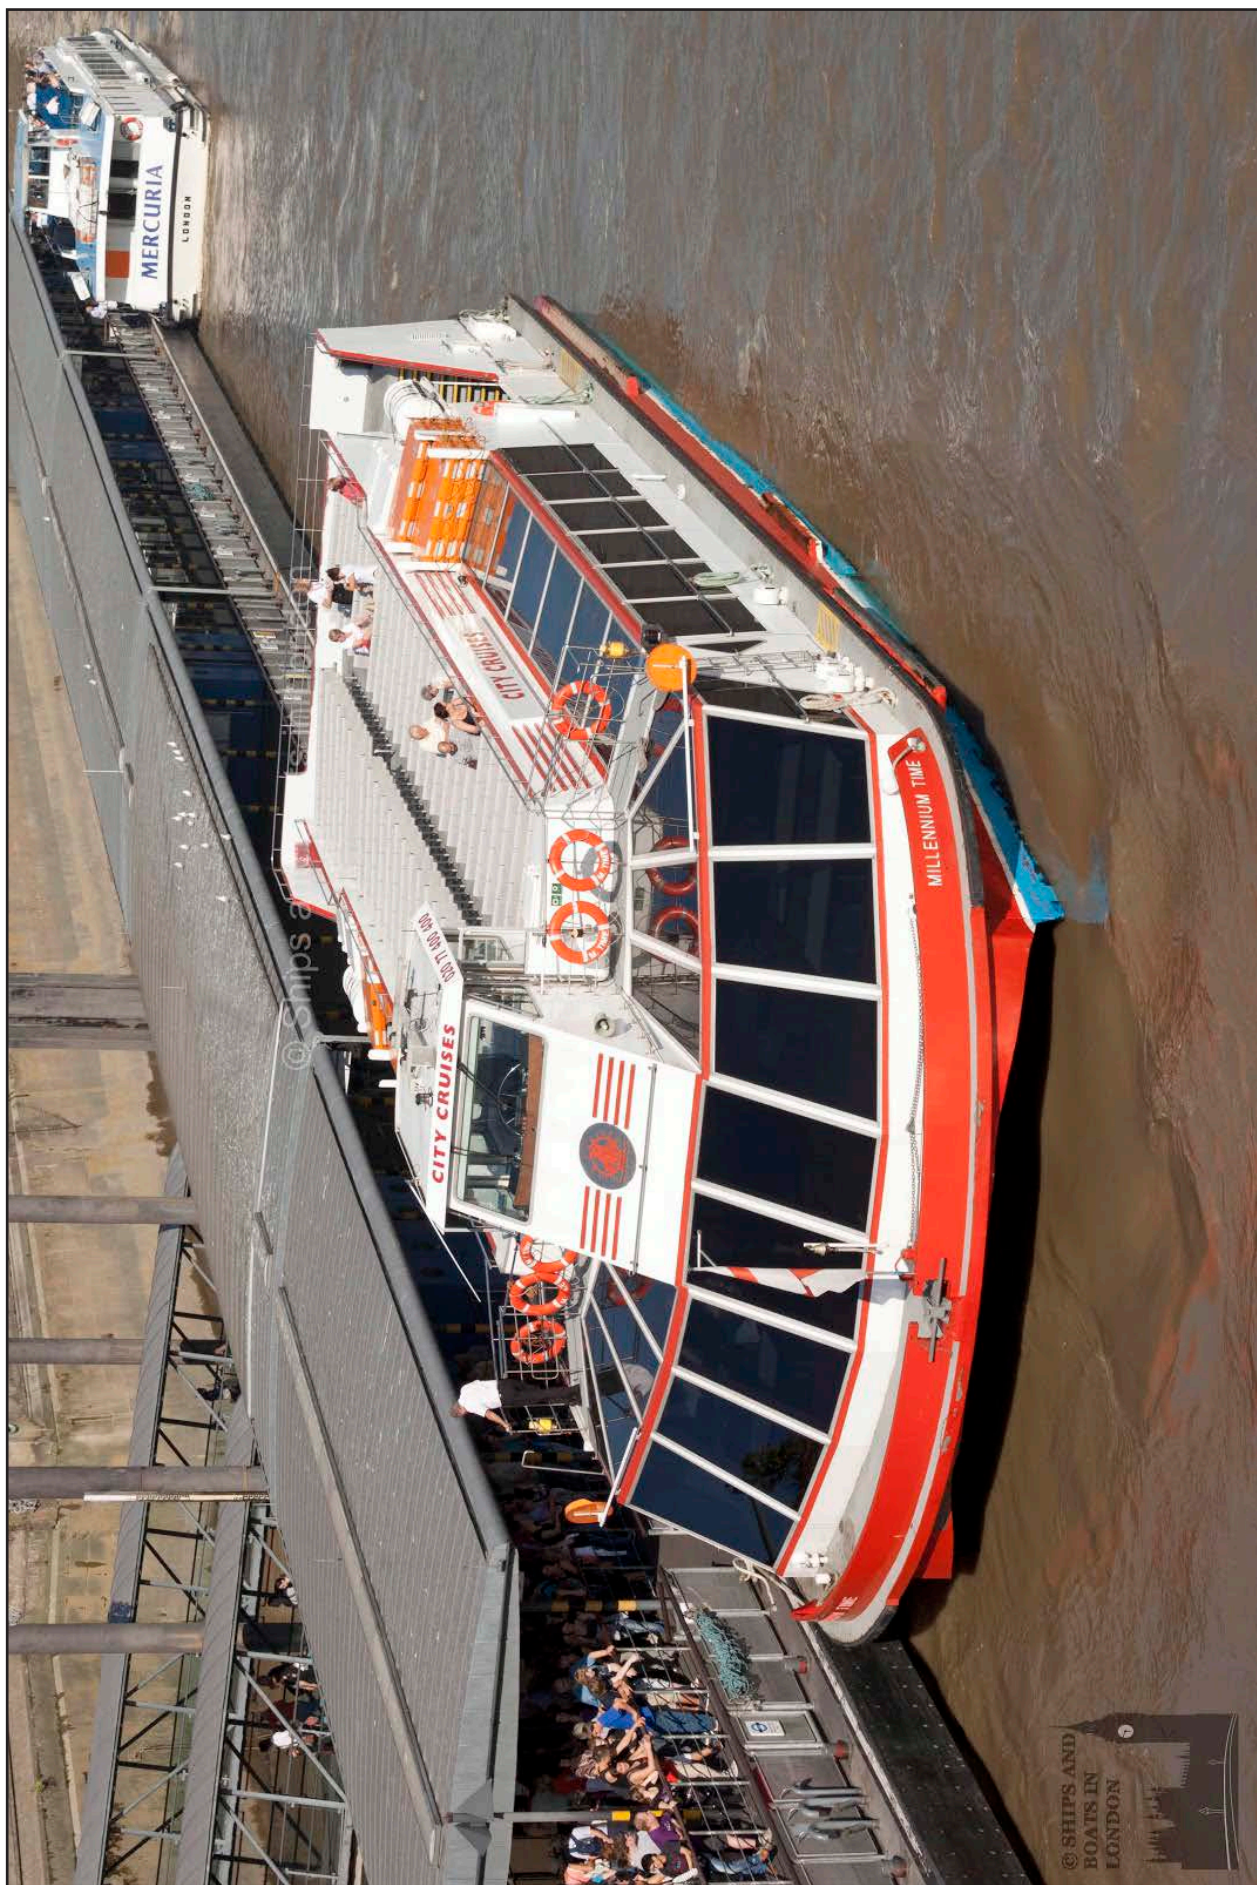
*Millennium Time* was one of four M2 class steel-hulled catamarans (**Figures 10 and 11**) built by Vosper Thornycroft UK at Woolston, Southampton and owned and operated by City Cruises Plc. The other vessels were *Millennium Dawn*, *Millennium of Peace* and *Millennium City*. The catamarans, which entered service in 1999, were 31.58m in length overall (LOA) with a beam of 10.9m and a draught of 1.48m. They were among the largest passenger vessels operating on the Thames. Powered by twin 350hp Cummins main engines, the M2 class were capable of a maximum speed of approximately 9 knots. The lower deck passenger saloon was enclosed with large windows. The top deck was open. The vessels were constructed with watertight sub-divisions and fitted with 12 bilge pumps and float alarms.

*Millennium Time*'s wheelhouse was at the forward end of the top deck (**Figures 10 and 11**) and its equipment included:

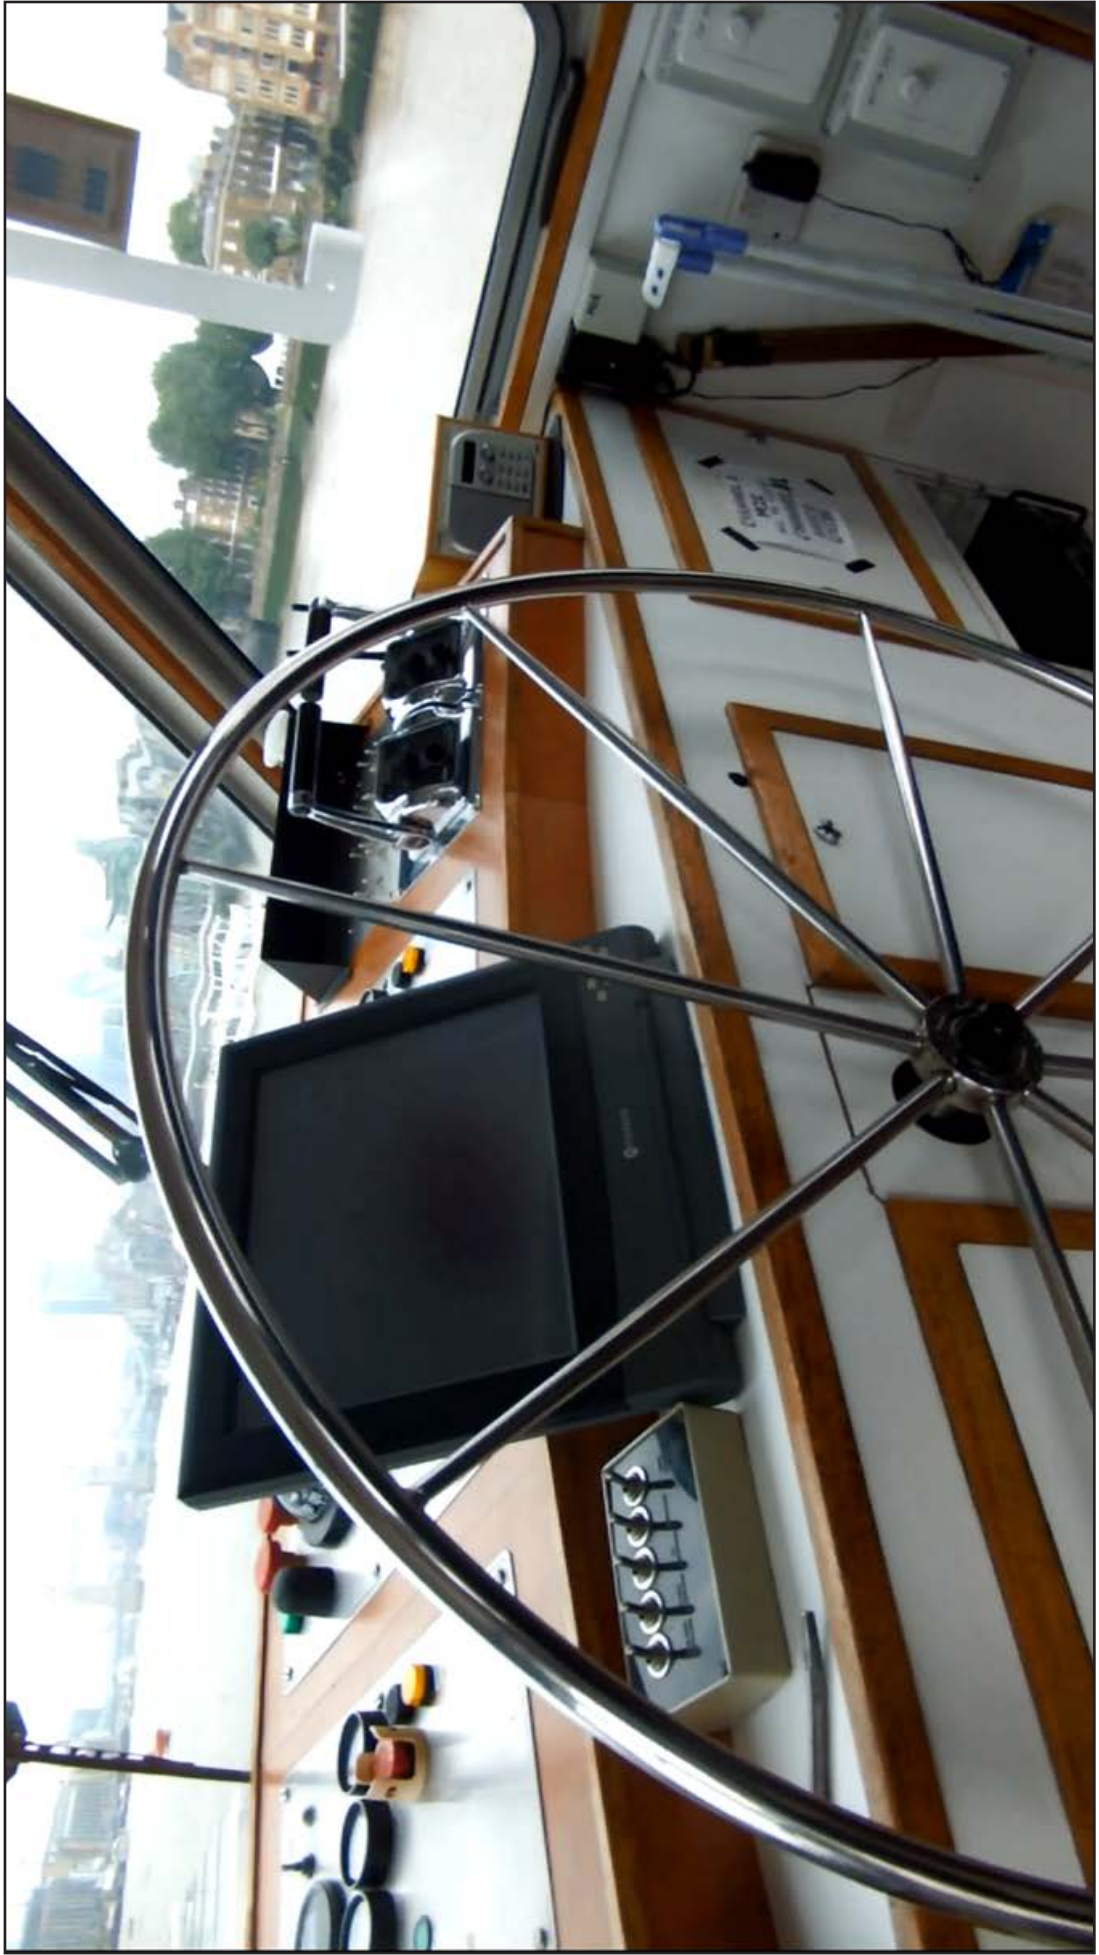
**Figure 13:** *Millennium Time*; steering wheel

The vessel's steering system was examined by MAIB inspectors. The large steering wheel (**Figure 13**) required almost five turns to move the rudder from hard over to starboard to hard over to port and vice versa. The wheel had no markings to indicate when the rudder was amidships and the wheelhouse was not fitted with a rudder angle indicator.

It is also likely that the wheelhouse ergonomics contributed to some degree to the mate's poor situational awareness. There was no rudder angle indicator so he could not easily check whether or not the rudder was amidships. Further, *Millennium Time*'s wheelhouse was positioned forward and had no visual references in the foreground, other than the top of the flag staff that was very close to and below the wheelhouse windows (**Figure 11**). Consequently it would have been harder for the mate to detect *Millennium Time* starting to swing if he was focusing on distant objects, such as the vessels ahead or number 4 arch of Blackfriars Road Bridge, at that time.

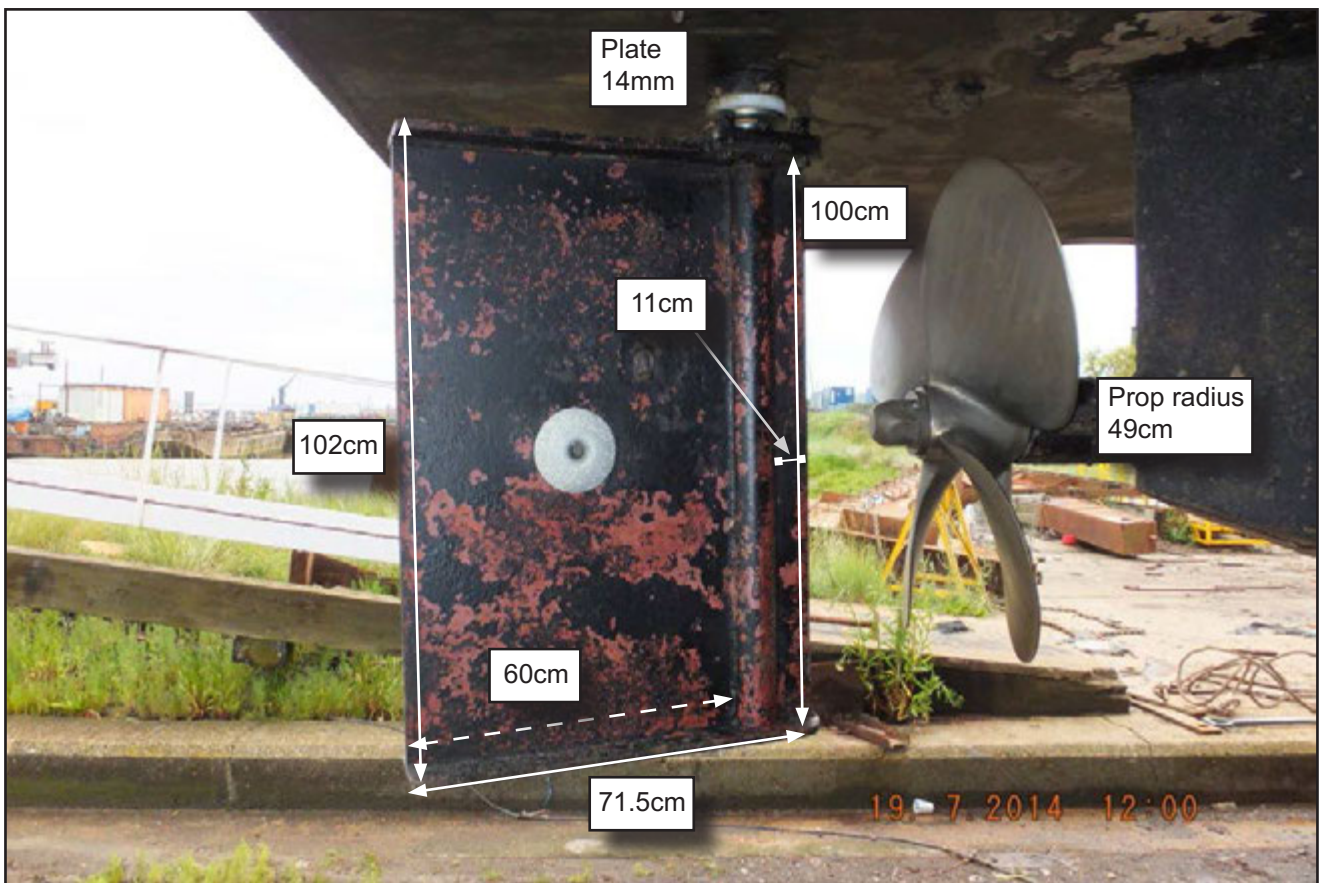
**Figure 14:** *Millennium Time*; rudders

Each rudder was 102cm high x 71.5cm wide, manufactured from 14mm steel plate (**Figure 14**). The rudders were not counterbalanced.
