Materials Technology Ltd - CO<sub>2</sub> cylinder report

## Examination of a Life Raft Gas Cylinder

| <b>Client:</b><br>MAIB<br>Mountbatten House<br>Grosvenor Square Southampton<br>SO15 2JU | <b>Date:</b> 4 <sup>th</sup> July 2016 | <b>Mat Tech Job No:</b> G6624 |

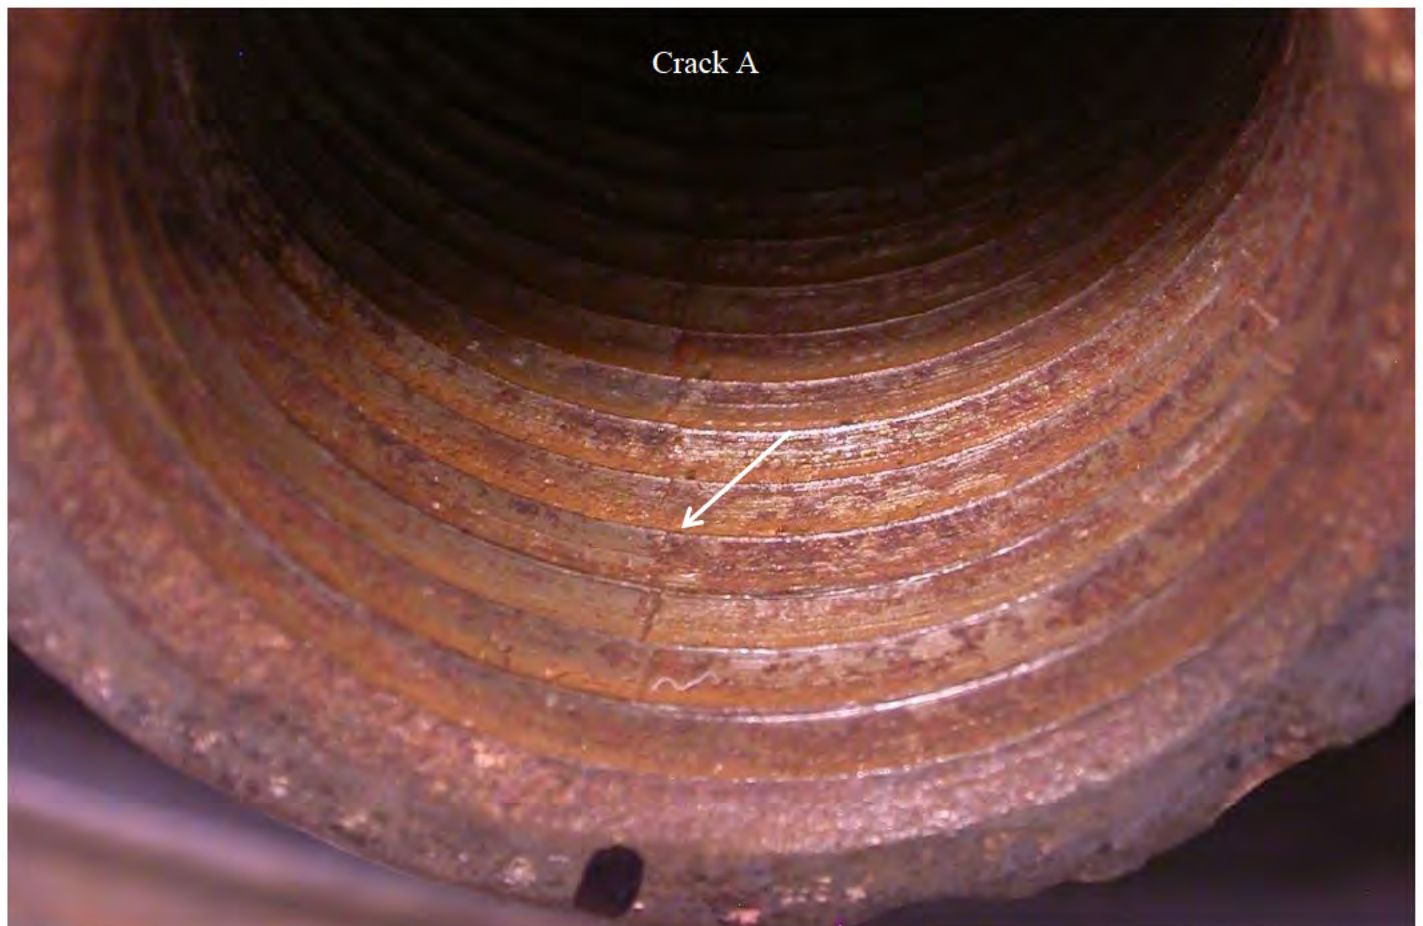
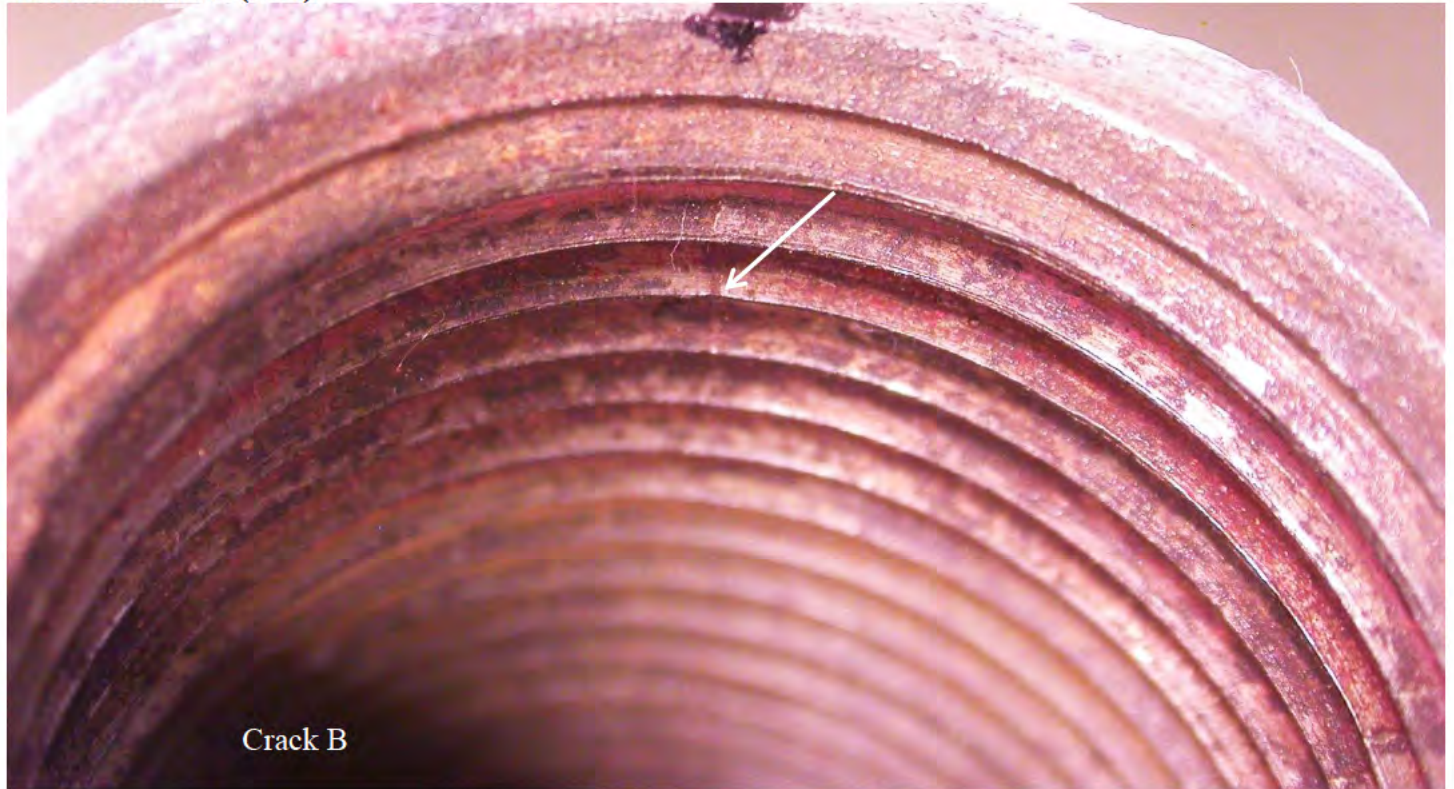
The internal regions of the neck were then examined initially using a low powered stereo microscope and then with a borescope to extend the region of examination beyond the threads into the body of the cylinder. Two regions with crack like defects were found running longitudinally down the inside of the neck approximately 90° apart. Views of the cracks are shown below and overleaf: For the purposes of the report these were denoted A & B.

Examination with the borescope did not reveal any evidence of the cracks extending beyond the threads into the body of the cylinder.

Examination of an emergency inflation gas cylinder has shown the presence of two cracks running longitudinally down the neck approximately 90° apart. Borescope examination has not revealed any evidence of the cracks having propagated beyond the end of the threaded region into the main body of the cylinder, however it should be stressed that it is not possible to clean the cylinder in this region and it is possible that cracks could be concealed by corrosion deposits etc.

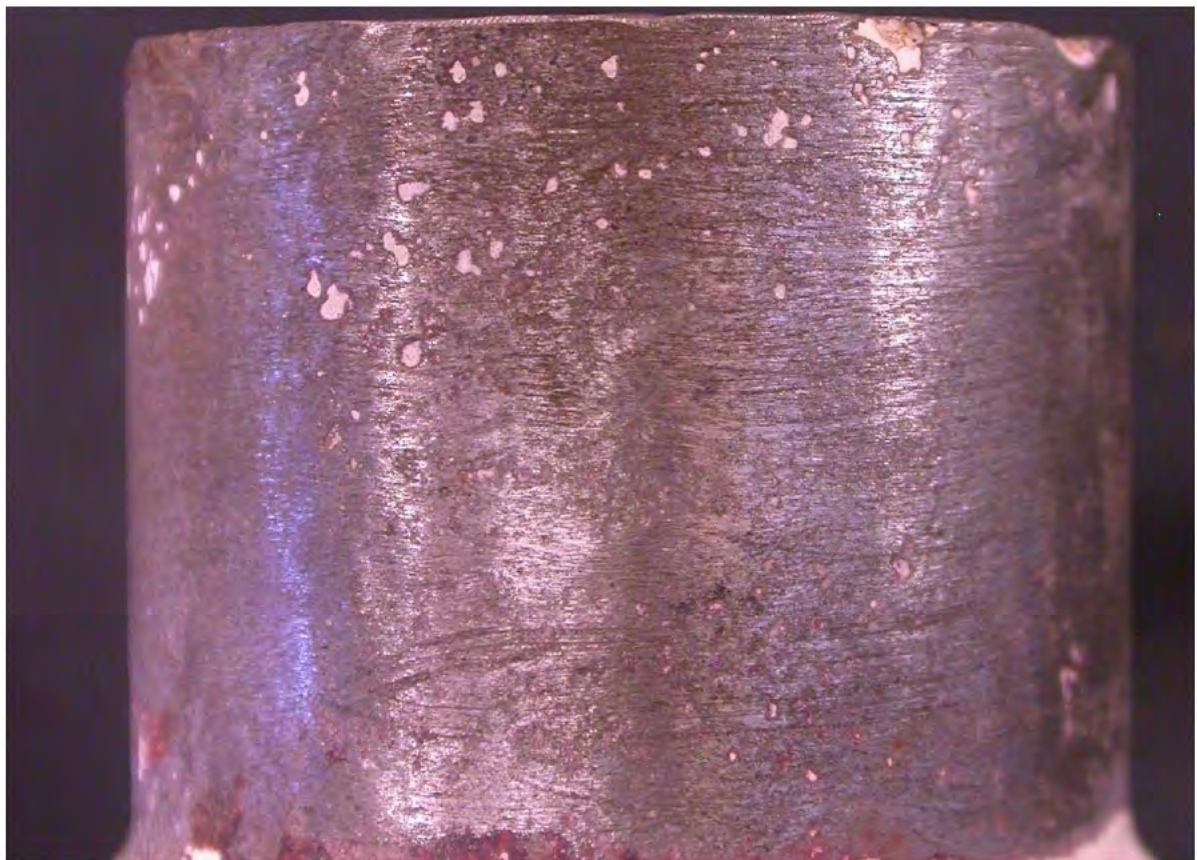
The external faces of the neck were then examined, however no evidence of the cracks having progressed through the wall were found. As an example view of the external face of the neck is shown below in the region of crack A.

Visual & dye penetrant examination has not shown any evidence of the cracks having penetrated through to the outside of the neck or the main body of the cylinder beyond.

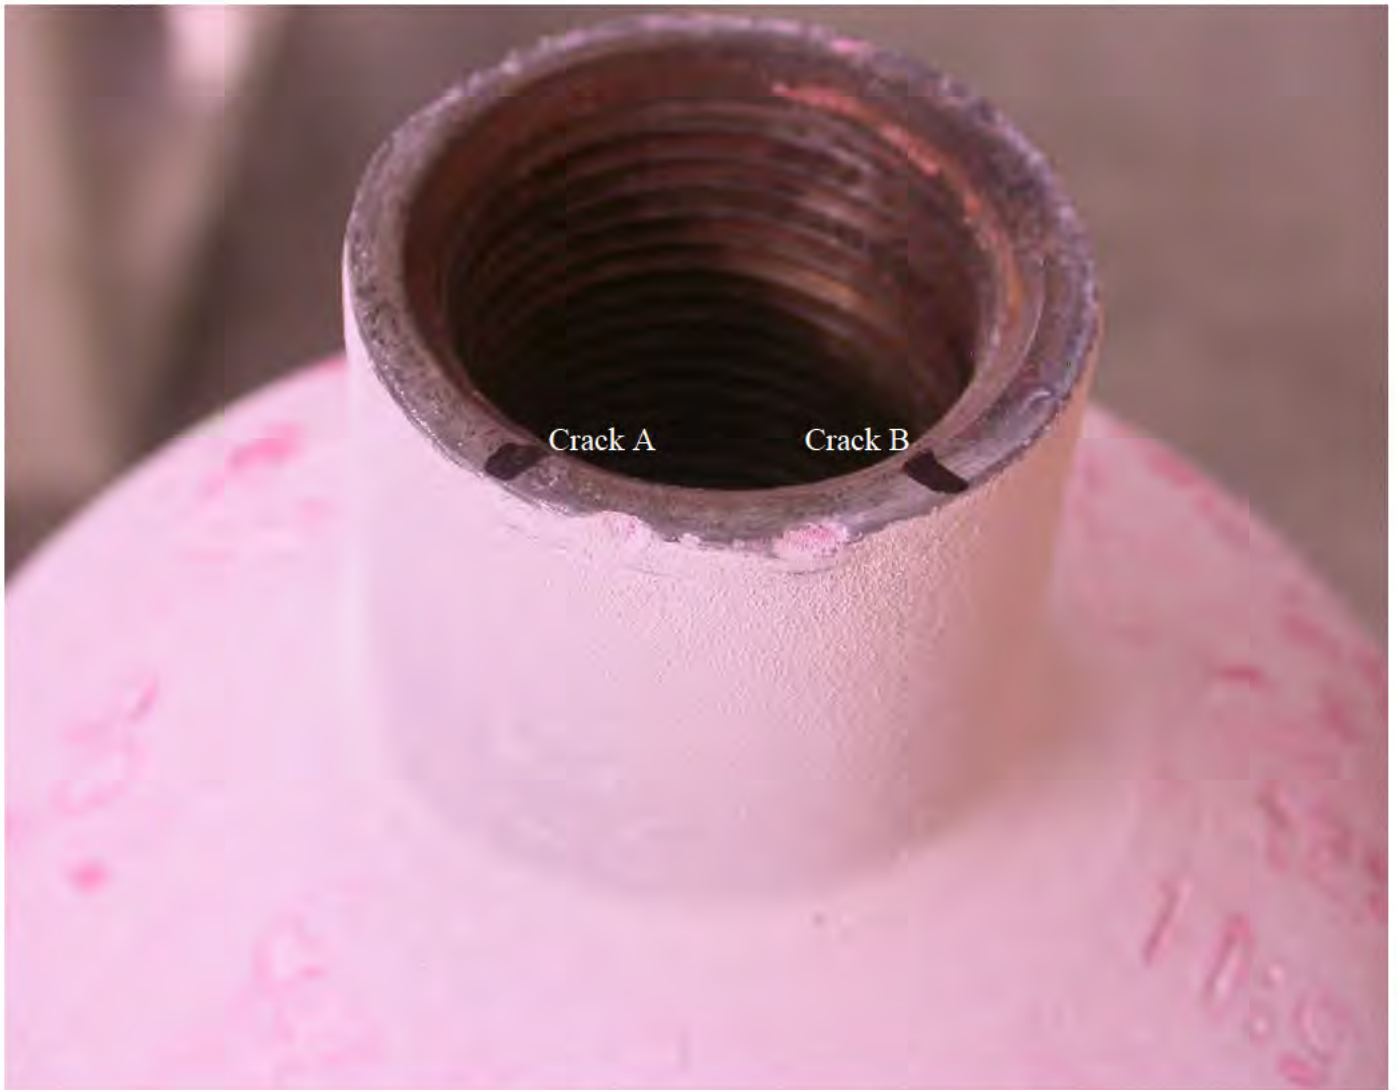
Dye penetrant testing was performed on the neck region of the cylinder as a further confirmation of the absence of through wall cracks. A view of the neck in the region of the 2 longitudinal cracks is shown below. As can be seen, there is again no evidence of the cracks having penetrated through the wall in either the threaded region, or beyond in the main body of the cylinder.

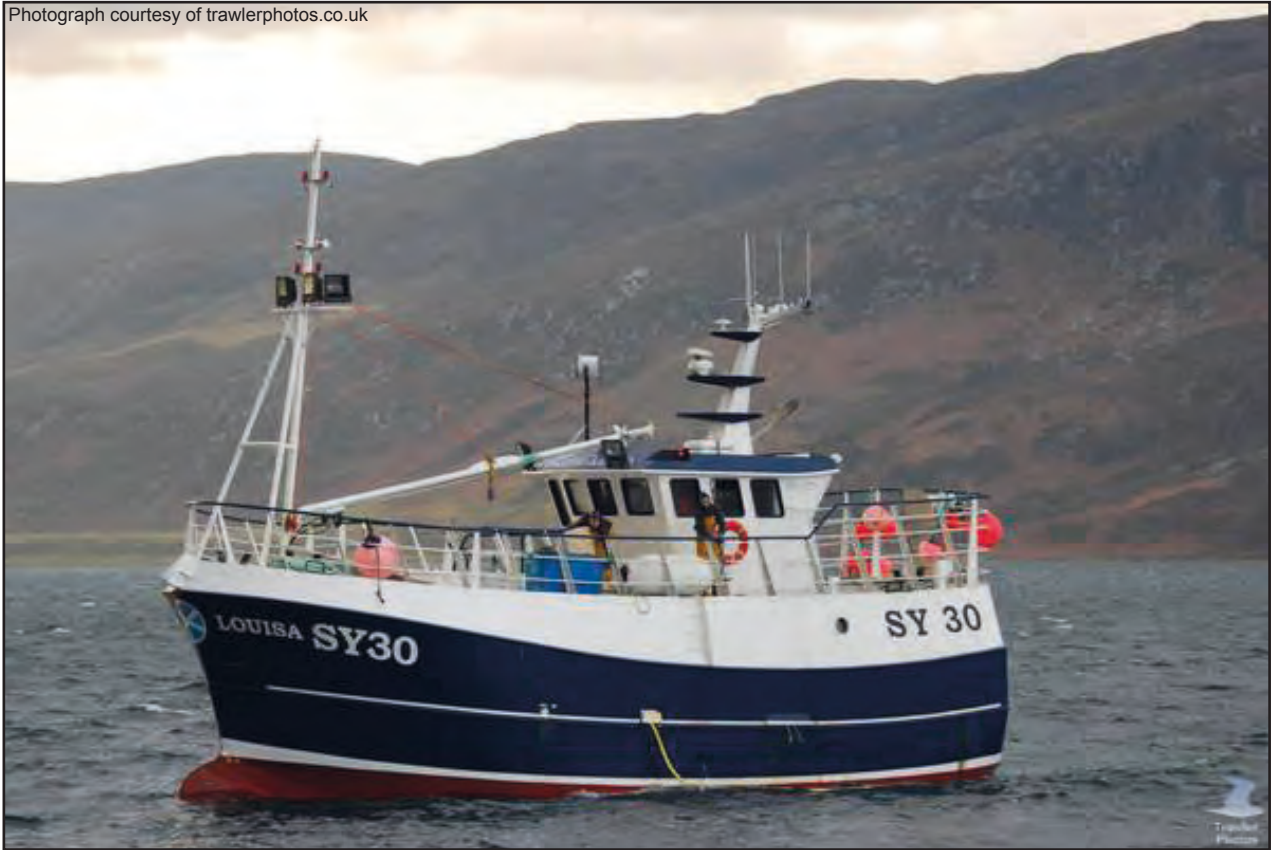
**Figure 1:** Fishing vessel *Louisa*

*Louisa*, a creel vessel fitted with a vivier system for maintaining the catch alive, foundered with the loss of three lives while anchored close to the shore in Mingulay Bay in the Outer Hebrides.

1. The skipper and crew had all gone to bed, leaving the wheelhouse unmanned despite the engine running apparently at slow speed with the propeller engaged astern, and the vivier system pump driven from the main engine power take off. All machinery and accommodation doors were left open and the hold hatch cover was secured in the open position. The deck wash pump had probably been left running, and it is concluded that flooding of the hold from the deck wash hose through the open hold hatch was the probable cause of the foundering.
