**Fatal man overboard from the fishing vessel  
*Pauline Mary*  
east of Hartlepool  
on 2 September 2016**

## SUMMARY

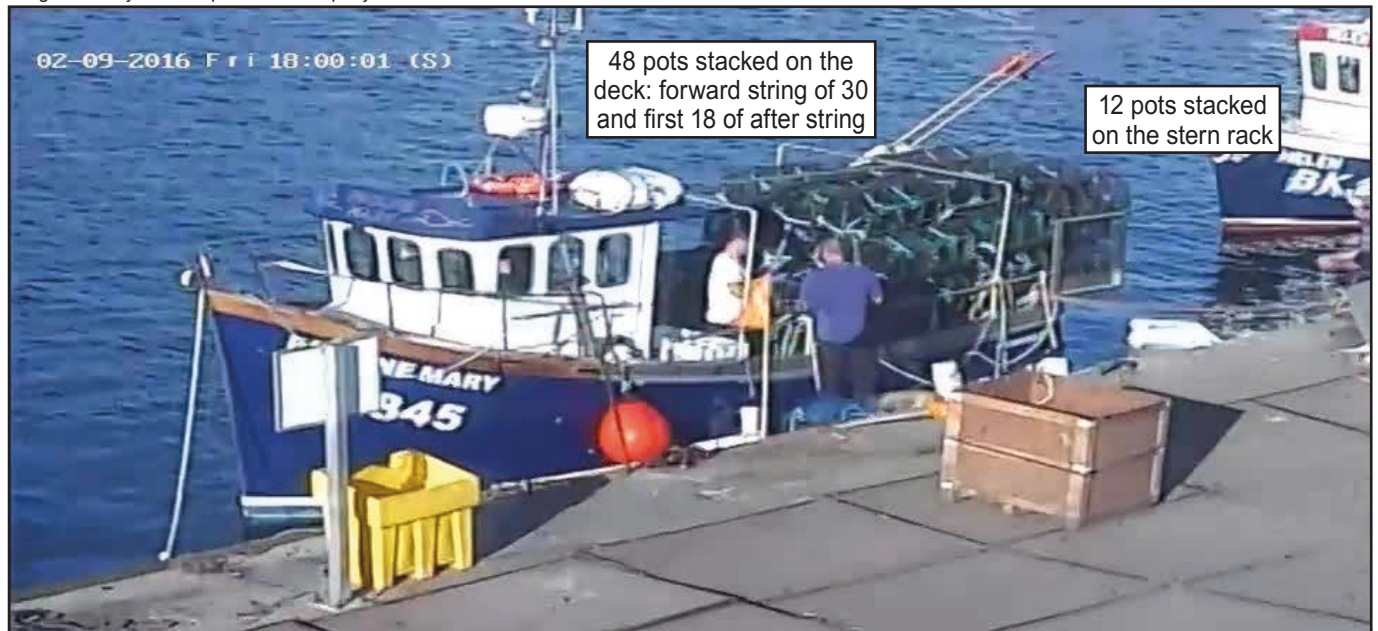
with one string of pots stacked on the forward end of the working deck and the other stacked behind. Eighteen pots from the after string were stacked on deck and 12 were stacked on the stern rack (**Figure 4**).

**Figure 4:** *Pauline Mary* at Hartlepool Fish Quay fully loaded prior to departure

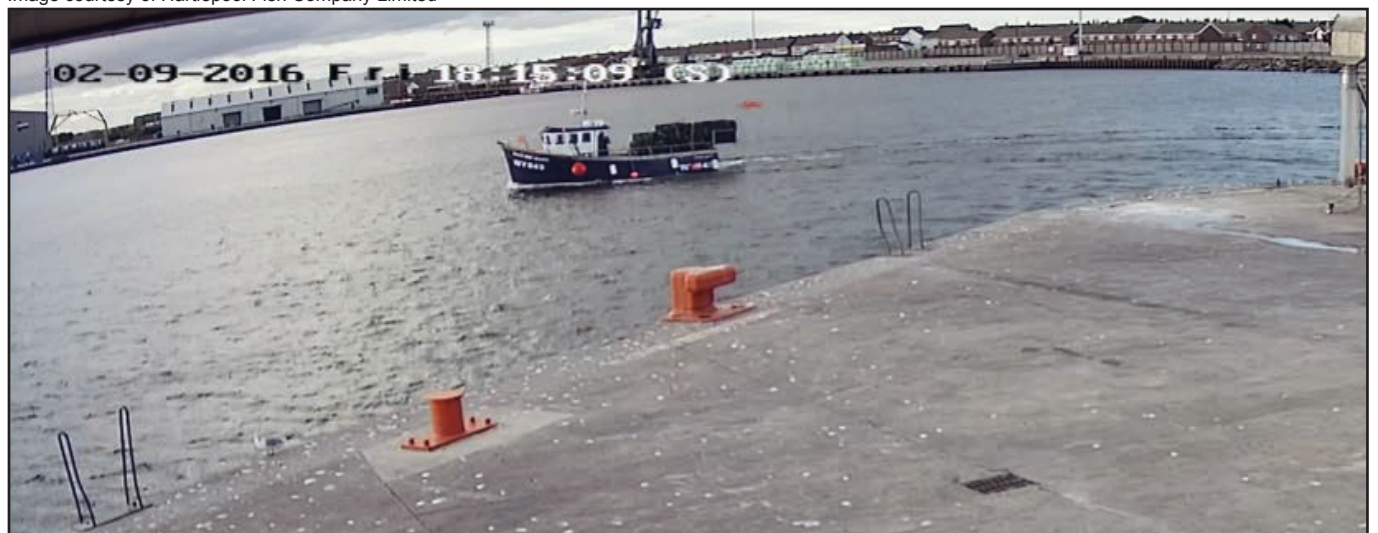
**Figure 5:** *Pauline Mary* departing Hartlepool Fish Quay at 1815

A female family friend and the skipper's 7-year-old son arrived at about 1810. Once they were on board, the skipper manoeuvred *Pauline Mary* out of the harbour and headed for the fishing grounds (**Figure 5**). The wind was westerly force 4<sup>2</sup>, the sea state was slight and visibility was good. The skipper's plan was to shoot the two strings of pots and then spend an hour or so sea-angling with his son.
