## SYNOPSIS

At 0455 on 24 October 2023, the Isle of Man registered general cargo ship *Verity* and the Bahamas registered bulk carrier *Polesie* collided in the German Bight traffic separation scheme. *Verity* sank quickly and five of the seven crew lost their lives. Before the collision, *Polesie* was heading westbound in the traffic separation scheme and *Verity* was heading northbound such that a risk of collision existed. *Verity* was required by the International Regulations for Preventing Collisions at Sea (IRPCS), 1972, as amended, to keep clear of *Polesie*.

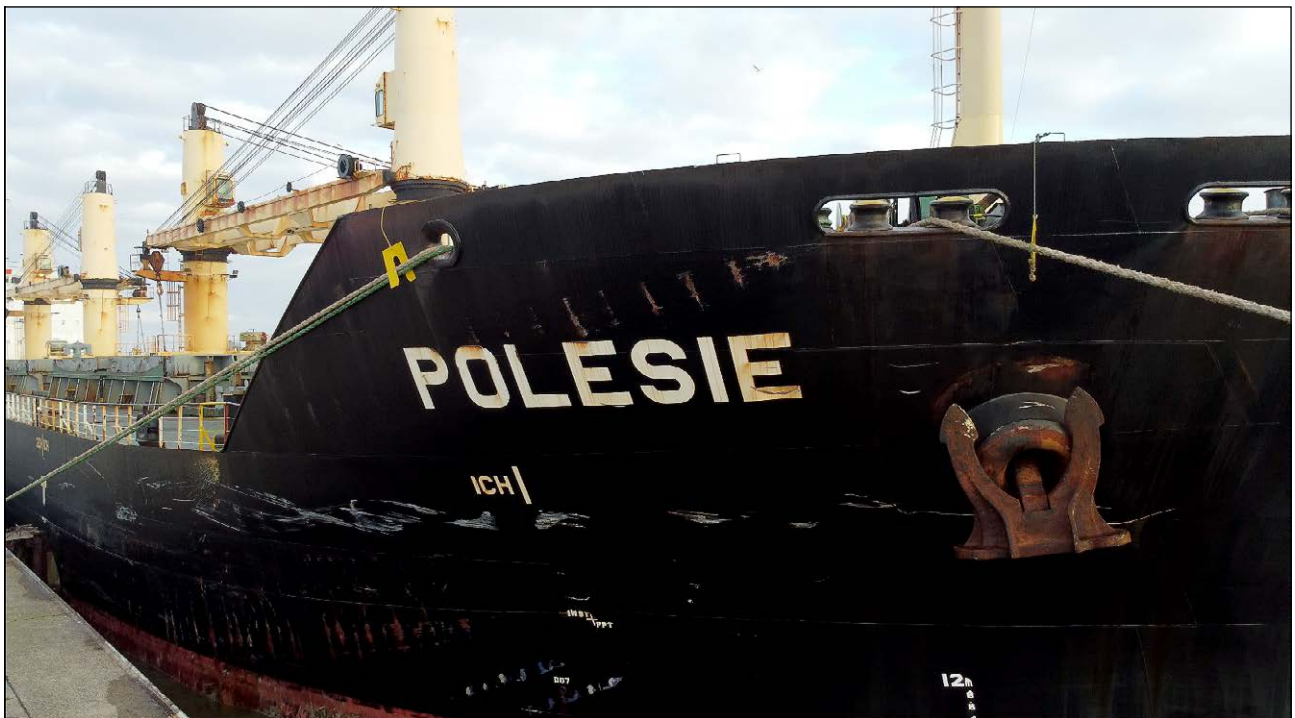
Following the collision, *Verity* was pushed around the bow and contacted the starboard anchor and the starboard side of *Polesie's* hull (**Figure 11**). *Verity's* speed reduced quickly as it scraped down the side of *Polesie*, on which the C/O had reduced the engine speed to half ahead.

**Figure 11:** Paint marks on *Polesie's* anchor and bow

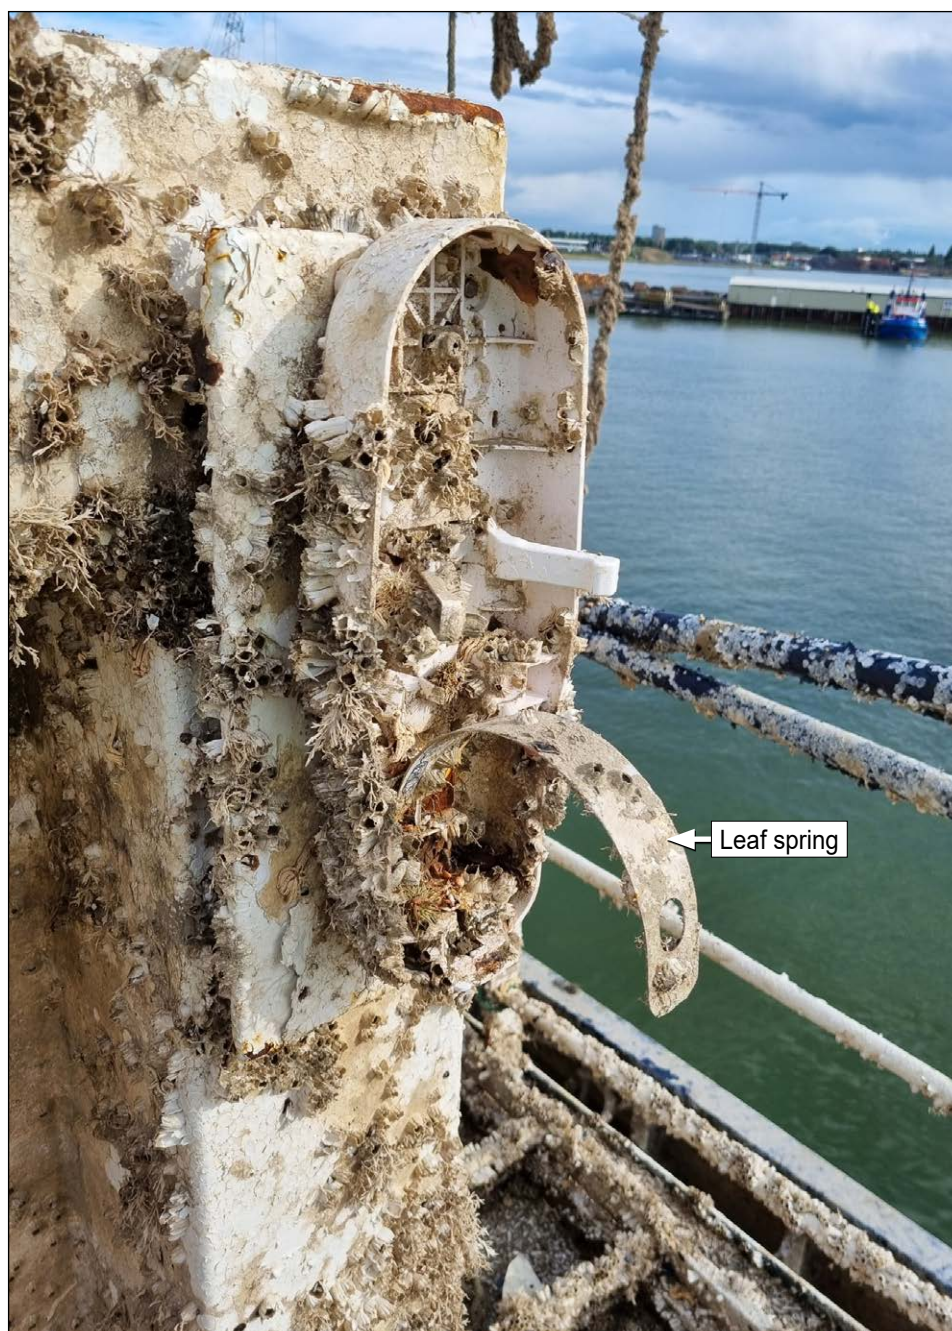
- The emergency position indicating radio beacon (EPIRB) was found on the aft deck. Its housing cover and hydrostatic release were absent and the leaf spring that ejected the EPIRB had activated (**Figure 15**). It could not be determined what had prevented the EPIRB from surfacing.
- The rescue boat was recovered on 18 November 2023.

**Figure 15:** EPIRB housing with cover missing and ejection leaf spring deployed
