## SYNOPSIS

At 0154 on 11 January 2014, the Liberia registered multi-purpose cargo ship *Rickmers Dubai* collided with *Walcon Wizard*, an un-manned crane barge which was being towed by the tug *Kingston* in the south-west traffic lane of the Dover Strait Traffic Separation Scheme. Following the collision, *Kingston* was pulled stern-first through the water until the towline ran free from its tow winch. *Walcon Wizard* was badly damaged and *Rickmers Dubai*'s hull was punctured above the waterline. The hydraulic system for the tow winch on board *Kingston* was also damaged. There were no injuries and there was no pollution. The accident occurred while the cargo ship was overtaking the tug and tow.

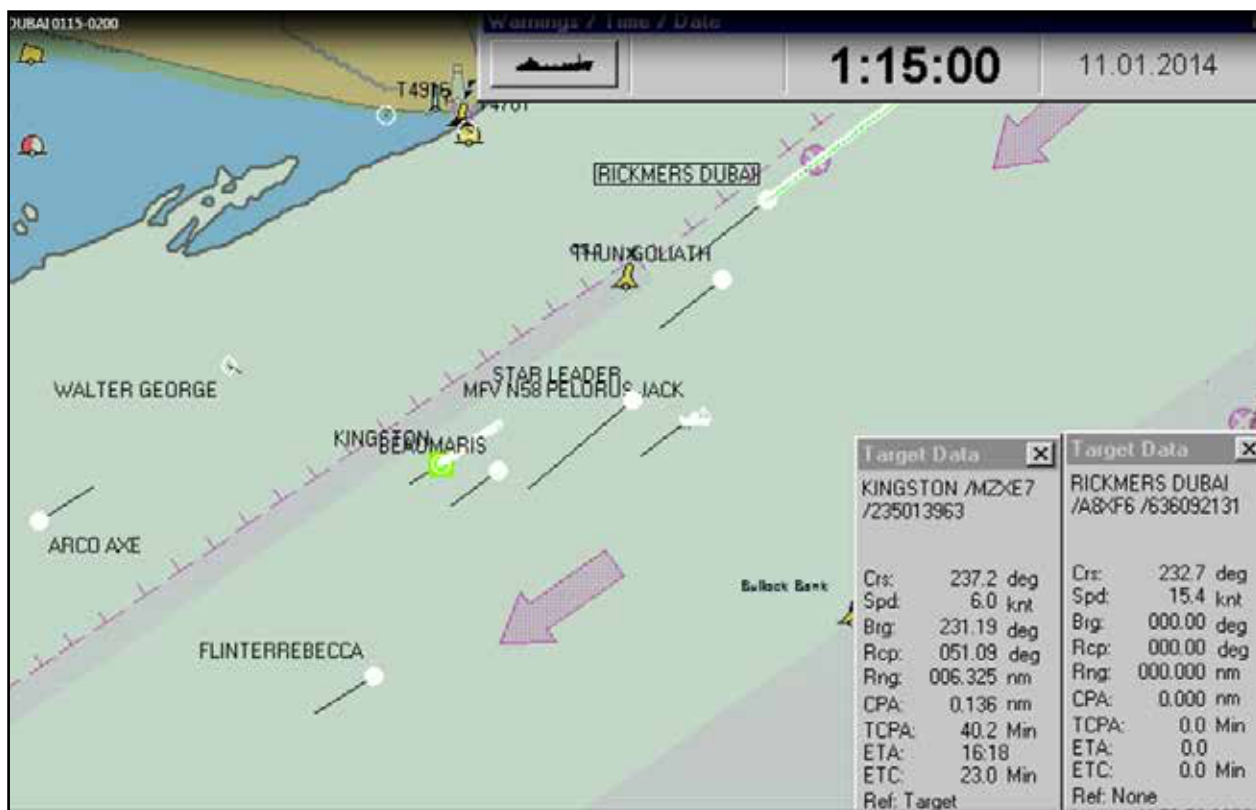
**Figure 1:** CNIS display at 0115

At 0115<sup>1</sup> on 11 January 2014, the multi-purpose cargo ship *Rickmers Dubai* was transiting the south-west lane of the Dover Strait Traffic Separation Scheme (TSS). The vessel was on passage from Hamburg, Germany, to Genoa, Italy, with cargo in its hold and on deck. *Rickmers Dubai* was making good a course over the ground (COG) of 233° at a speed over the ground (SOG) of 15.4 knots (kts) (**Figure 1**).

Directly ahead of *Rickmers Dubai*, at a range of 6.3nm was the tug *Kingston*, which was towing the unmanned crane barge *Walcon Wizard*. The tug and tow were on passage from Ipswich, UK to Southampton, UK. The length of the wire towline was 250m. The tug was making good a COG of 237° at a speed of 6kts and was keeping to the northern edge of the traffic lane to enable other vessels to pass down its port side. The predicted closest point of approach (CPA) between *Rickmers Dubai* and *Kingston* was about 250m at 0155.

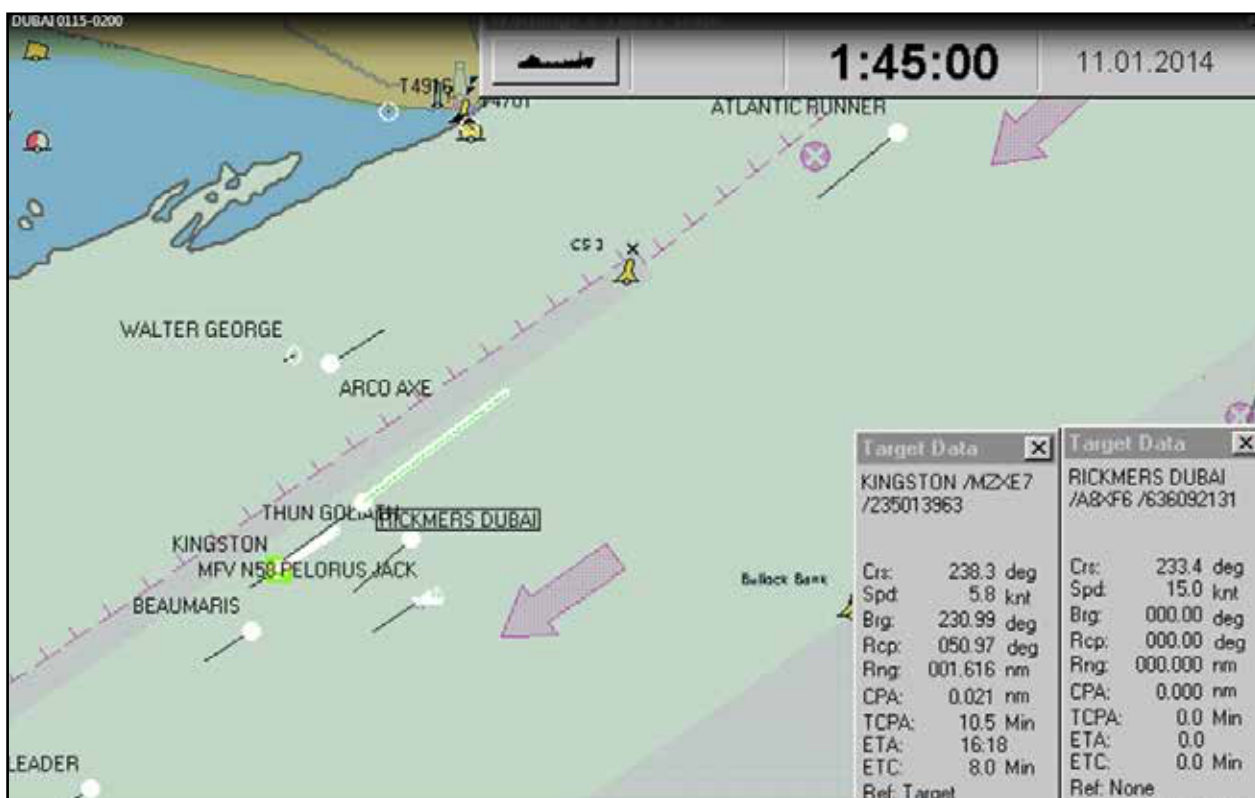
Figure 2: CNIS display at 0145

At 0145, the distance between *Rickmers Dubai* and *Kingston* had reduced to 1.6nm and the CPA of the vessels was 40m (**Figure 2**). At about this time, *Kingston*'s wheelhouse watchkeeper became aware of the cargo ship approaching on the tug's starboard quarter. He assessed that, although the cargo ship was close, it would pass clear down the starboard side of *Walcon Wizard* and *Kingston*. The watchkeeper noticed that the automatic identification system (AIS) data included the

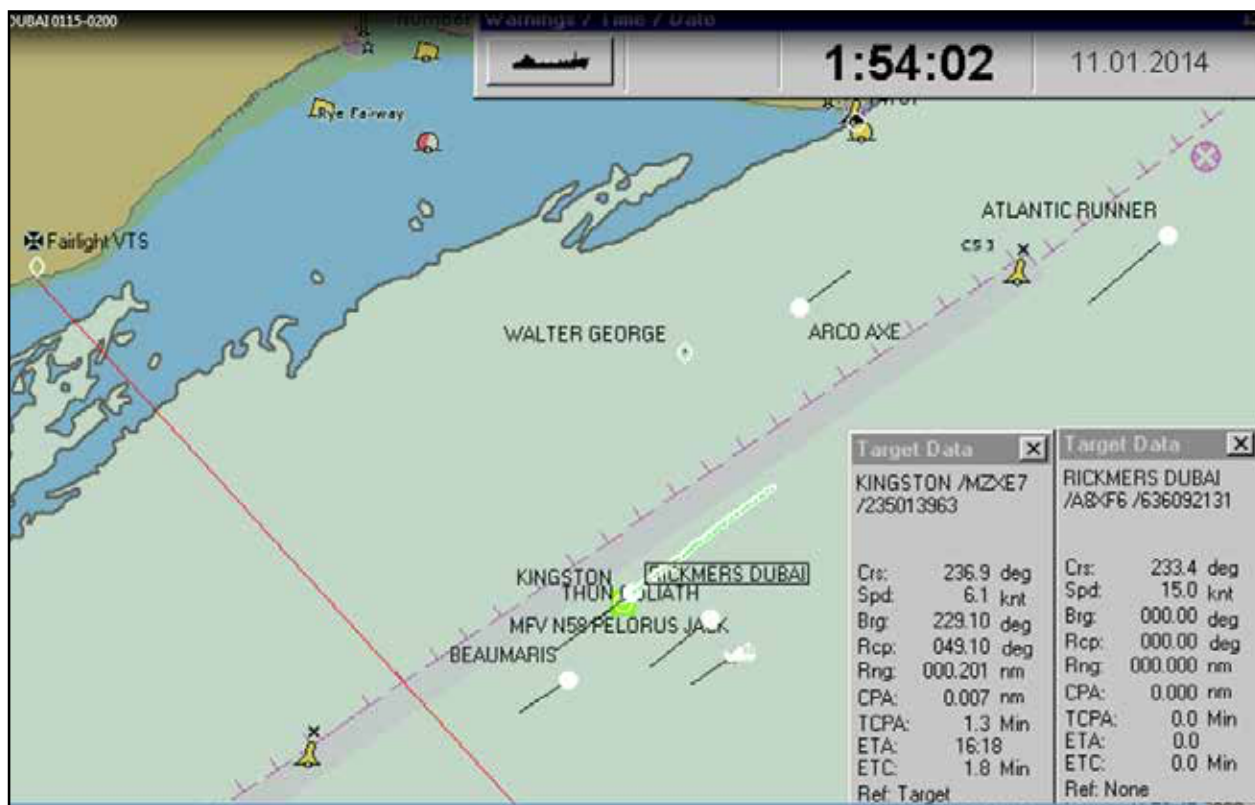
Figure 3: CNIS display at 0154

Shortly after, *Rickmers Dubai's* second officer, who was the officer of the watch (OOW), saw *Kingston's* lights very fine off the cargo ship's port bow. At 0154, he adjusted the autopilot to port in order to overtake the tug on its port side (Figure 3). Seconds later, *Rickmers Dubai* collided with *Walcon Wizard*. It then passed between the crane barge and the tug, catching on the towline as it did so.

The VHF call was heard by *Rickmers Dubai's* OOW, who quickly reduced the ahead pitch on the controllable pitch propeller (CPP) from 83% to 29%. As *Rickmers Dubai* overtook *Kingston*, the lead of the towline moved from astern to ahead, which pulled the tug through 180°. *Kingston* was then towed stern-first.
