## SYNOPSIS

At 1851 on 20 December 2009 the Singapore registered bulk carrier *Alam Pintar* was in collision with the UK registered fishing vessel *Etoile des Ondes* 15 nm north of the Cherbourg peninsula. As a result of the collision the fishing vessel sank; one of her four crew, Chris Wadsworth, tragically lost his life.

### 1.1 PARTICULARS OF *ETOILE DES ONDES*, *ALAM PINTAR* AND ACCIDENT

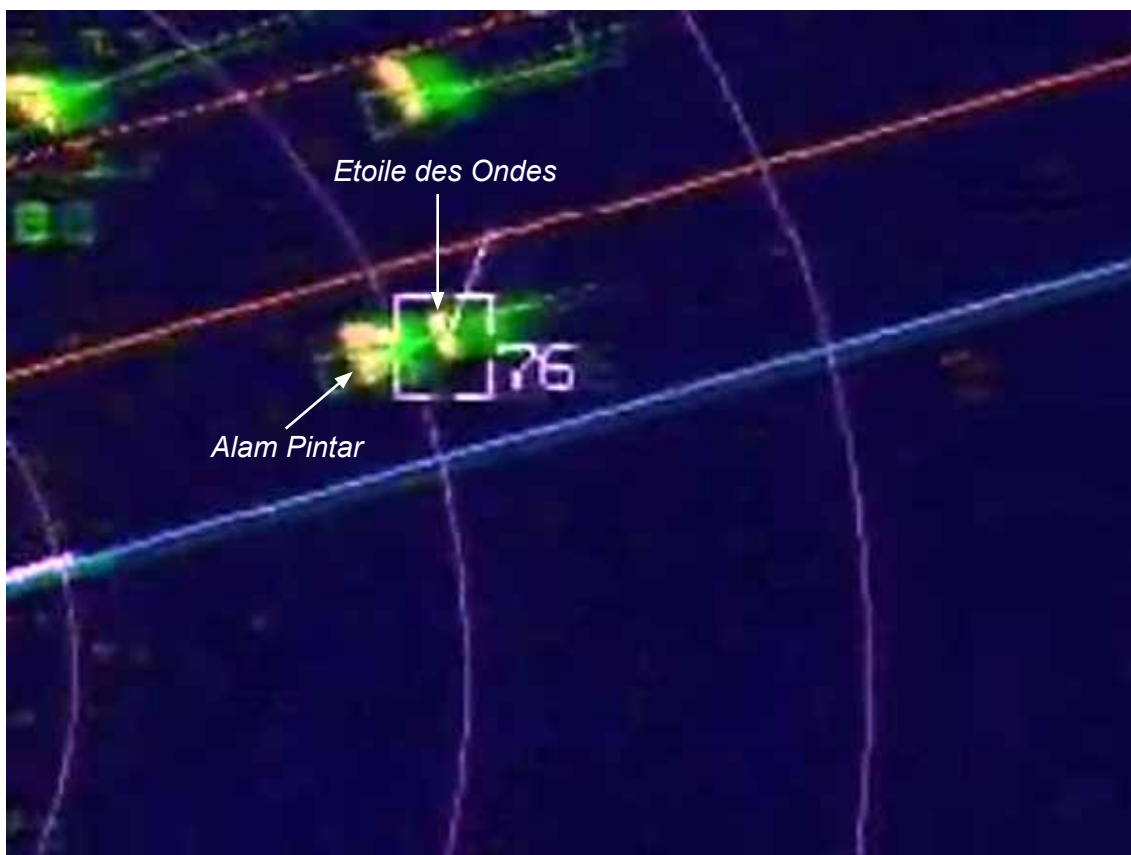
Although the 4<sup>th</sup> officer was unsure about the actions of the fishing vessel, he did not consider using the whistle to warn the other vessel, nor did he call the master. Instead, he engaged manual steering, instructed the cadet to take the wheel, and then altered the course back to port onto a heading of 072° (G). This was intended to place the fishing vessel at a broader angle on the starboard bow. However, both the radar target and working lights remained ahead of *Alam Pintar* (**Figure 5**).

Radar screen shot showing *Etoile des Ondes* still ahead of *Alam Pintar* with a vector to the north

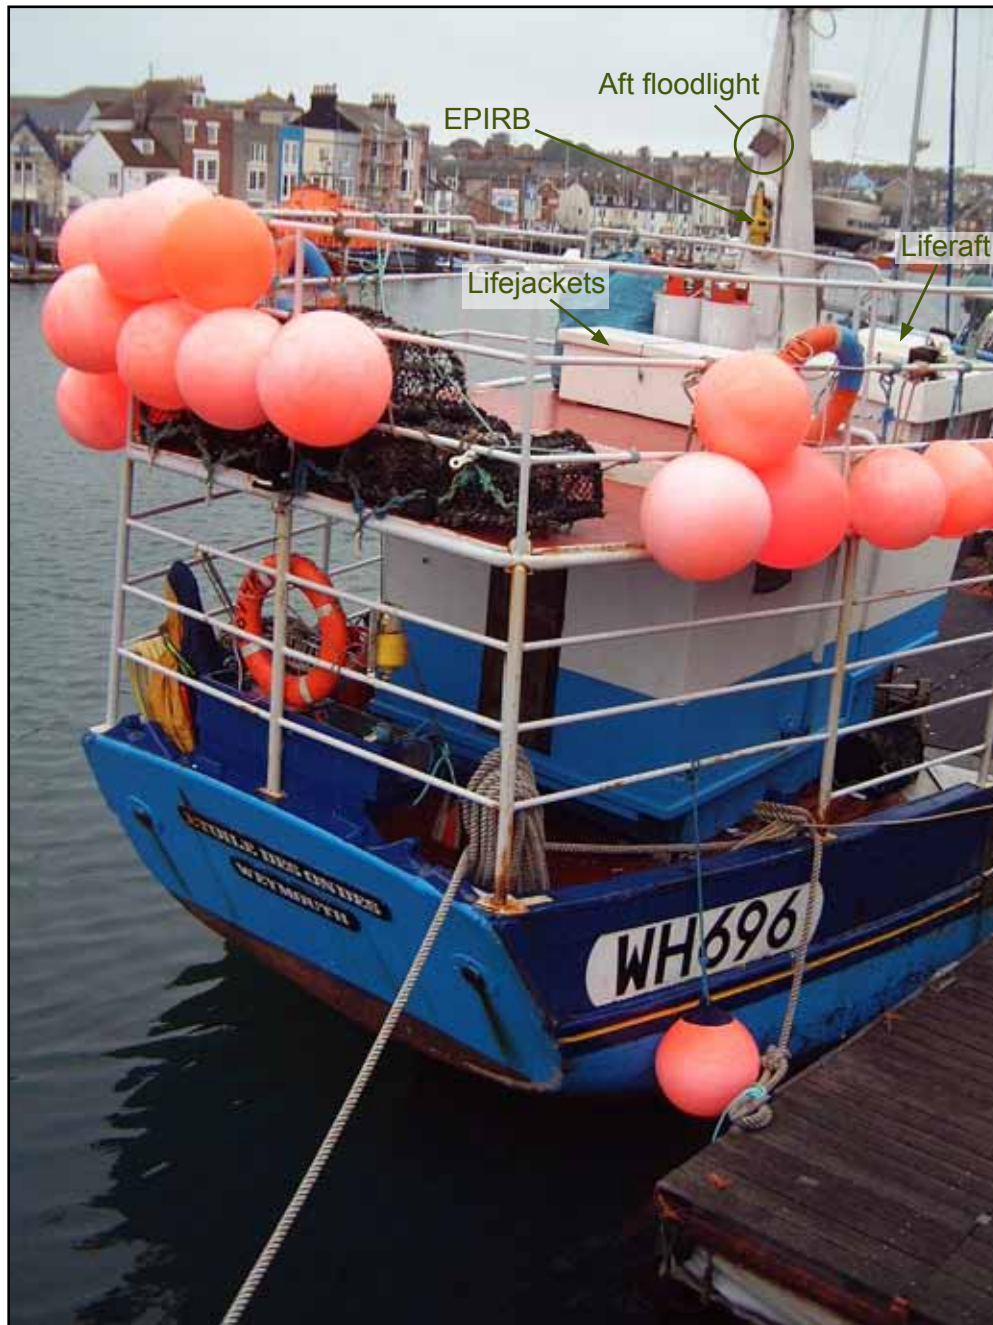
Figure 9

When the skipper climbed out of the wheelhouse, he released the liferaft from its stowed position on top of it (**Figure 9**). Inflating it manually, he boarded along with the crew. It was at this time that they realised Chris was missing. Despite shouting and searching for him in the water, he could not be found.

General overview of *Etoile des Ondes*' wheelhouse top and quarter deck  
(deck shelter omitted for clarity)
